TORNADO PROJECT SUMMARY SHEET

Investigation dates September 22 and 26, 1984 Investigation, photographs and report by Steven Leitch Downsview office 667-4662

INTRODUCTION:

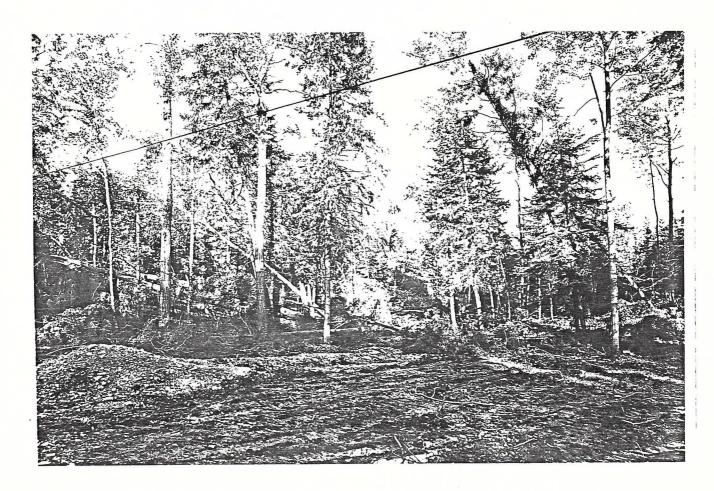
3) (ABOVE) A number of trees were knocked down in a bush area near a cottage road. They were mostly poplars and conifers that fell, generally, northward.

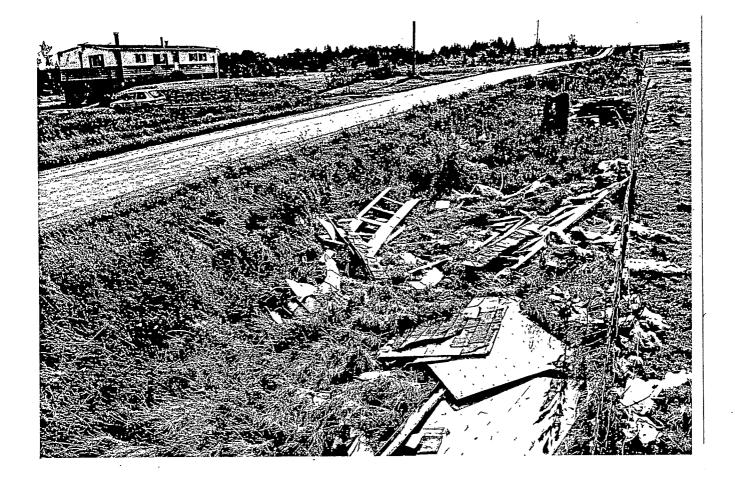
Looking southwest at the house that had half of its roof removed by by the storm. The disintegrated roof lays strewn in the foreground of this photo.

- 5) (PHOTOS OPPOSITE) A modular home had the south half of its roof ripped off and blown 100m northeast where it landed disintegrated and strewn for another 50m. Shredded pink fiberglass insulation could be seen scattered along a line to the northeast through an open field. Most of the windows on the south side were broken, the southwest wall had been pushed in and the TV tower folded northeast over the edge of the roof.

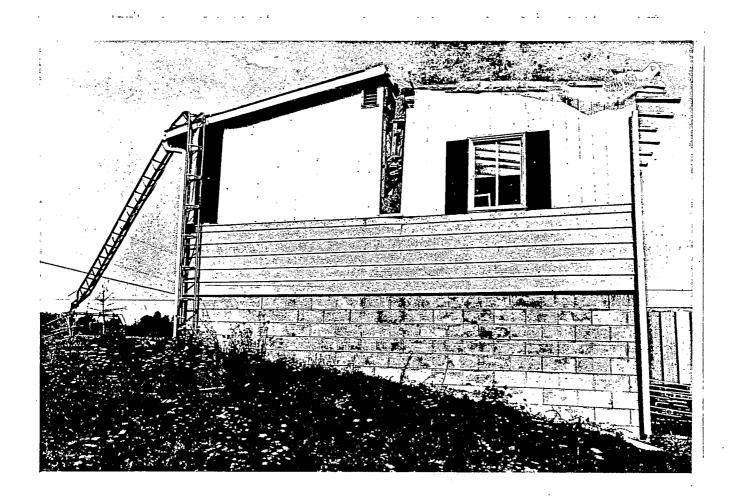
Looking at the west wall of the modular home with half its roof missing. At the time of this photo the house was in a partial state of reconstruction 12 days following the storm.

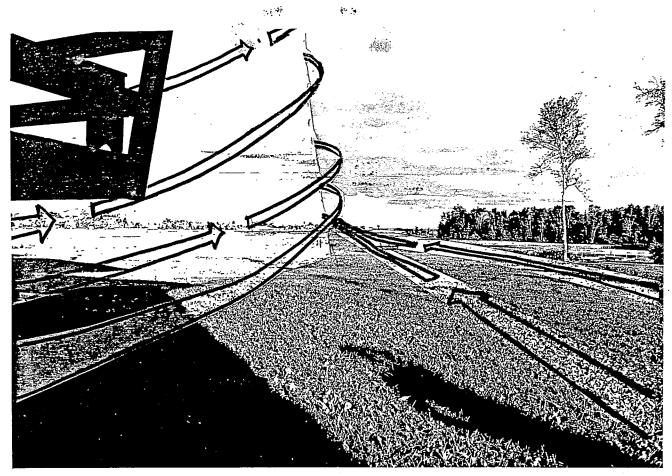
- 4) (ABOVE) EYEWITNESS Doug Varcole telephone 705-438-3591 Doug Varcole's house is located on the northwest corner of Canal Lake. He was at home in his basement office when the storm struck. At about 4:30 pm the clouds became dark, he heard banging noises outside and suddenly for a few seconds there was a ' screaming roar like a jet plane that was about to crash into his house '. He sensed that the house was straining under the wind and thought that it was going to let go. He then looked eastward from his basement window and viewed a rushing wind curving counter-clockwise away from him and carrying debris outward and upward over the lake (as reconstructed in the ABOVE photo). At his house and the adjacent houses TV antennas were broken, trees were uprooted to the northwest, another tree was broken eastward, some shingles were removed, small boats were thrown onto shore or conversely into the water, a satellite dish heart was wrecked and a metal garden shed (which had been screwed down to a wooden platform) was dismantled and blown northwestward. One piece of the shed was wrapped over a power line.

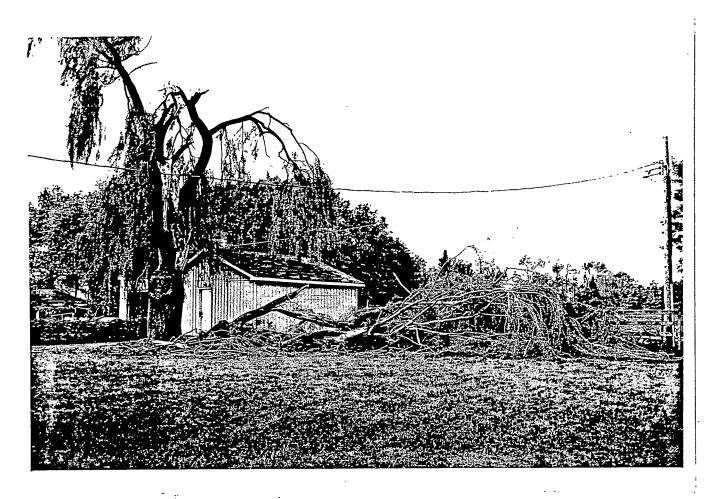
A broken willow tree at the Sharps (location 6) at Fox' Beach

over power lines at 4:30 pm. A large willow tree had some of its
 branches knocked off (see photo OPPOSITE-TOP) and smaller branches
 were strewn down a field northeastward. Trees that lay on power lines
 were reported to have been burning. Some lawn furniture left outside
 had not been moved at all. There had been no lightning or thunder
 during the storm and afterwards the sun came out making it a nice day.

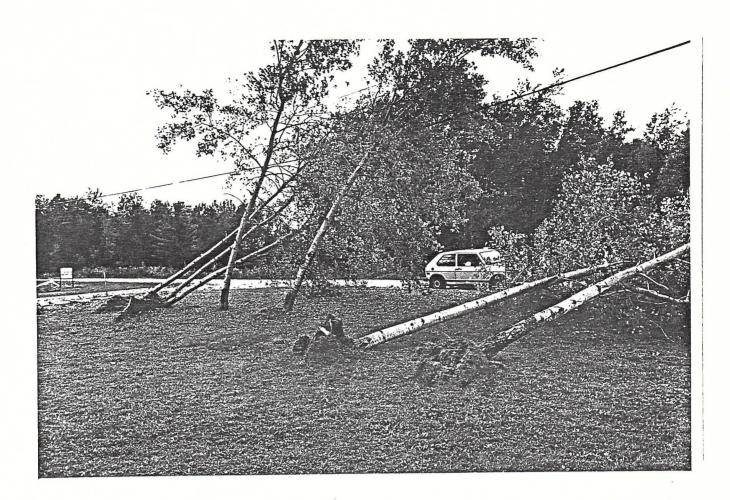
This is an extra photograph of the damage at Doug Varcole's house. (Location 4) These trees on his lawn have been uprooted to the northwest while another tree only 20 m away (not shown) fell to the east.

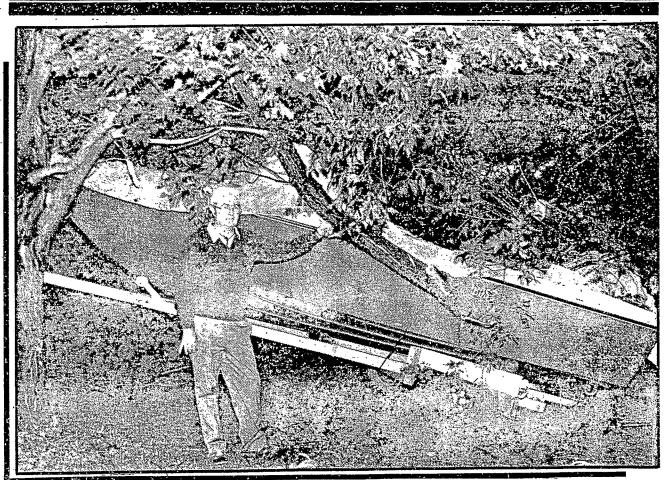
John Naylor of Oshawa arrived just in time to help a friend begin removing tree limbs dumped on his boat by the storm.
