**Confirmed Tornado
Franktown, Ontario
May 16, 2000**

Tornado F-Scale Assessment

Explanation of Assessment: Old barn of questionable construction blown down.
Siding and steel roofing blown around.

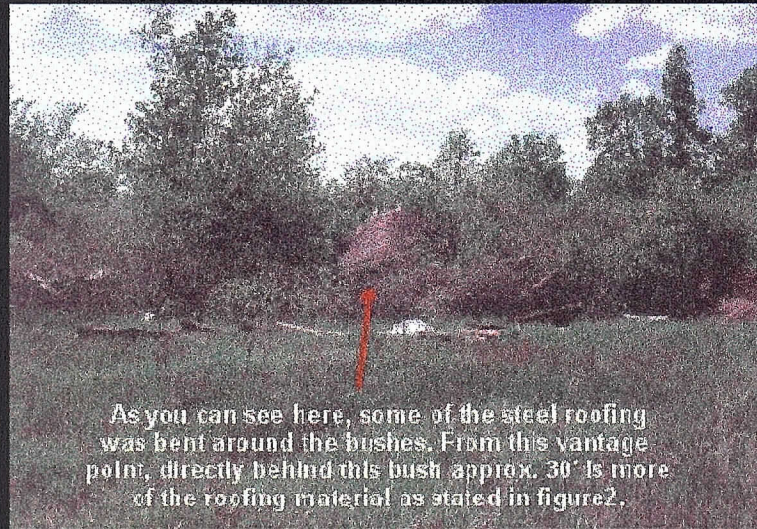
figure7.gif

As you can see here, some of the steel roofing was bent around the bushes. From this vantage point, directly behind this bush approx. 30' is more of the roofing material as stated in figure2.
