**Confirmed Tornado
Florence, Ontario
August 7, 2003**

Tornado F-Scale Assessment

Storm Damage Survey - 7 August 2003

- Florence -

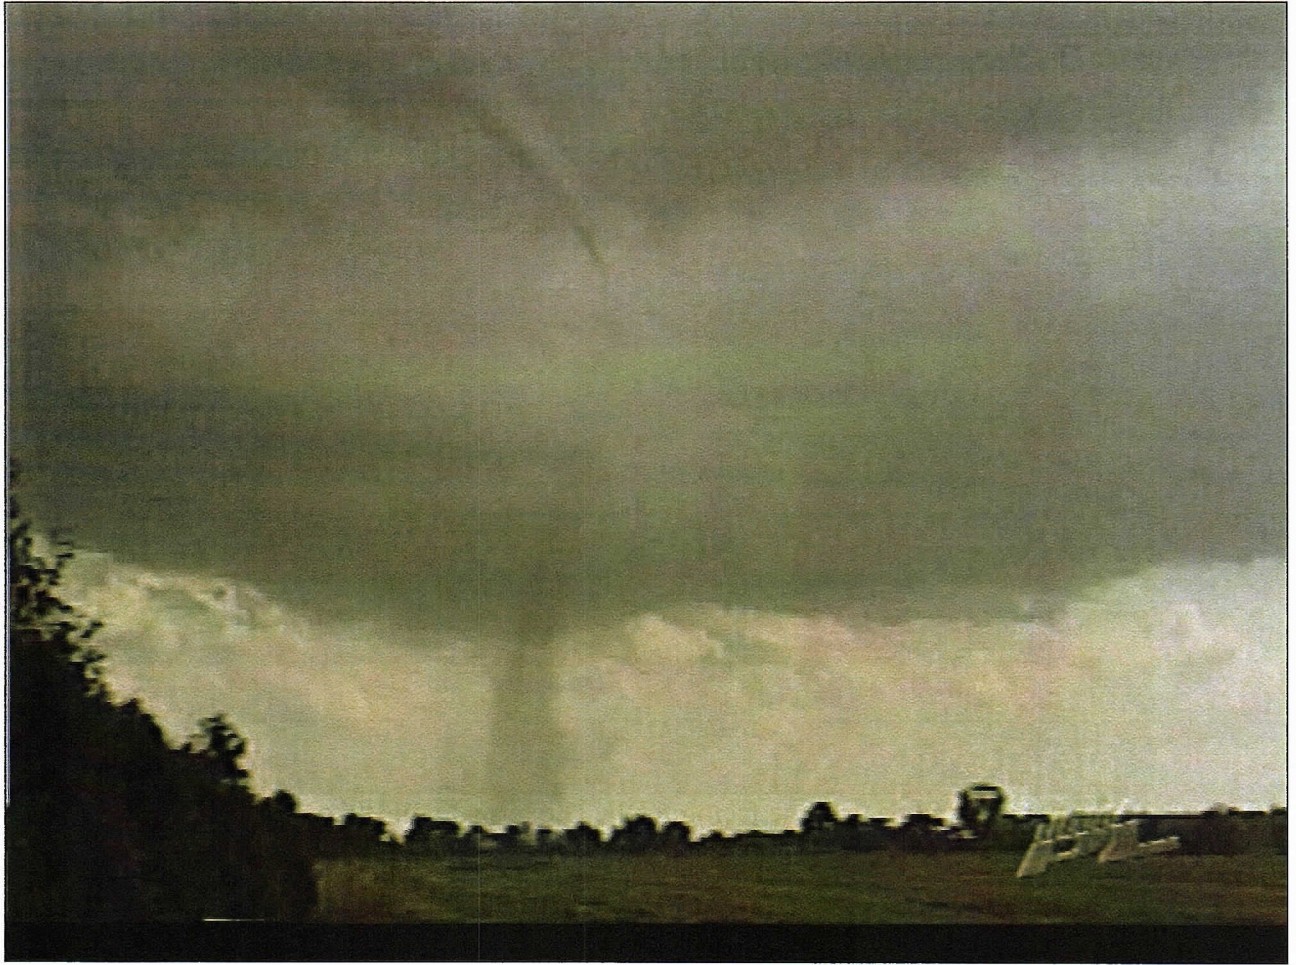
The following video capture shows the tornado with a funnel cloud protruding from cloud base and dirt / debris revealing the lower part of the vortex. There is little evidence of a lowering commonly associated with supercell tornadoes. Mr. Tamminga recalled that the vortex was rotating cyclonically. Further careful inspection of his video supports this.

Video capture of tornado as shown on the New PL courtesy of Ben Fuller.

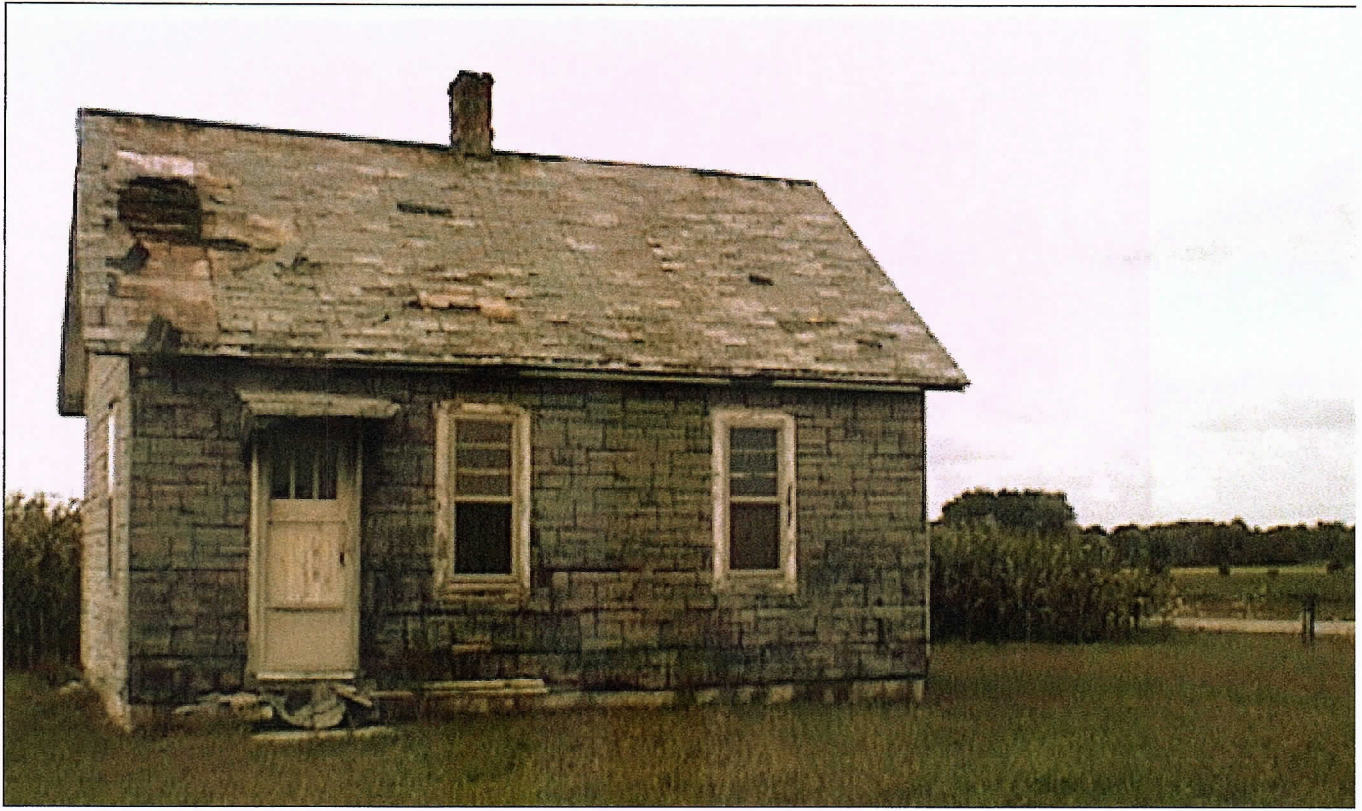
Explanation of Assessment: Some shingles knocked off an old shed.

An eyewitness that saw the tornado from his residence roughly 200 m north of the tornado's path said that the tornado tore shingles off on an old shack and tore through the crops on the east side of the road, moving in a northeasterly direction for about 1 km. The shack, shown below, did have sections of shingles removed. Shingles were found on the ground both to the west and the east of the shack and up to 20 m away. A tree branch was found on the ground on the east side of the road. It had been broken off a maple tree close by. There was little crop damage along the tornado's track. A few stalks of corn were torn out and there was one area of beans that appeared to be flattened. It is surprising that damage was so light considering the dirt and debris churned up by the tornado, as shown in the video capture and even more clearly in the video. In any case, such damage is consistent with a rating of F0 on the Fujita scale (Fujita 1981).

Shack with shingle damage facing NNE. The tornado moved over the shack and into the bean fields shown at the right side of the photograph.

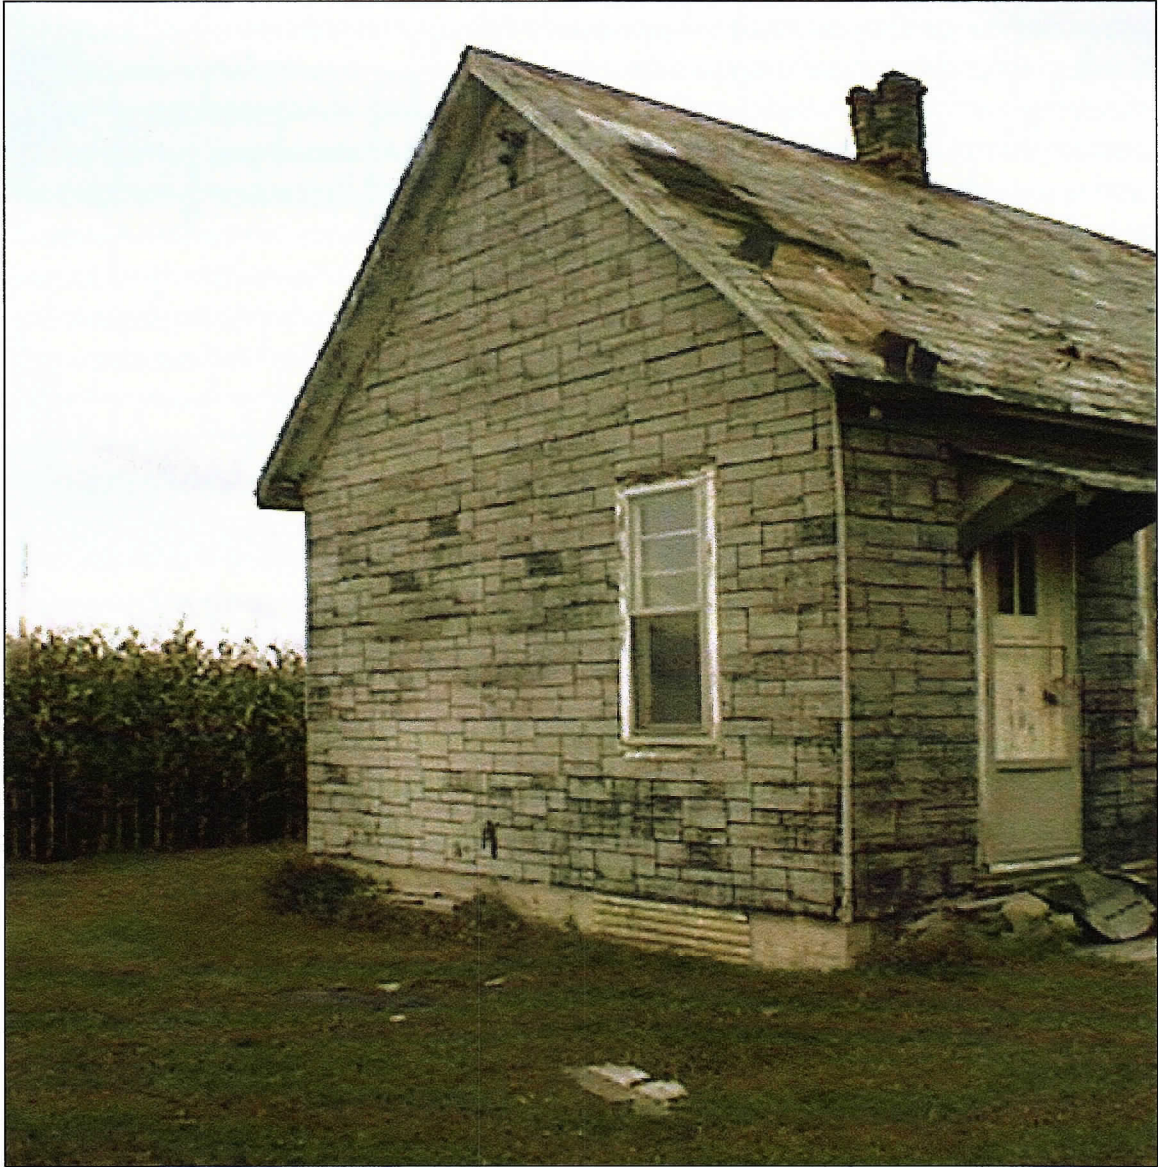
Shack and shingles on ground facing NE.

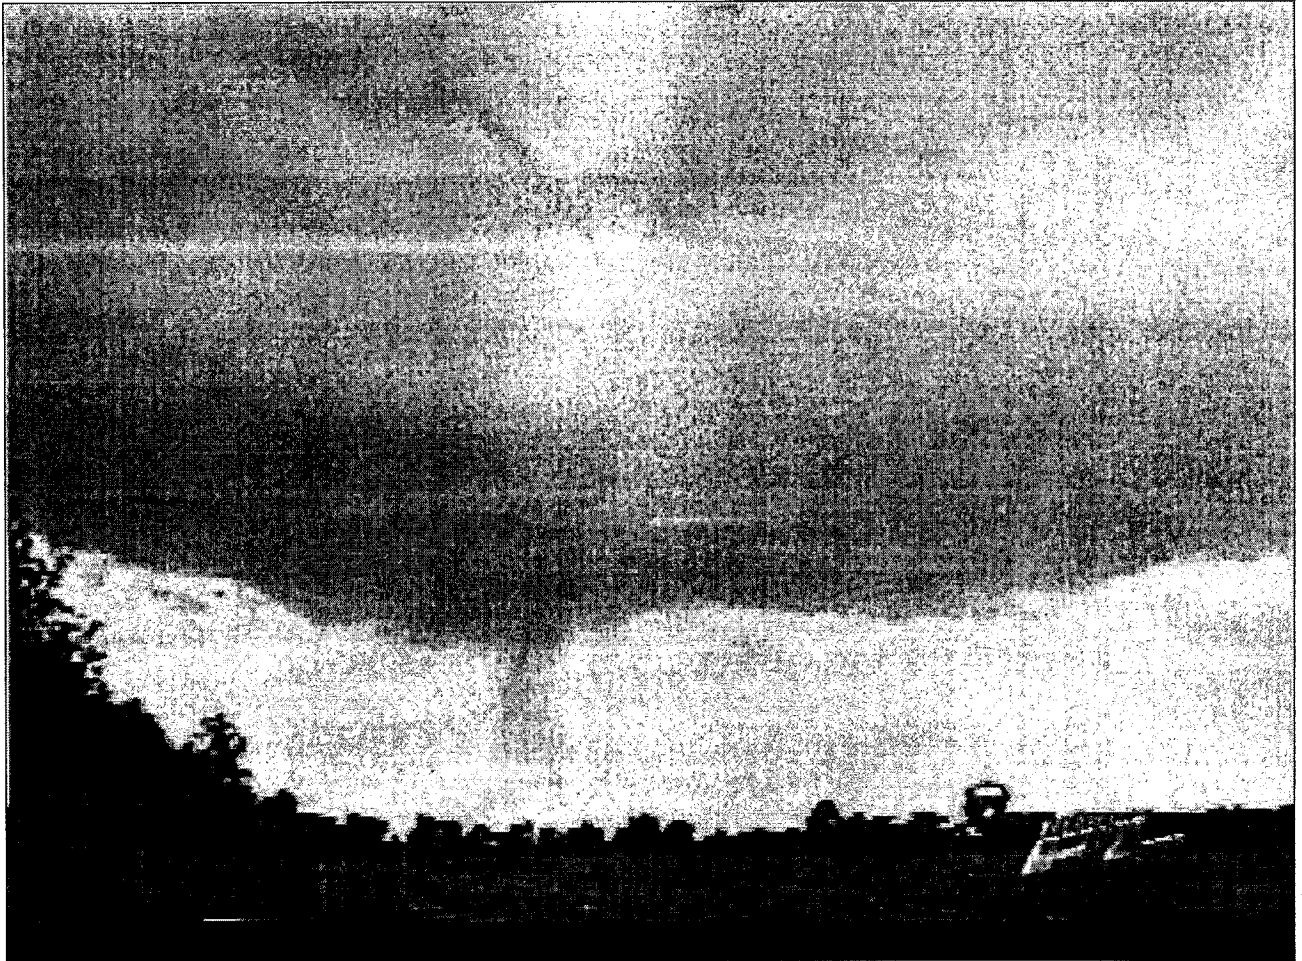
The following video capture shows the tornado with a funnel cloud protruding from cloud base and dirt / debris revealing the lower part of the vortex. There is little evidence of a lowering commonly associated with supercell tornadoes. Mr. Tamminga recalled that the vortex was rotating cyclonically. Further careful inspection of his video supports this.

Video capture of tornado as shown on the New PL courtesy of Ben Fuller.

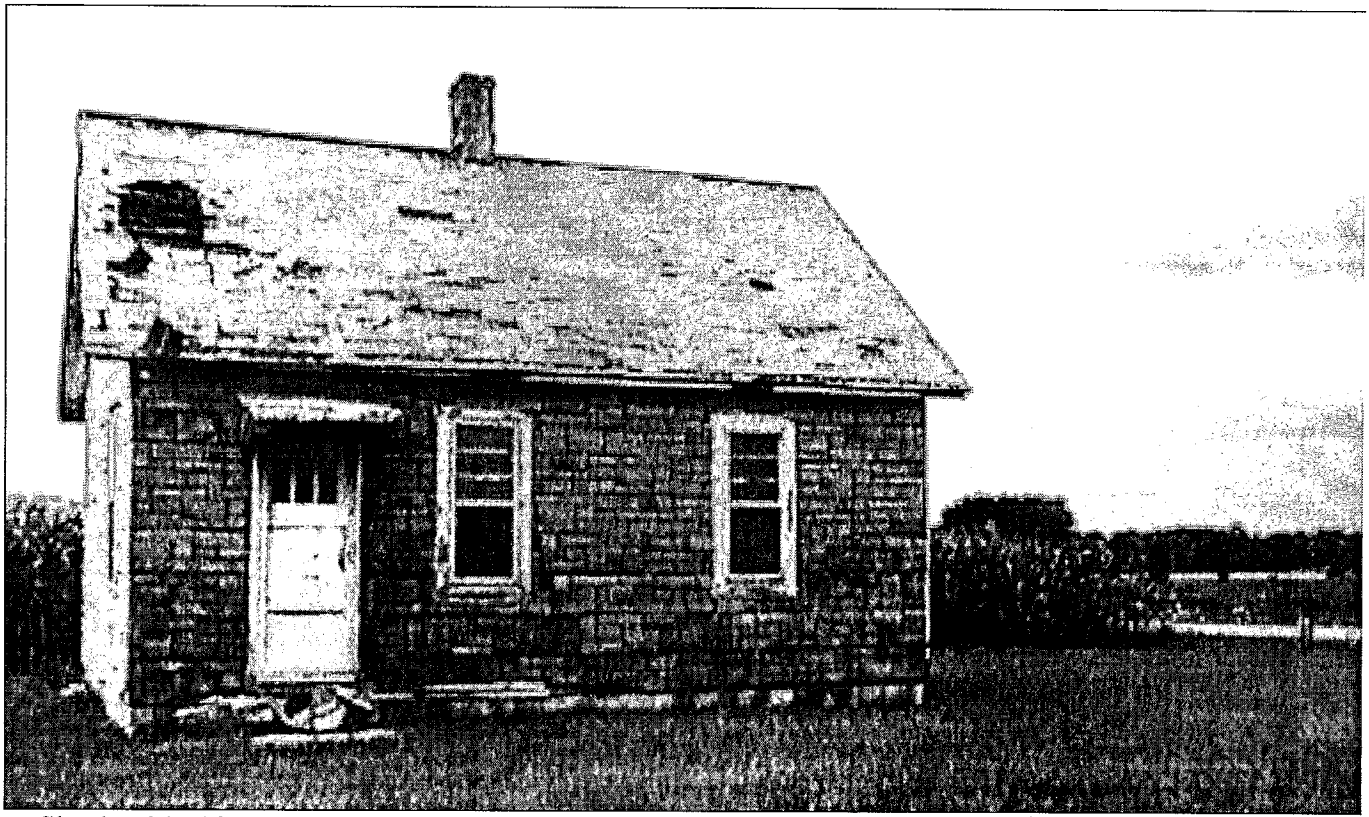
An eyewitness that saw the tornado from his residence roughly 200 m north of the tornado's path said that the tornado tore shingles off on an old shack and tore through the crops on the east side of the road, moving in a northeasterly direction for about 1 km. The shack, shown below, did have sections of shingles removed. Shingles were found on the ground both to the west and the east of the shack and up to 20 m away. A tree branch was found on the ground on the east side of the road. It had been broken off a maple tree close by. There was little crop damage along the tornado's track. A few stalks of corn were torn out and there was one area of beans that appeared to be flattened. It is surprising that damage was so light considering the dirt and debris churned up by the tornado, as shown in the video capture and even more clearly in the video. In any case, such damage is consistent with a rating of F0 on the Fujita scale (Fujita 1981).

Shack with shingle damage facing NNE. The tornado moved over the shack and into the bean fields shown at the right side of the photograph.

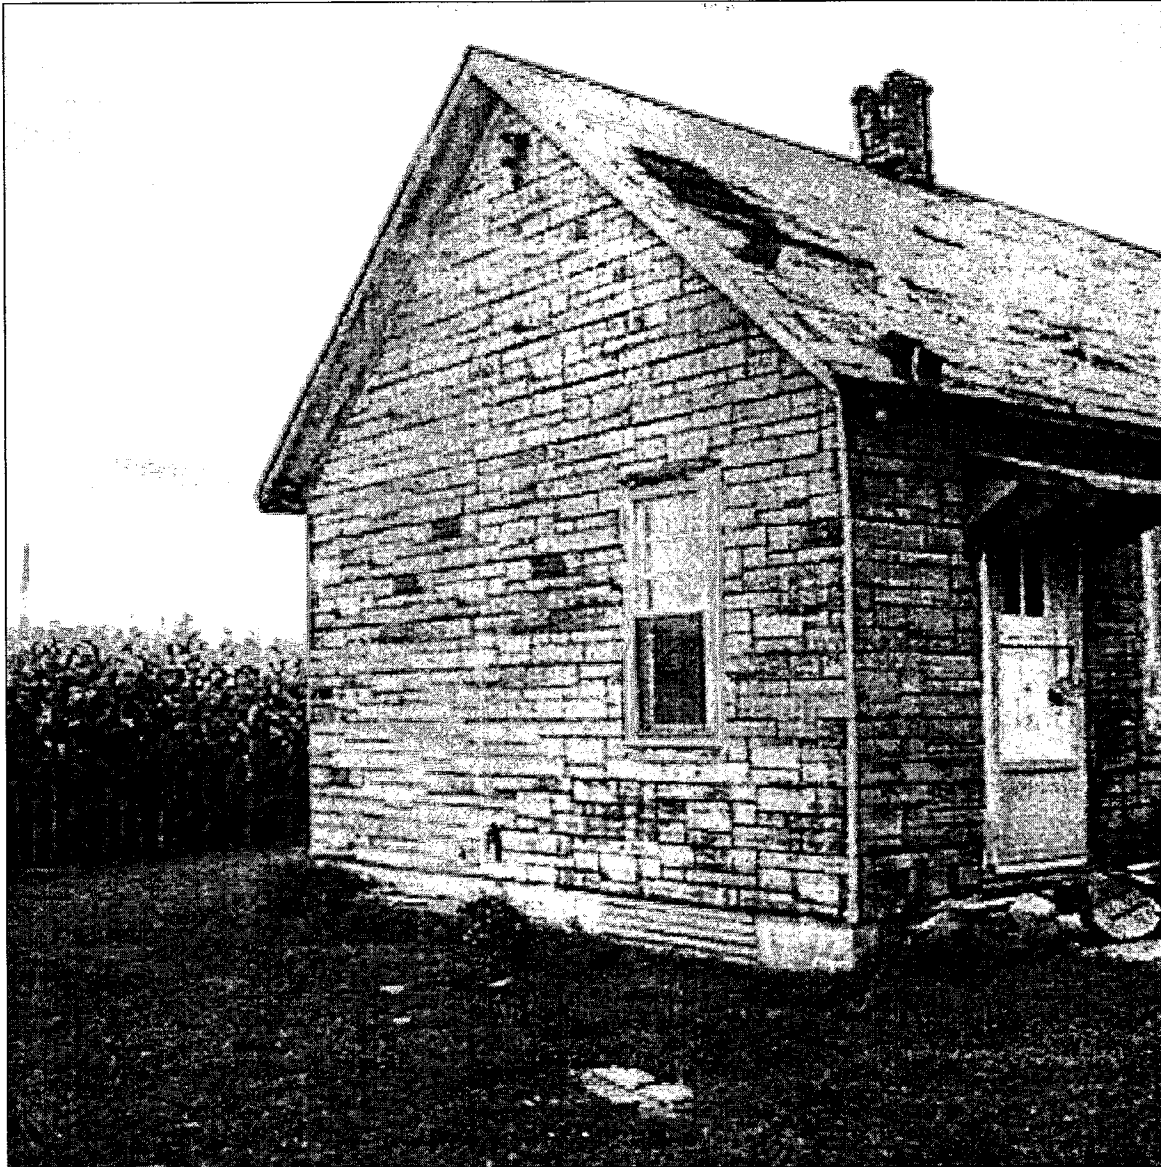
Shack and shingles on ground facing NE.
