**Confirmed Tornado
Burnstown, Ontario
August 10, 2004**

Tornado F-Scale Assessment

Burnstown Tornado: August 10th 2004

Investigation by: Stan Siok, Warning Preparedness Meteorologist &
Denis Paquette, Outreach Officer, Environment Canada
Performed on August 11th, 2004

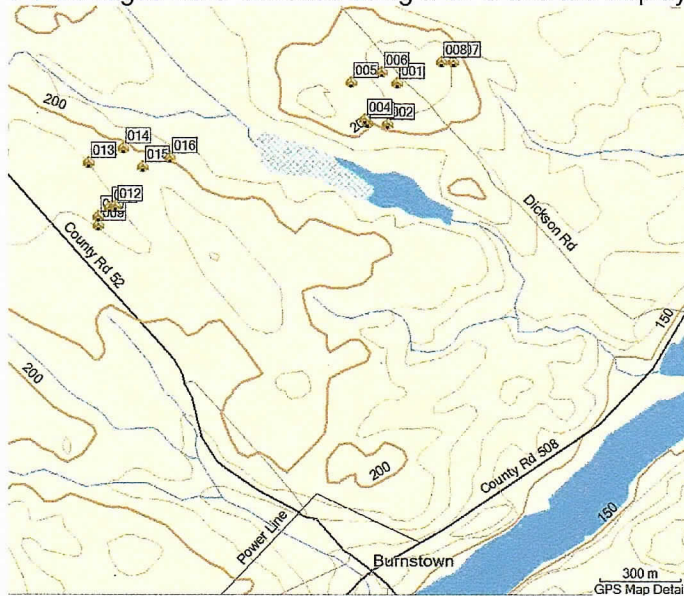
Figure 3: Some damage locations found by using a GPS system. The numbers (001 to 016) identify specific locations of some of the damage.

It appears evident that the damage areas surveyed from Dickson Rd, as well as those off Burnstown Rd were associated with the same damage track. Although more sparse in nature, there were downed tree limbs within a few hundred meters northeast of waypoint 16. Taking into account the downed trees that could be seen visually in addition to the waypoints, the length of the damage track is about 2 Km, and its width 200 to 300 meters. The track orientation is towards the northeast (070°).

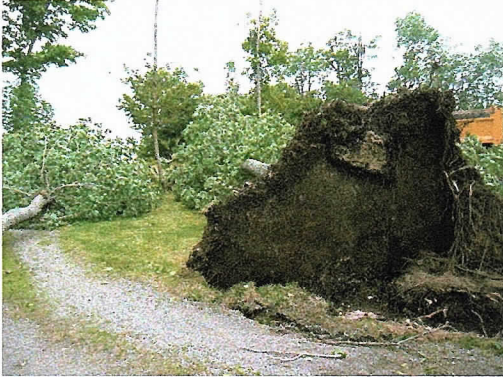
There were two properties surveyed on Dickson Road: the properties of Murray Burgess (1091 Dickson, near waypoint 001 on figure 3), and Brad Kauffeldt (1109 Dickson, near waypoint 006). Both locations sustained dramatic tree damage with numerous trees uprooted (figure 4) or snapped and twisted at the trunk (figure 5). Remarkably however, both the Burgess and Kauffeldt houses sustained little damage. The tree damage however was extensive and widespread as far west as waypoints 004 and 005. Many of the trees were of the hardwood variety (oak or maple). Immediately west of these points the tree damage appeared to thin out. The topography west of these locations drops markedly to below 190 meters elevation, whereas to the east it was in excess of 210 meters elevation. Further east, the tree damage area crossed Dickson road and several uprooted and broken trees were noted (Way points 007 and 008). East of these two waypoints, the tree damage became less widespread. The topography also drops off markedly in this direction to below 180 meters elevation. The general orientation of the fallen trees was towards the northeast (050°). However in a few locations the damage was towards the north (360°) while in other towards the southwest (210°).

Figure 4: some uprooted trees west of Dickson Rd

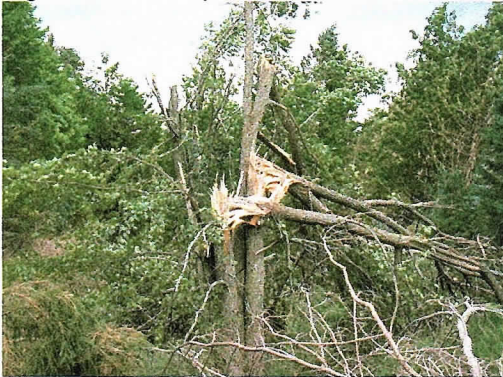
Figure 5: trees twisted and broken west of Dickson Rd.

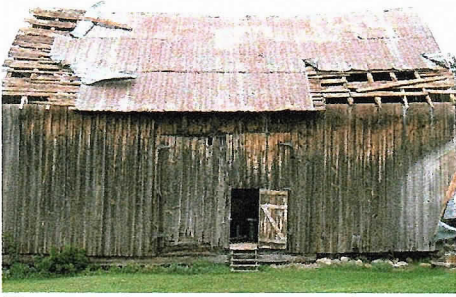
The other area that was extensively surveyed was the Ron and Mona Frazer property on 2030 Burnstown Rd (County Rd 52 on figure 3). The main property damage was to the barn where pieces of tin roof were propelled some 250 meters towards the northeast (figure 6), and a machine building that was totally demolished (figure 7). There was some tree damage near the Frazer home, but more spectacular and widespread tree damage northeast of the property (waypoints 14 and 16) with trees either broken, shredded or uprooted (see figure 8). Beyond waypoint 16, the tree damage became less extensive as the topographical elevation dropped off to below 190 meters as one approached the stream (see figure 3). Beyond the stream, from waypoint 16, one could easily see at a distance the damage to tree tops on the other side of the stream, less than 300 meters to the northeast (070°). Thus, there appeared to be a positive correlating between elevation and the density of the tree damage with the more dense damage corresponding to the higher elevations.

Figure 6: damage to barn roof near waypoint 009 on figure 3.

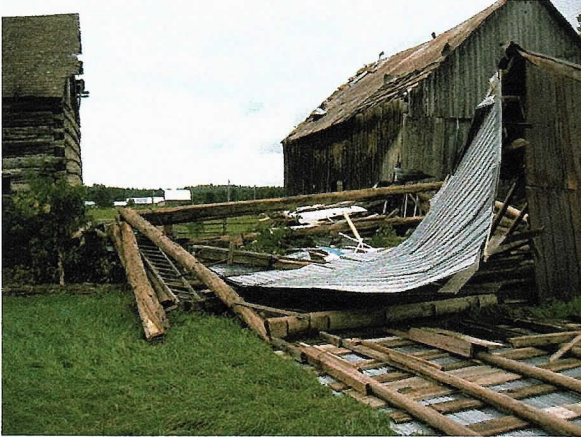
Figure 7: machine building completely flattened near waypoint 009 on figure 3.

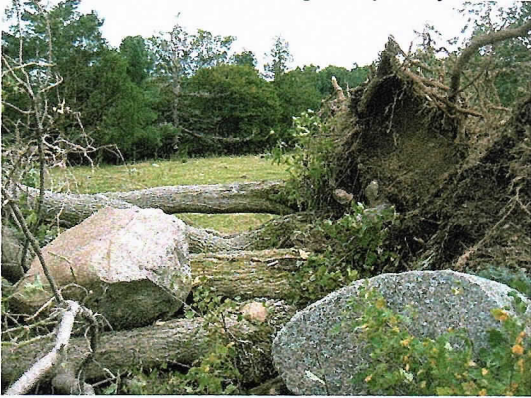
Figure 8: Tree completely uprooted lifting large boulders near waypoint 015 on figure 3.
