**Confirmed Tornado  
Elmvale, Ontario  
June 2, 1998**

## **Tornado F-Scale Re-Assessment**

## Rough Summary of Damage in the Elmvale Area

# F2 Tornado in Elmvale, Ontario on June 2<sup>nd</sup>, 1998

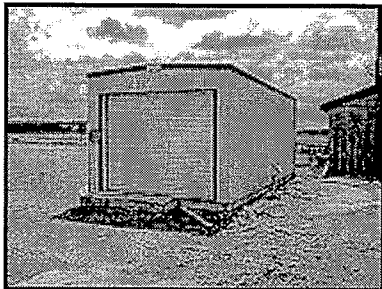
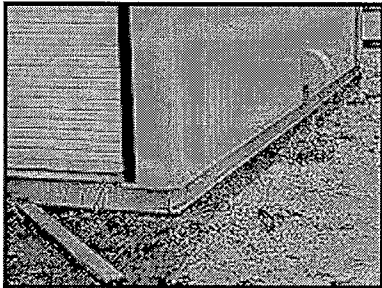
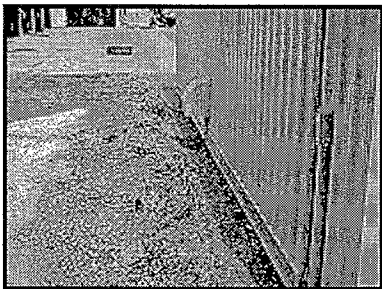
## Elmvale Co-op Hwy#27 & 8th Concession

A fully loaded 15x30 ft chemical storage bldg moved 10-12" off its base.

- Just across from the silo (40-50ft away) that was damaged an older silo and loading mechanism were left untouched.
- A fully loaded 15x30 ft chemical storage building was moved 10-12 inches off its concrete slab. See photo of [Chemical Storage Building](#).

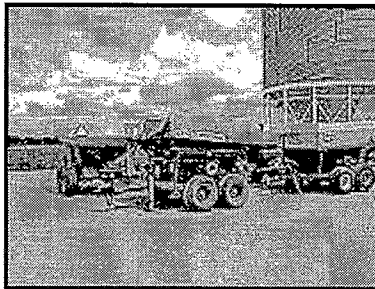
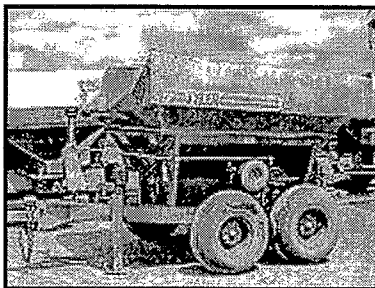
**2nd Road South & Mill Road**

Two 5-tonne manure spreaders were tossed 250m.

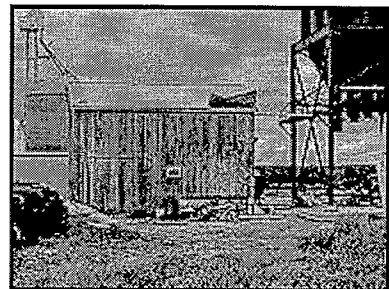
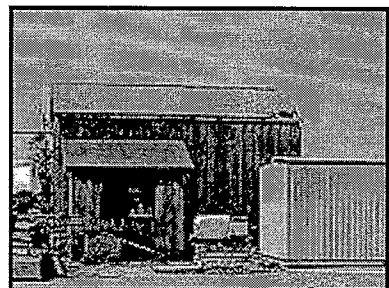
**Simcoe Side Rd#11 & Cedarlane**

Metal roof partially removed, with a section blown 500m.

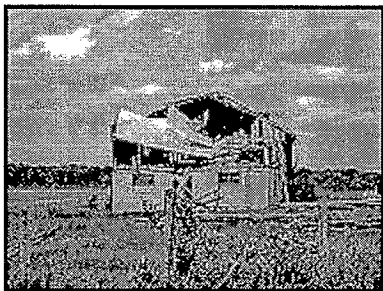
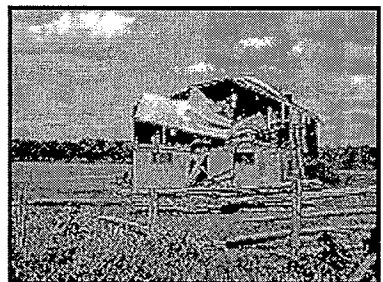
**2nd Rd North, SE of the 7th Concession**

Roof of large barn 1/2  
knocked in.

- About 500m away from the Maple of the 2nd Road, a large barn had half its roof knocked in.
- The roof was not carried away and it was an old barn to start with, however the metal roof appeared to be newer than the rest of the barn. See photo of the Convertible barn or different view of barn.

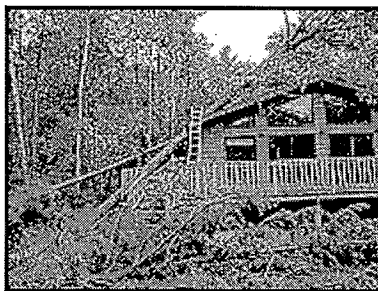
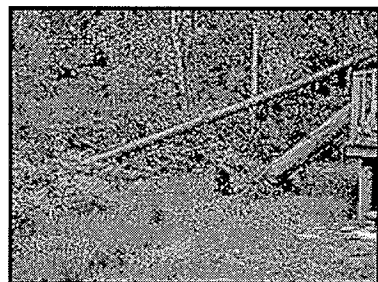
Two 12-14" maples uprooted  
& fallen on roof of cottage.

- Two 12-14" maples down on the roof of a house or cottage. See photo of trees on roof.
- The Maples were uprooted while nearby pine trees (10" trunks) were snapped right off at about 15 ft off the ground.
- On the other side of Cedarlane there were another couple of trees down.

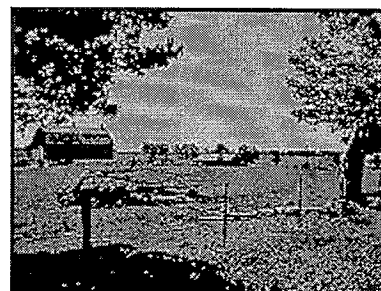
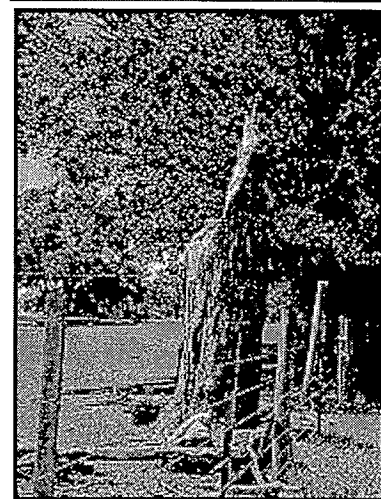
Maple tree snapped 8ft above  
the ground with debris  
scattered.

- At the Maplefront farm one large maple tree out of line was knocked down with the trunk being snapped at about 8 feet off the ground.

- There was lots of debris as the tree was vigorously torn apart. See photo of Shredded Maple
- Other Maples on either side were left untouched although they were littered with debris from their neighbours.
