**Confirmed Tornado  
Gads Hill, Ontario  
May 22, 2004**

## **Tornado F-Scale Assessment**

# Storm Damage Survey - 22 May 2004

## - Gads Hill/Seabringville Area -

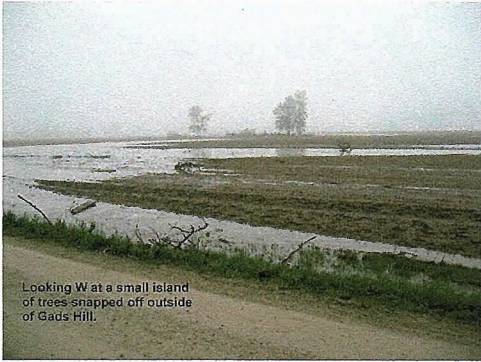
The following is an island of trees just west of Road 122 approximately 600m north of 39 Line. You can see that there were at least 2 trees that were snapped or uprooted on the island.

Looking W at a small island of trees snapped off outside of Gads Hill.

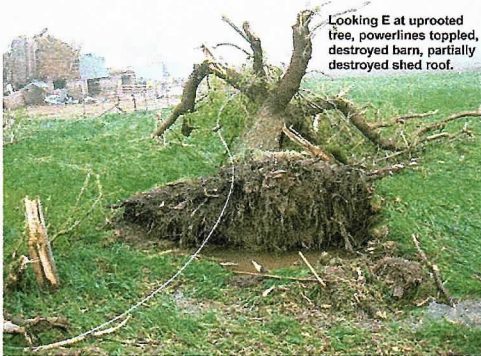
This was the view from the side of the road where trees were uprooted and stripped of leaves. Power lines were down. The barn no longer existed and the silos were damaged. The shed in the background, although standing, was severely damaged as well.

Looking E at uprooted tree, powerlines toppled, destroyed barn, partially destroyed shed roof.

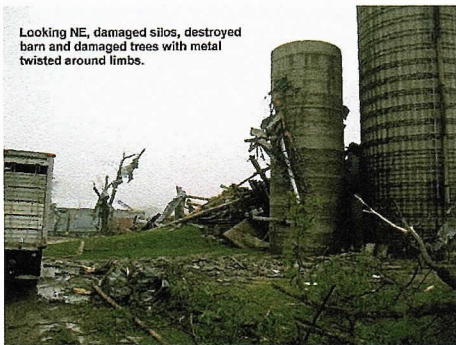
The view from the end of the lane shows the silos which had the tops and parts of the cement layers removed. Debris from the barn was mangled and twisted about trees, thrown into surrounding barns and the house and crumpled and carried away for distances longer than 1km.

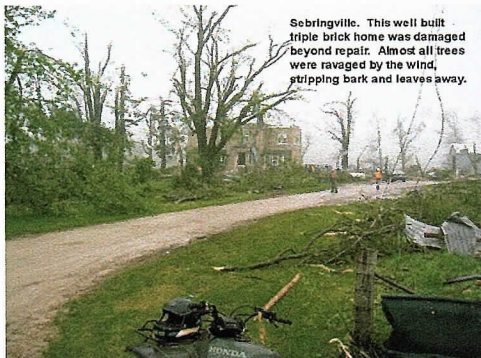
This photo shows the view of the house. To the left of the lane way many trees were stripped of leaves, branches and even bark. However, towards the end of the property at the road (to the left of the lane way) many trees still have branches remaining. A lilac bush was also left virtually untouched. The house in the distance is missing its roof, and power lines in the tornado's track were down.

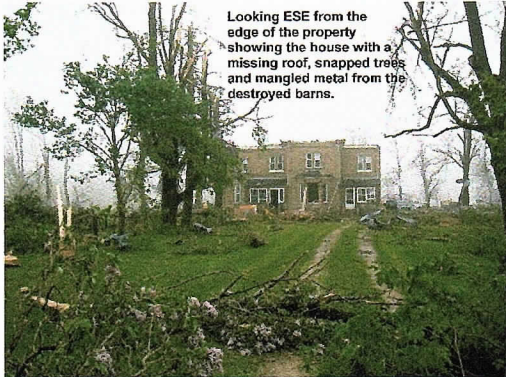
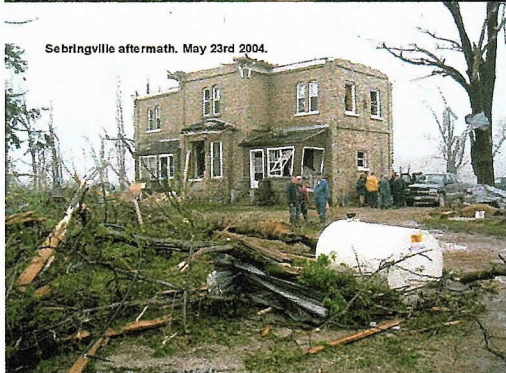
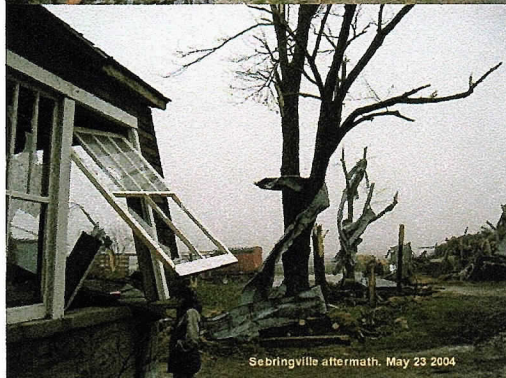
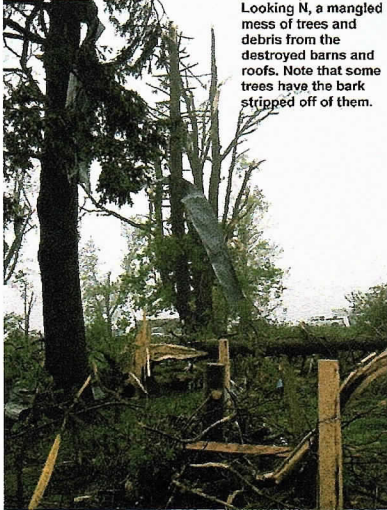
The following pictures show the destruction in the front yard and to the front of the house. Trees were destroyed along the pathway leading up to the house. Those trees that were still standing were without leaves. The house itself had the windows broken, the roof removed and the entrance severely damaged. There is a large gas tank that has also been moved from in front of the barn to the front lawn. In many of the pictures, it can be seen that the debris from the barn is strewn across the property.

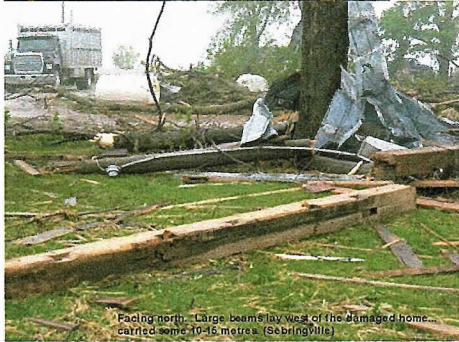
Looking N, a mangled mess of trees and debris from the destroyed barns and roofs. Note that some trees have the bark stripped off of them.

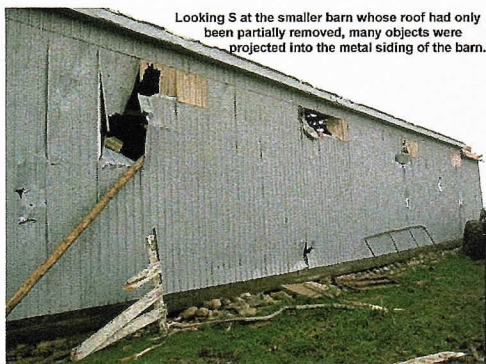
From the view from the road and the aerial shot, it can be seen that the rear of the smaller barn had been damaged. There was a small silo at the back that was damaged. The damage shown in the following photograph is due to missiles created from debris from the barn, for the most part.

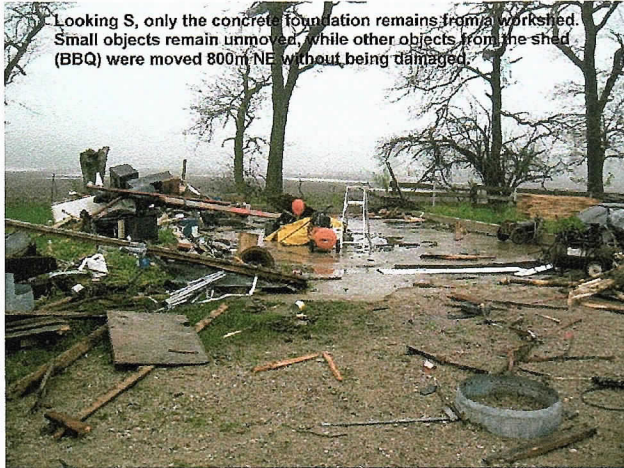
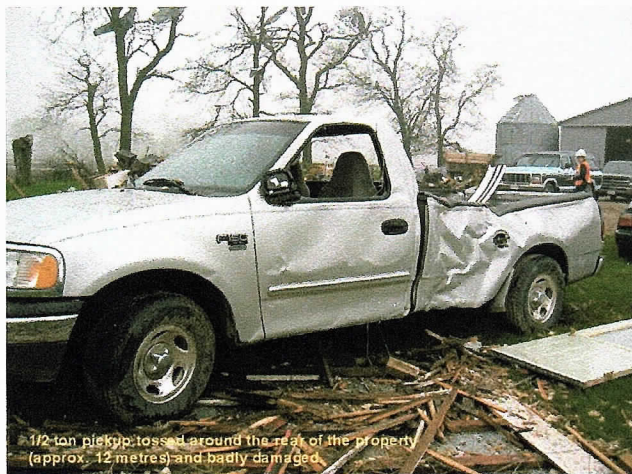
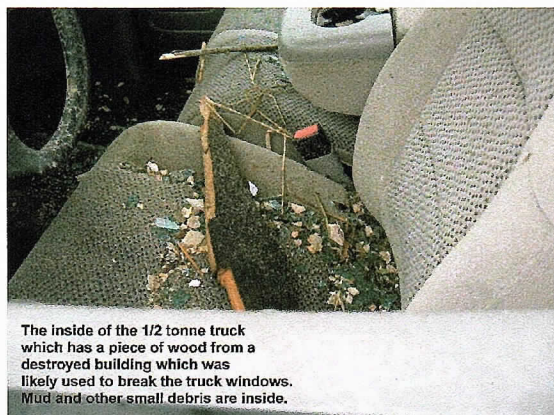
Behind the house used to stand a drive shed. The truck in these pictures was parked in front of the shed initially and came to rest about 10-15 m away. The truck itself was badly damaged. The contents of the shed were littered across the countryside, with a BBQ found in near perfect condition about 800m away.

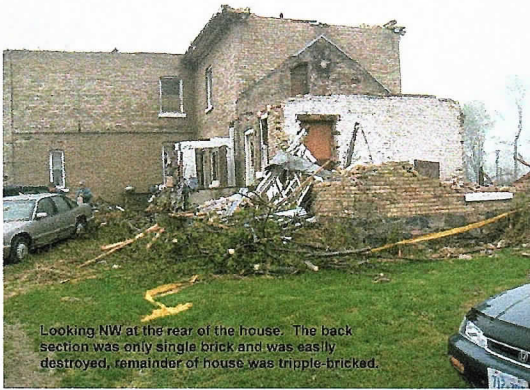
The rear (Northeast side) of the house received the worst damage. The windows are blown out. Large portions of brick wall have been torn away. One room at the back of the house has been completely destroyed. This was an addition and was single brick.

Looking NW at the rear of the house. The back section was only single brick and was easily destroyed, remainder of house was triple-bricked.

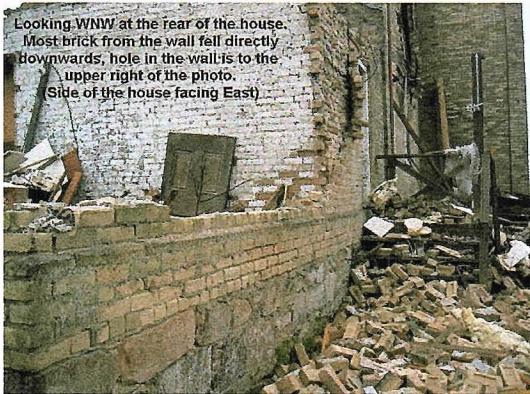
Looking WNW at the rear of the house. Most brick from the wall fell directly downwards, hole in the wall is to the upper right of the photo. (Side of the house facing East)

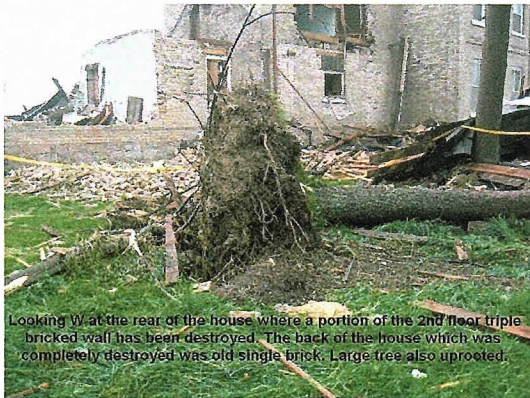
Looking W at the rear of the house where a portion of the 2nd floor triple bricked wall has been destroyed. The back of the house which was completely destroyed was old single brick. Large tree also uprooted.

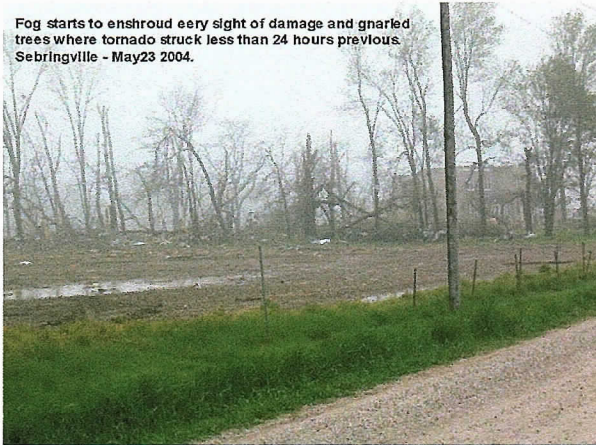
Fog starts to enshroud every sight of damage and gnarled trees where tornado struck less than 24 hours previous. Sebringville - May 23 2004.

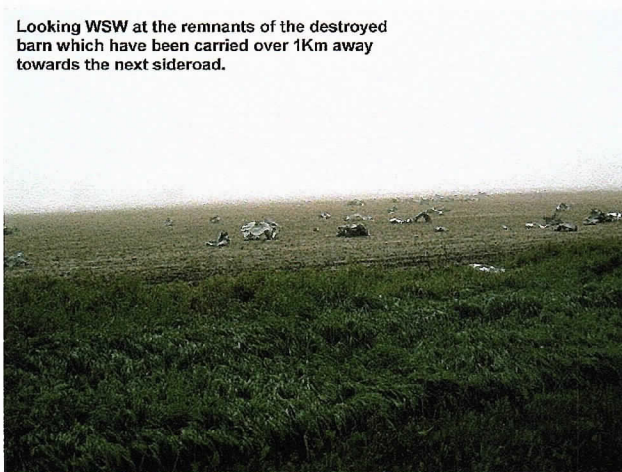
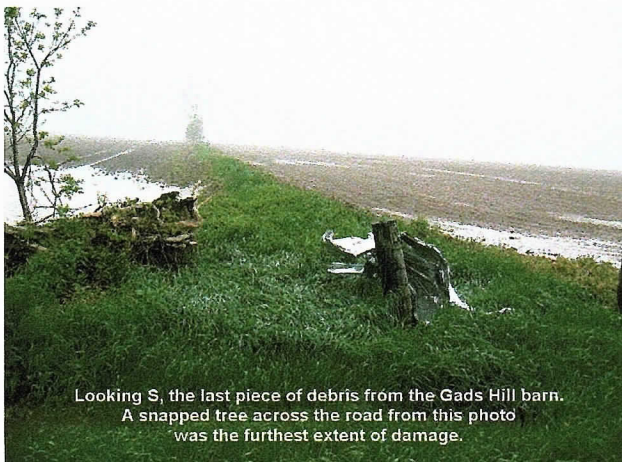
This was the end of the debris track where parts of the destroyed barns and shed had been crumpled into balls and deposited over 1km away from its origin.

Looking WSW at the remnants of the destroyed barn which have been carried over 1km away towards the next sideroad.

Looking S, the last piece of debris from the Gads Hill barn. A snapped tree across the road from this photo was the furthest extent of damage.
