**Confirmed Tornado  
Feversham, Ontario  
September 25, 2005**

## **Tornado F-Scale Assessment**

# Feversham Tornado September 25, 2005

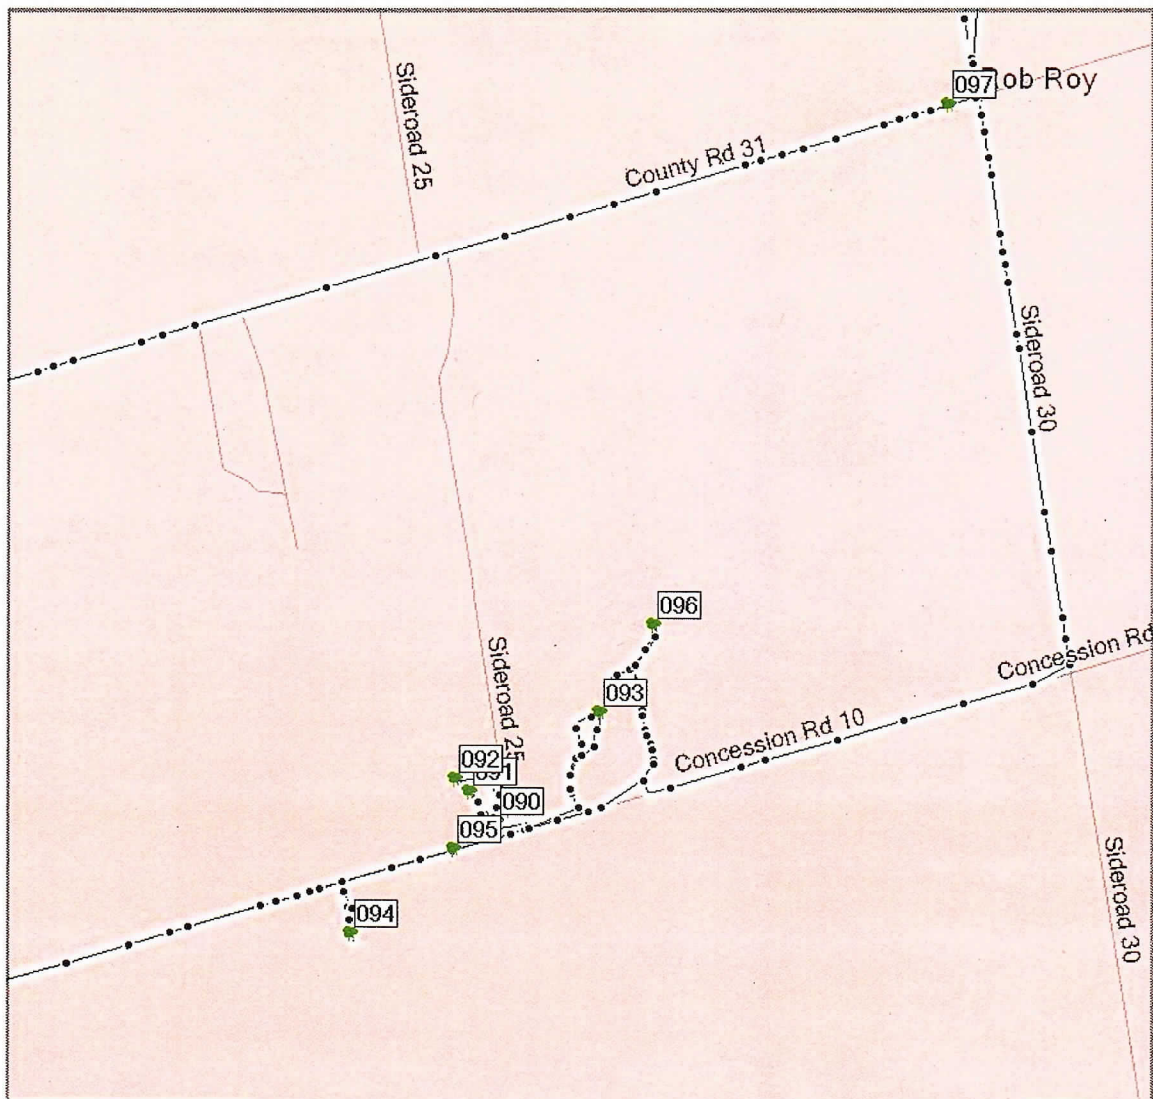
Damage Investigation Waypoints northeast of Feversham at 500 metre resolution

Waypoint 094 – First indication of damage. An examination of the field to the southwest of this point showed no indication of structural, tree or crop damage. An equipment shed was totally destroyed at this location. Smaller farm implements were carried 10's of metres from their original location. A large piece of farm machinery was not appreciably moved. Picture 0244 was taken facing the northeast of the foundation area of this shed and shows some of the contents of the shed strewn off to the northeast. It also shows the largest piece of farm equipment to the right of the picture was not moved. Picture 0245 is another shot facing northeast of the destroyed equipment shed. Picture 0246 was taken facing west from the destroyed shed and shows a small storage shed that was untouched by the damaging storm...this shed was approximately 20 metres west of the destroyed

Waypoint 090 – Tyson Farm at the corner of Concession Road 10 and Sideroad 25 in the Municipality of Grey Highlands. This was the location of the most intense damage that lead to Fujita Scale 1 Tornado determination. Barn at this location had roof totally removed and two of the walls severely damaged. In addition a cinderblock shed/barn was leveled as well a hay barn (a roof supported by four poles) was totally destroyed. Farmhouse about 40 to 50 metres to the southeast of the barns and shed was not damaged in any way. Short video 0231 shows the barn which lost its roof...the video is taken facing the east. Picture 0232 is taken facing the northwest, the fencing shown is about 30 metres to the west of the barn but it is believe that this material wrapped around the fencing is from the equipment shed destroyed at Waypoint 094, a distance of over 650 metres away. Picture 0233 shows the barn with the roof removed, the shot was taken facing the west and shows the significant damage done to the eastward facing wall of the barn. Picture 0234 was taken facing north and shows some of the debris in the farm yard. Picture 0235 is a shot taken facing the south and shows the significant damage done to the north facing wall of the barn as well as the remnants of the cinderblock shed/barn in the foreground. Basically on the foundation remained of the cinderblock structure. Picture 0236 is a shot similar to the previous but shows the green-tinged roofing from the remnants of the hay barn in the foreground. Picture 0237 is taken facing to the east and northeast and shows the debris from the Tyson farm scattered over the adjacent property. Picture 0238 is another shot of the severely damaged barn and destroyed cinderblock shed and hay barn facing the west. Picture 0240 shows remnants of the hay barn (green-tinged roofing) scattered across the adjacent property...picture taken facing the east. Picture 0242 shows tree damaged just to the northeast of the farmhouse (or approx. 50 metres east of the barn). As picture shows, the tree was fairly rotten.

Waypoint 091 – Three pieces of wood debris driven into the ground at this position, approximately 140 metres northwest of the barn at waypoint 090. See picture 0241 which shows this wood...the picture was facing the north. All three pieces of wood were not embedded deeply into the ground and were able to be moved (and could have easily been removed from the ground)

Waypoint 092 – approx 200 metres northwest of the barn. This area had metal debris from either the barn or the equipment shed at waypoint 094. Given the fog it was impossible to tell if more debris was present further north from this location.

Waypoint 093 – Gravel Pit approximately 500 metres northeast of the Tyson farm. Picture 0243 was taken in the Gravel Pit facing north and shows the presence of corrugated metal from the Tyson farm.

Waypoint 096 – Two properties east of Tyson Farm. Picture 0248 was taken at this location facing west and shows scattered debris in field from Tyson farm. Pictures 0249, 0250 were taken at the eastern edge of this property facing east and southeast. More debris was evident even further to the northeast of this location. Measurement from the GPS shows that debris from the Tyson farm was carried almost 1 kilometre from its original location
