Probable Tornado Echo Bay / Laird Township, Ontario June 6, 2008

Tornado F-Scale Assessment

OSPC Storm Damage Survey Report

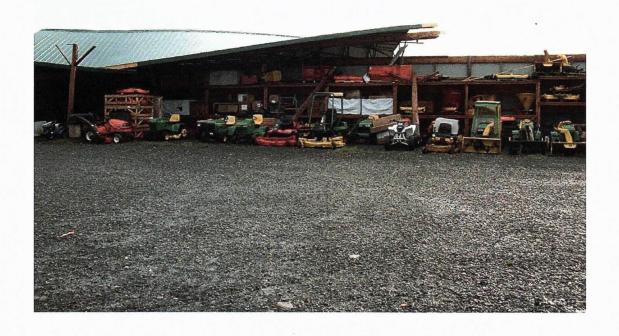
Damage Description partial roof removal from open-faced warehouse; roof

damage on neighbouring house; damage at neaby arena; sporadic tree damage along 7 km path (see
