**Confirmed Tornado  
Leamington, Ontario  
June 25, 2009**

## **Tornado F-Scale Assessment**

# OSPC Storm Damage Survey Report

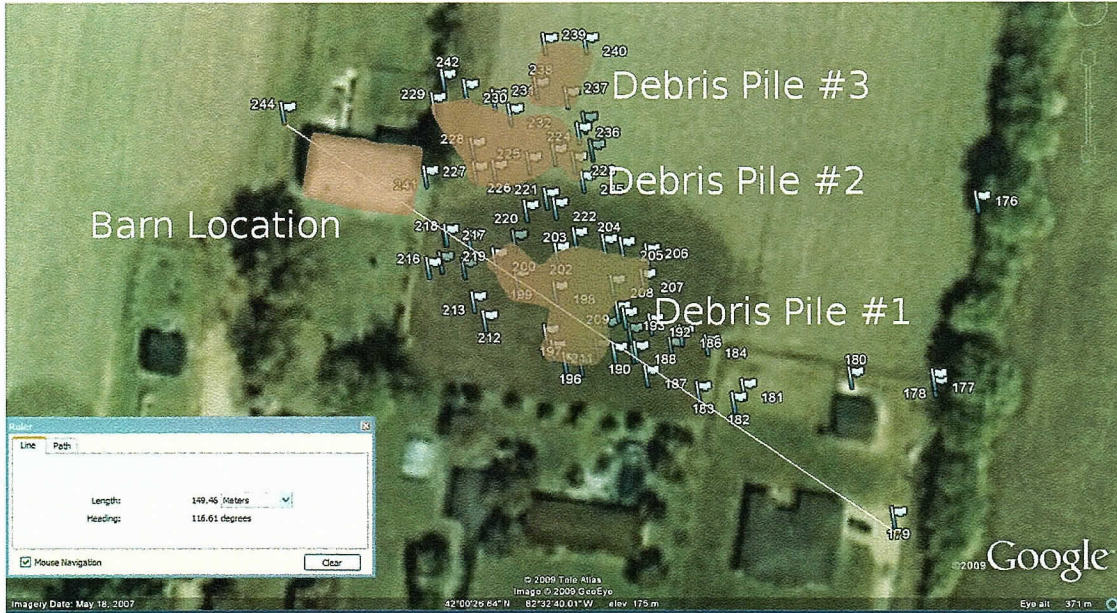
Close-up of damage distribution at 1431 Mersea Rd. C  
 Distance from barn to furthest barn-related debris is 149 metres

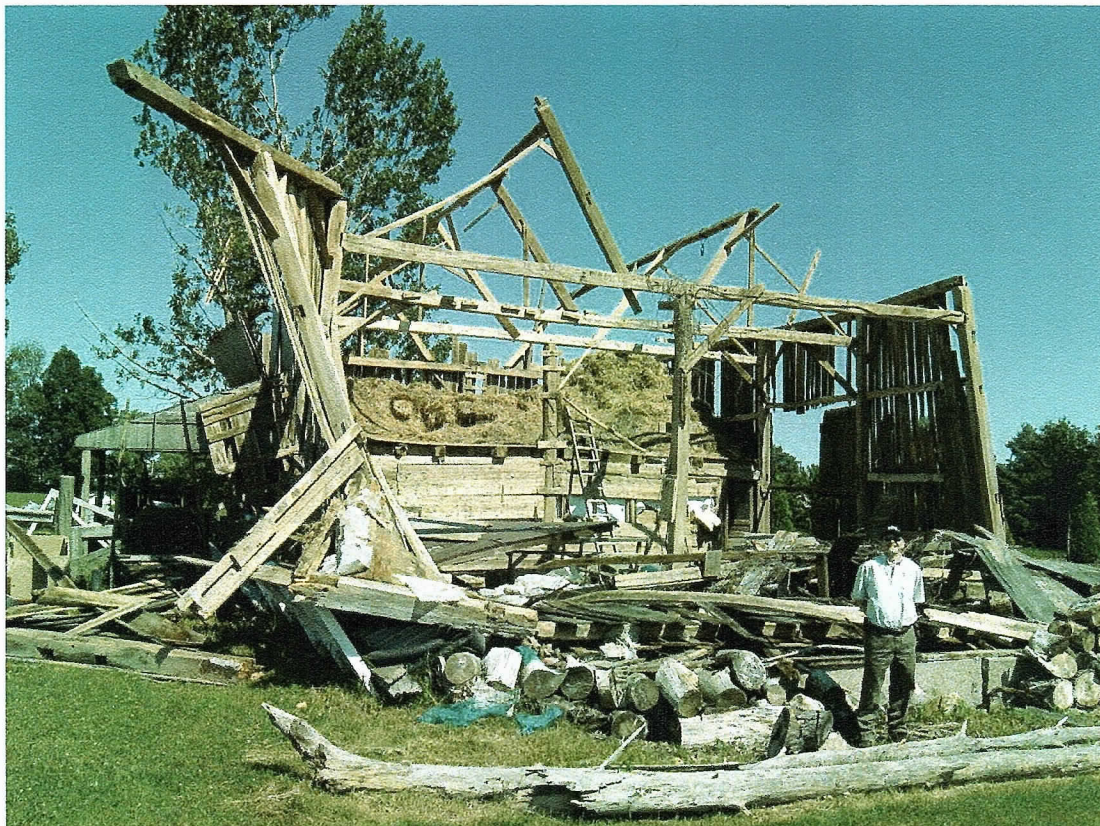
Looking East  
 Lat/Long - 42.0076N, 82.5452W  
 Barn on the west side showing most extensive damage to the structure, showing collapsed west wall and roof removed

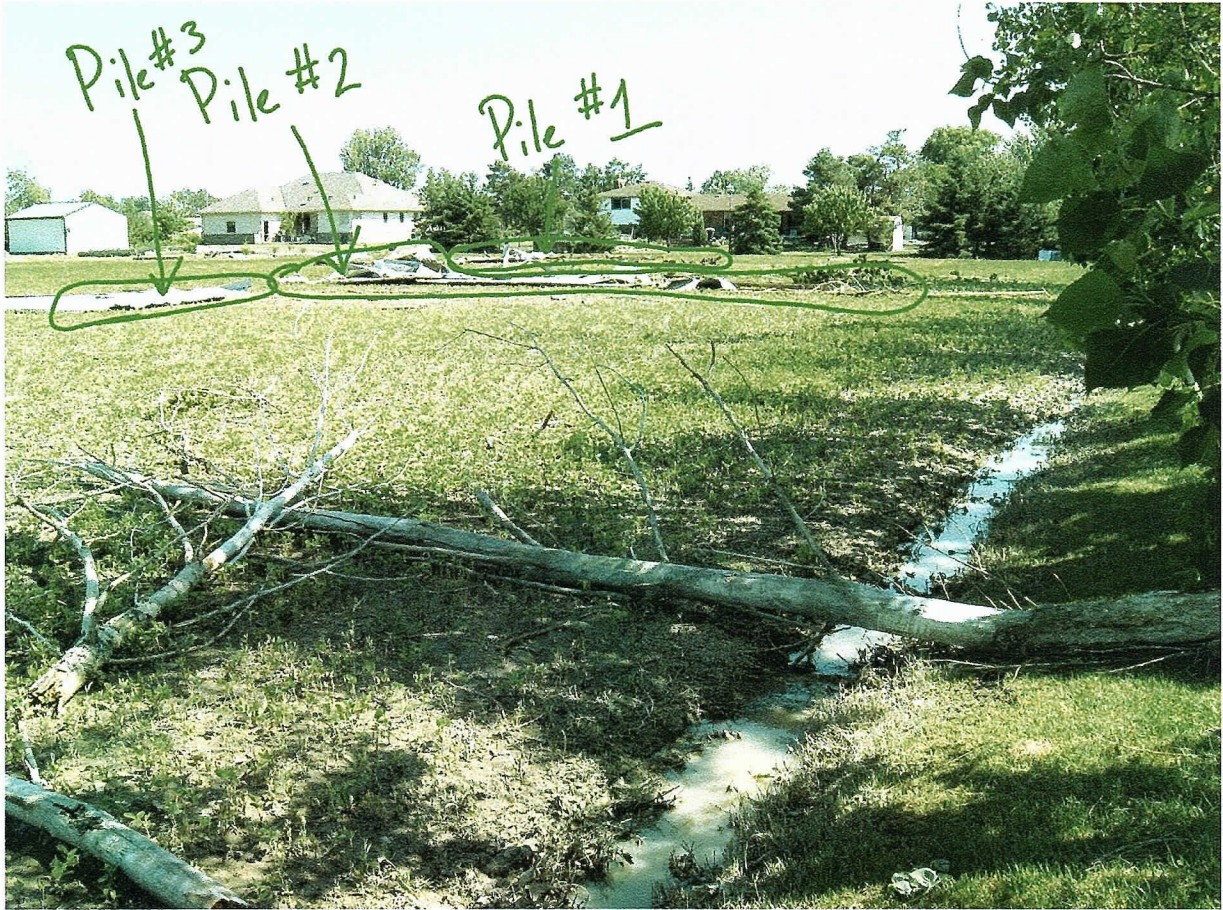
Looking South-East

View from most-northerly damage on the property at 1431 Mersea Road C, looking SE toward soybean field where most of debris from barn landed. Soil was very muddy from heavy rain, and soybean plants were maximum 4cm tall. Piles indicated show location of roof material removed by the tornado.
