## Full-Scale Tests of a Wood-Frame Structure under Extreme Wind Loads

# Full-Scale Tests of a Wood-Frame Structure under Extreme Wind Loads

## **Abstract**

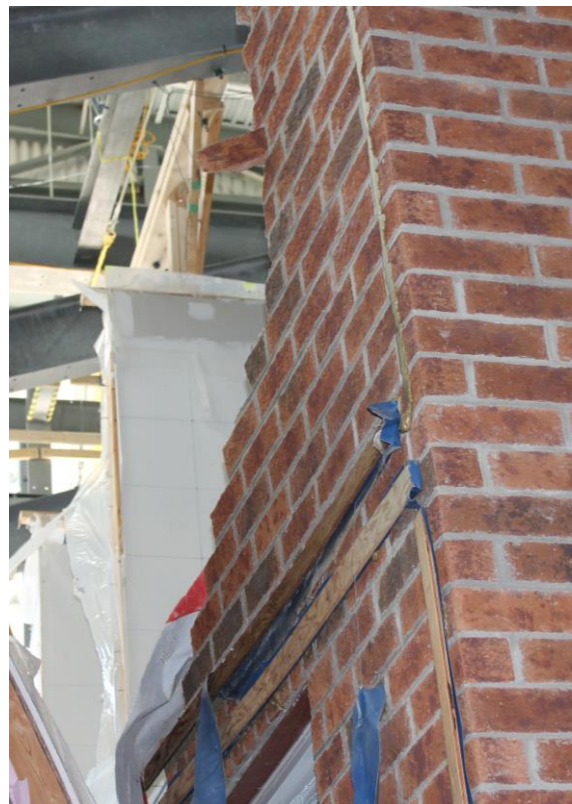
**Figure 4.3 - Damage to the house similar to what was observed in Barrie and Goderich.**

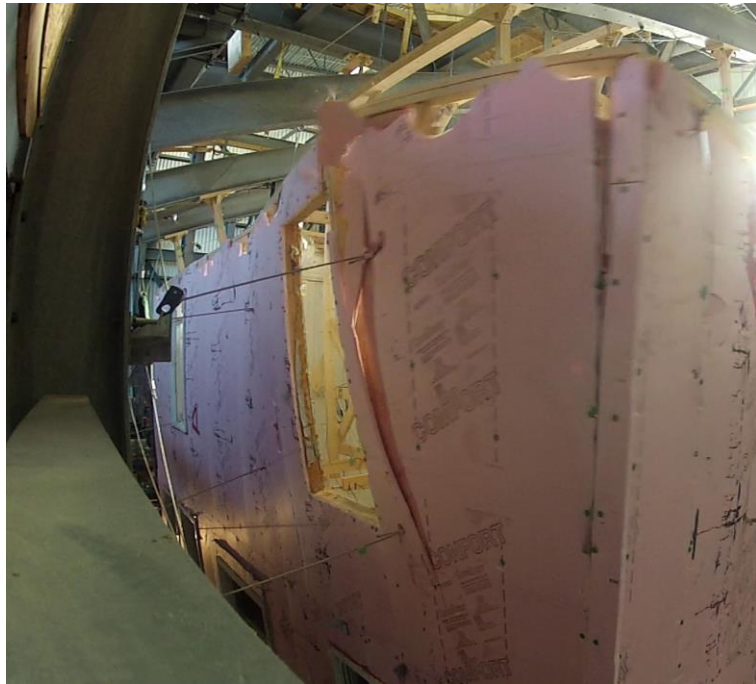
**Figure 4.4a – Failure Time + 0:00.00**

**Figure 4.4b – Failure Time + 0:00.03**

**Figure 4.4c - Failure Time + 0:00.07**

**Figure 4.4 d - Failure Time + 0:00.10**

**Figure 4.4e - Failure Time + 0:00.13**

**Figure 4.4f - Failure Time + 0:00.17**

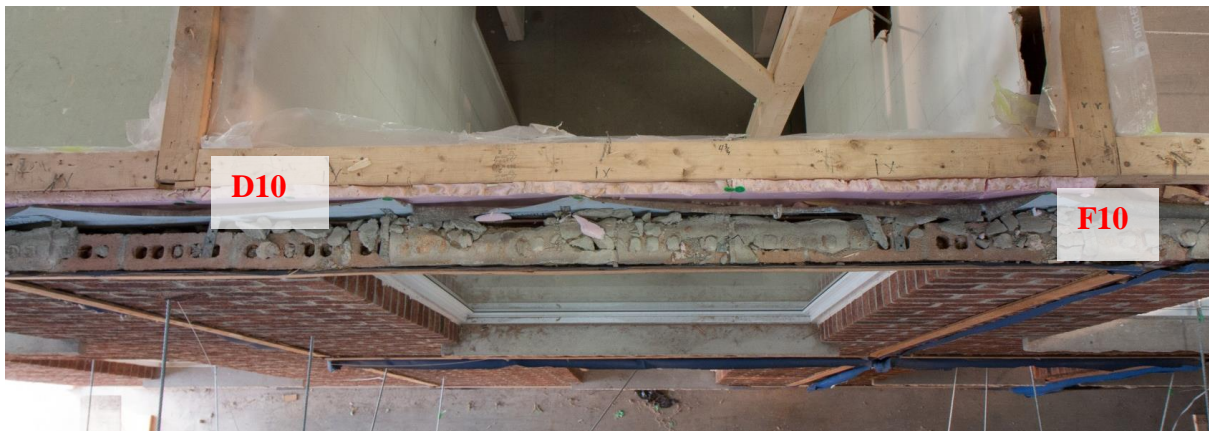
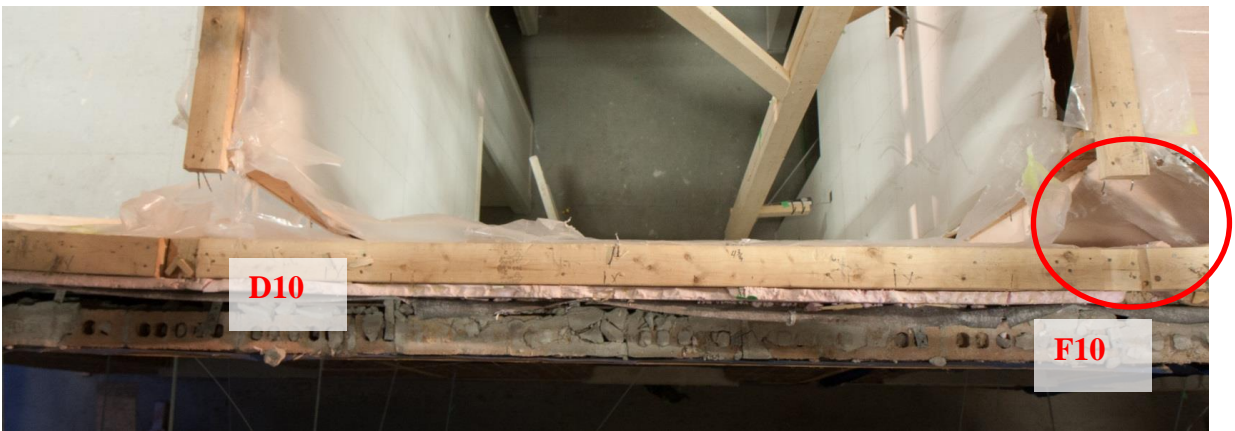
If observed in real time, the failure of the two joints located at D10 and F10 appears to be simultaneous. However, a frame-by-frame analysis shows a different story. Failure first occurred at the joint at D10, followed by the joint at F10. Figures 5.1 to 5.4 show the progression of the failure: Figure 5.1 shows the wall in its unloaded state, Figure 5.2 shows the loaded wall immediately prior to failure, Figure 5.3 shows the wall after failure of the joint at D10 and Figure 5.4 shows the wall after failure of the joint at F10. Joint failures in each figure are identified by circles.

Figure 5.1 - Wall D10 - F10 before loading.

Figure 5.2 - Wall D10 - F10 loaded immediately prior to failure.

Figure 5.3 - Wall D10-F10 as the joint as D10 is failing.

Figure 5.4 - Wall D10 - F10 after both joints have failed.

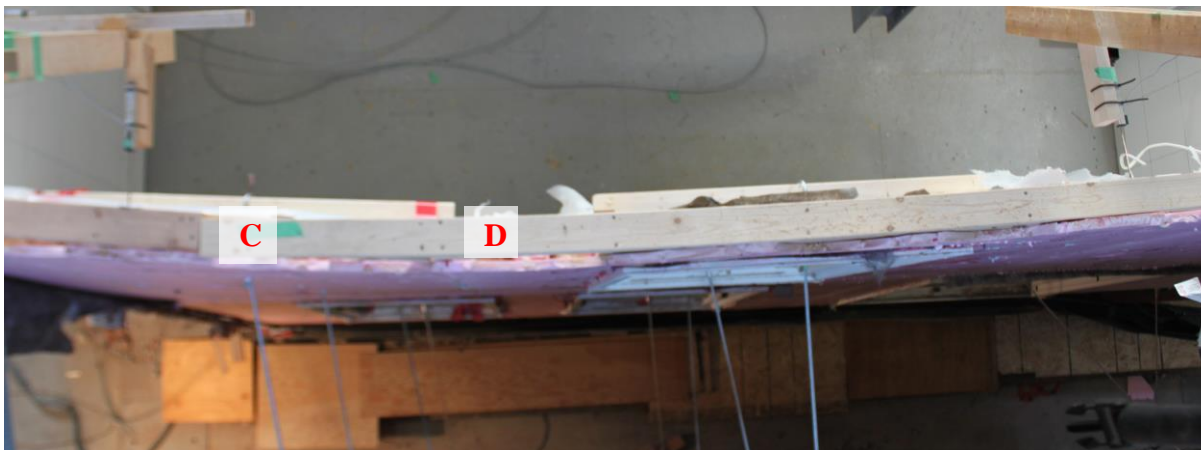
Before the failure occurred, there was a visible slipping at the joint in the upper top plate at the location of the nails. The wood in the connection failed, causing the top plate to become two members pinned at D (instead of one long member subject to bending). As with the previous failure, more nails placed closer to the center of the member would have created a stronger connection and given a higher failure load.

**Figure 6.4 - The North East wall prior to failure E1 – J1.**

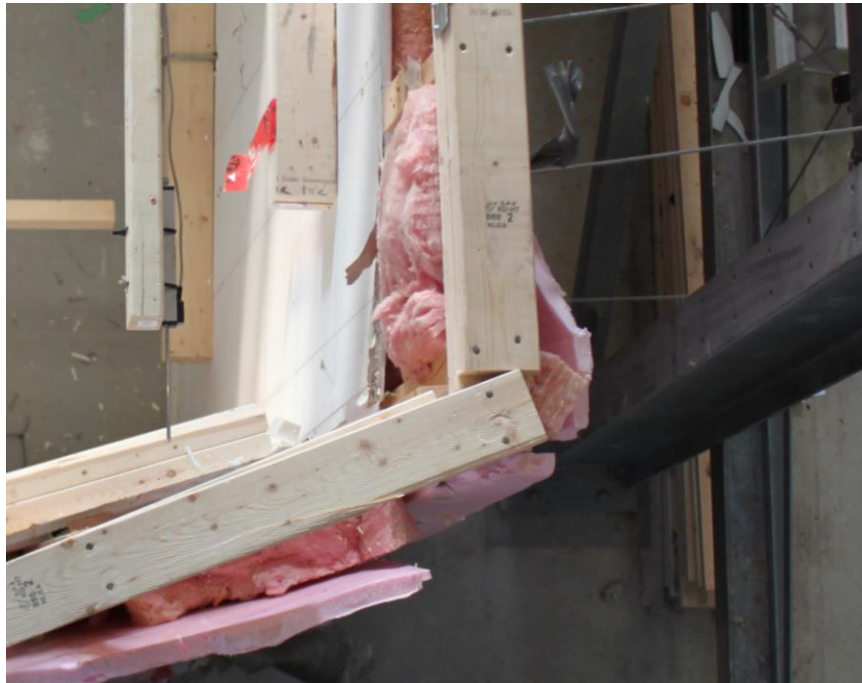
**Figure 7.1b and 7.1 c – From left to right, the corner located at A1, progressively throughout the test with no brick veneer. The far right picture is after failure.**

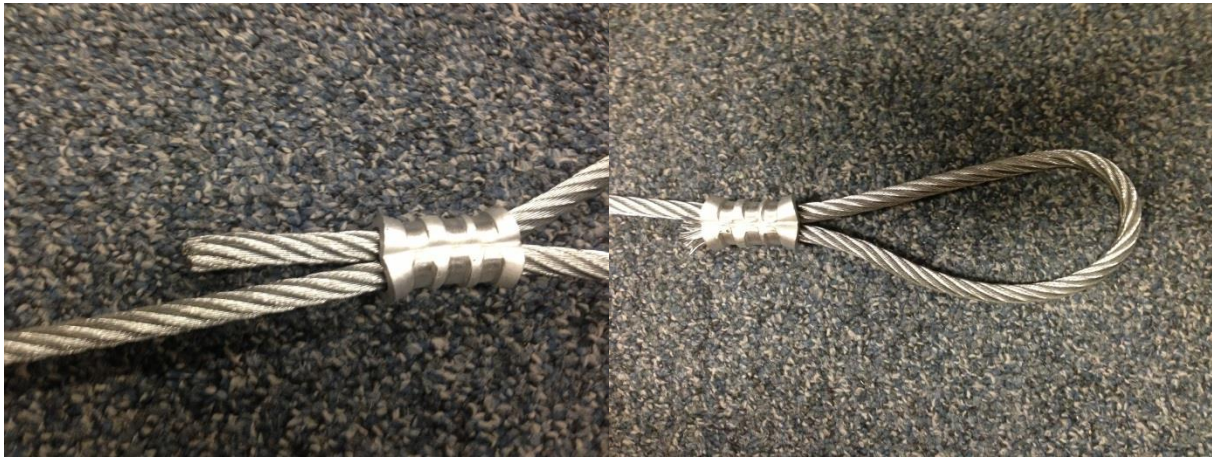
Figure G4a (LEFT) - An unfailed swaged cable connection .      Figure G4b (RIGHT) - The swaged cable connection post failure
