USE OF AN UNMANNED AERIAL VEHICLE (UAV) TO ASSESS TRANSPORTATION INFRASTRUCTURE, IMMEDIATELY AFTER A CATASTROPHIC STORM EVENT

Laird D Ferguson, BScE, EIT
MScE Candidate, University of New Brunswick, Canada

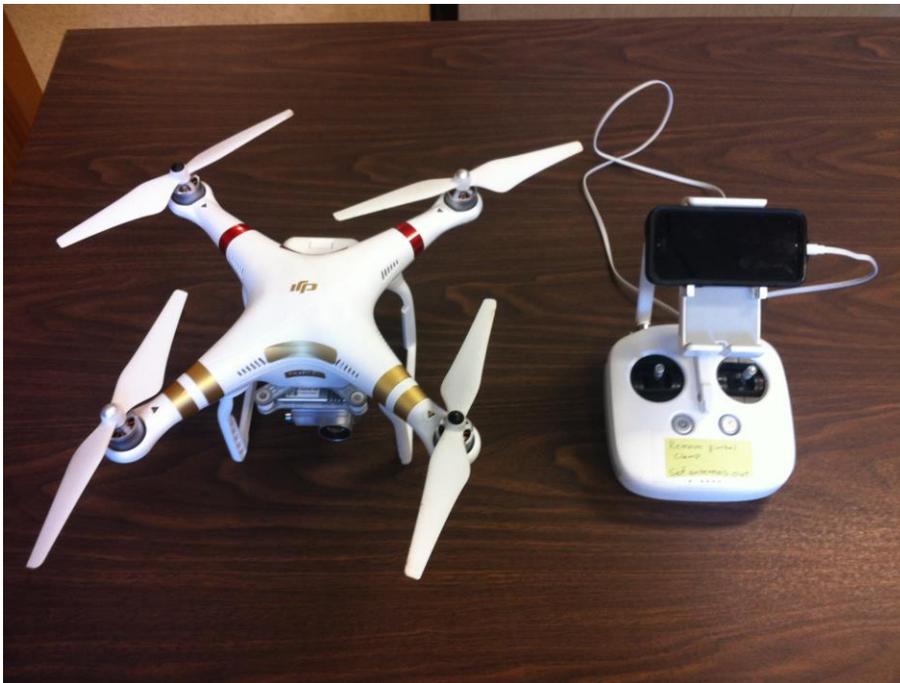
Figure 3: P3P & RCt

The UAV used was a Phantom 3 Professional (P3P) manufactured by DJI (www.dji.com). The UAV is a quadcopter that is controlled by a remote controller (RCt) which uses a phone (iPhone 5S for this case) or tablet as the control device through the manufacture's app (DJI GO). Using the control device, the aircraft and camera settings (ISO, shutter speed, camera angle, etc) can be adjusted, along with a live stream from the camera. The camera is mounted on a 3-axis gimbal attached to the aircraft and captures 12MP stills and records up to 4K video. Figure 3 shows the UAV, RCt, and the control interface. A canon 60D camera with a 20mm lens mounted on a virtual reality panoramic head attached to a tripod was utilized to capture ground level panoramas. The camera captures 18MP stills and the panoramic head provides the ability to capture a 360° view.

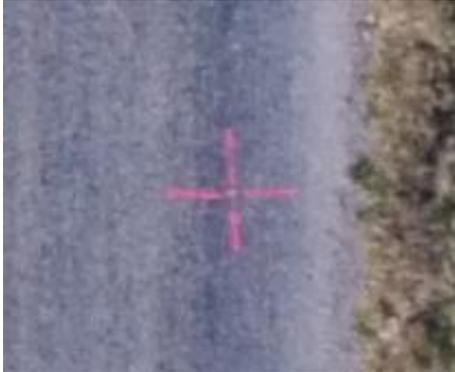
Figure 4: GCP Marking

The first step at each site was to paint Ground Control Points (GCP); they were distributed across the site. The GCPs were surveyed at a later date by high accuracy positioning survey methods. The GCP markings were painted throughout the site with at least five points per site and each point in at least three images. A cross (see Figure 4) was determined from previous operations to be the best symbol as it is easily identifiable in post processing. With GCPs marked, a flight plan was then created. This consisted of creating a grid to capture images with a 75% overlap between images. This was completed by drawing a scaled grid on the UAV map in the control device. A spreadsheet was developed to determine the required grid spacing to achieve a 75% overlap based on the altitude of the UAV and the camera sensors. Once a grid was created the flight was completed to capture vertical (or nadir) images at each grid intersection. The procedure of drawing a grid on the manufacture's app was required because a third party flight planning app was not updated to include the P3P. Once the images were captured for the creation of a 3D model, overview images were captured. Vertical overview and oblique perspective images were collected at a max altitude of 90m to capture a site overview, as well lower altitudes images of site specific details were captured. Finally, on select sites, video was captured of the site to simulate a car driving on the road. While traveling between sites, the batteries for the UAV as well as the control device were charged using a power converter in the vehicle. This was identified to be necessary from the start of the project and as a result no operation was delayed because of low batteries.
