## Response of a Two-Story Residential House Under Realistic Fluctuating Wind Loads

A thesis submitted in partial fulfillment of the requirements for the Doctor of Philosophy degree in Civil and Environmental Engineering

# **Response of a Two-Story Residential House Under Realistic Fluctuating Wind Loads**

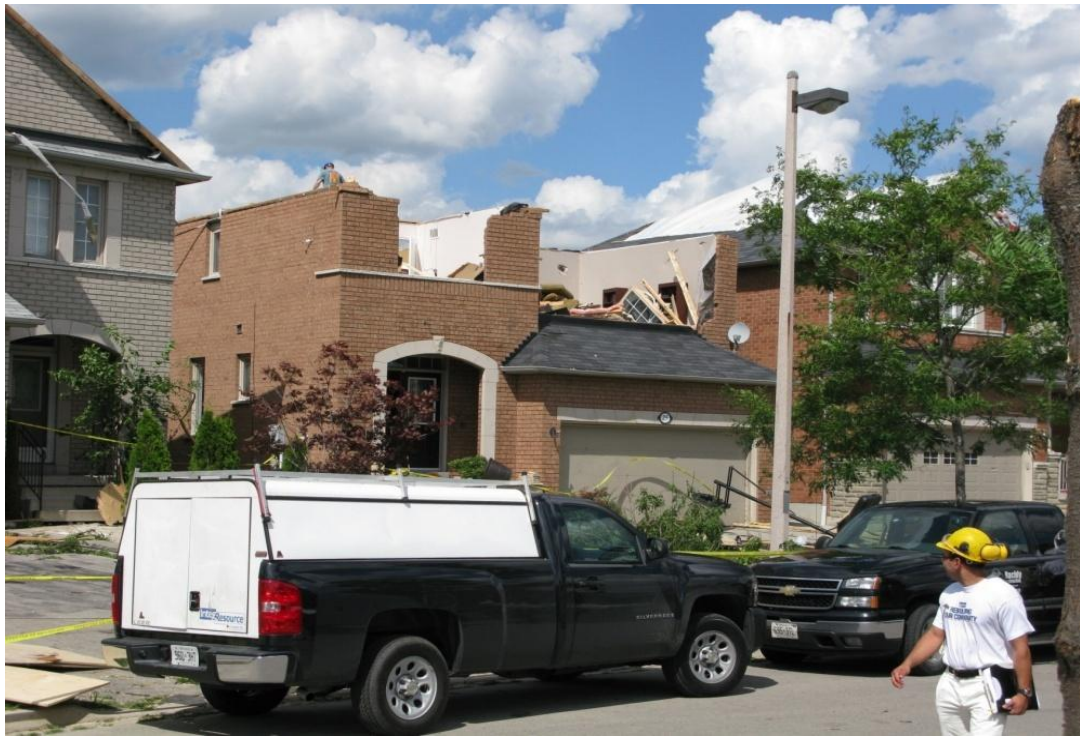
Figure 1.1 Global roof failure of a house due to a tornado that struck Vaughan, Ontario on August 20, 2009.

Figure 1.1 to Figure 1.3 show some recent examples of failures of roof-to-wall connections (RTWC) in timber frame construction under high wind loads. Toe-nails are the most common type of RTWC in North America. While it is now common to use hurricane straps in hurricane prone regions such as South Florida and the Gulf Coast, other regions can still be susceptible to extreme wind events, such as tornadoes and downbursts, which are capable of causing failures to toe-nailed RTWC connections, examples of which are discussed by Kopp et al. (2009) and Morrison et al. (2010). Furthermore, there still exist a large number of residential houses in hurricane prone areas that use toe-nails as RTWC, making the development of mitigation strategies important. One major challenge is that mitigation strategies need to be cost effective in order to be widely implemented; a point which has proven difficult for retro-fitting existing structures. This is where realistic analysis of performance, leading to optimal solutions,

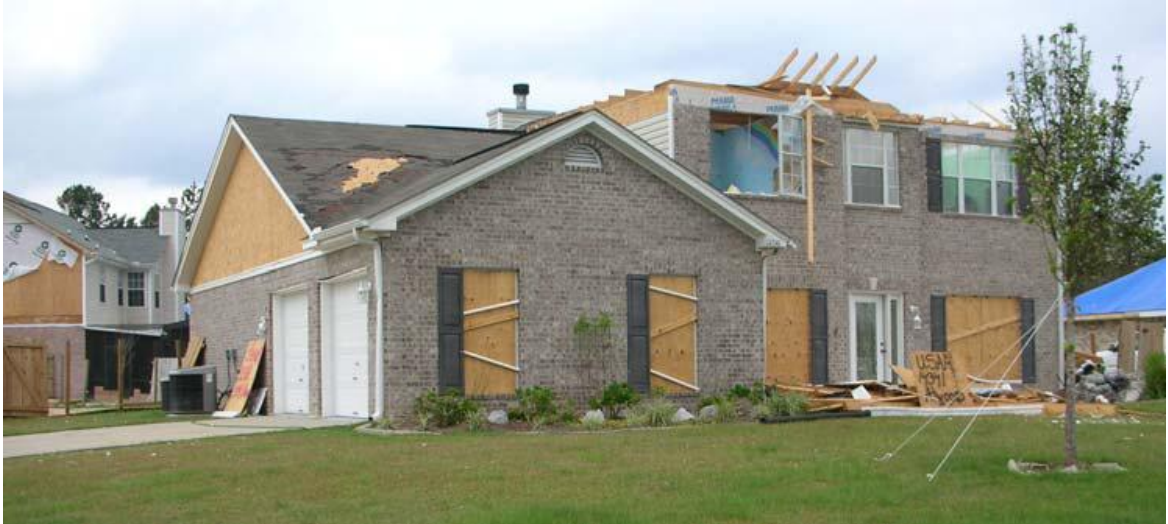
Figure 1.2 Failure of windward windows, shingles and roof trusses during Hurricane Katrina in August, 2005.

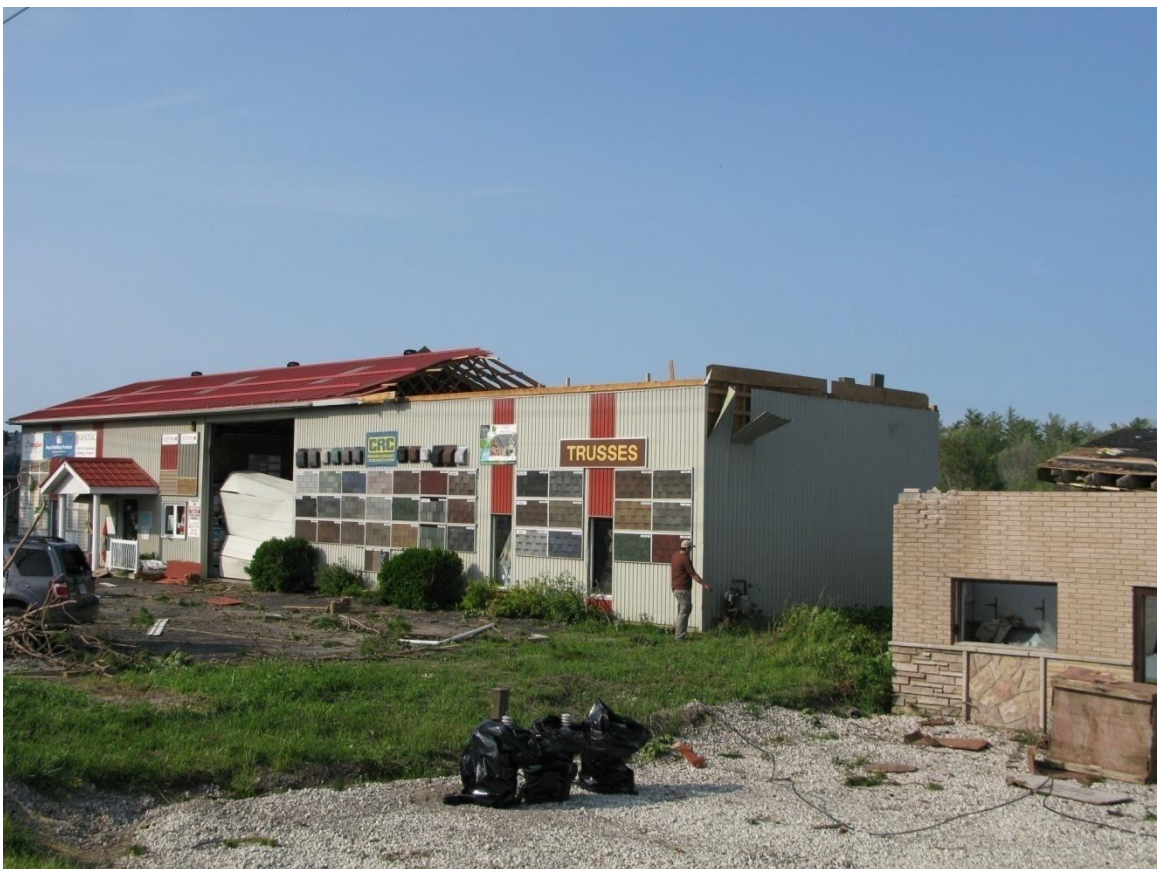
Figure 1.3 Failure of a group of trusses during a tornado in Midland Ontario, June, 2010.

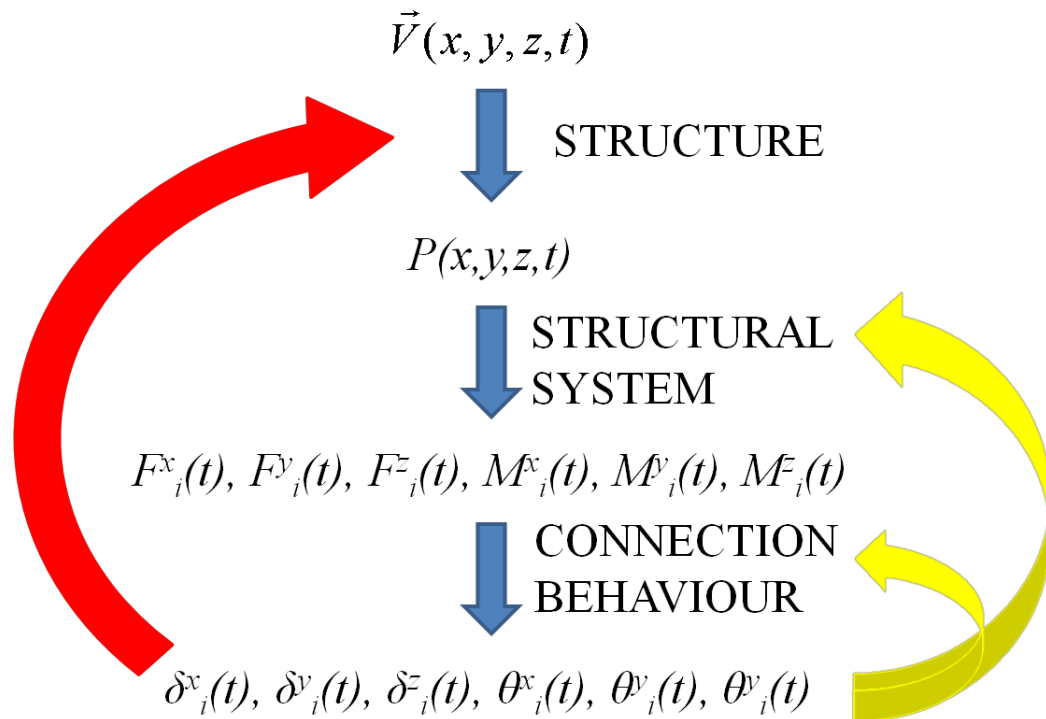
Figure 1.4 Flow diagram of wind action on a building and the structural response

There are also two feedback mechanisms as indicated by the red and yellow arrows. The first feedback mechanism (red arrow) represents a change in the shape or configuration of the structure caused by the wind loads that will effect the wind loads at a later time. Related to this, a change in the relative wind speed and direction can occur due to the movement of the structure. This latter effect can be significant for high rise buildings that tend to sway in the wind, as well as for long span bridges. However, for low rise buildings, both of these effects are minimal, and if the structure were to displace sufficiently for them to have an effect, the structure would have already sustained significant damage. Consequently these effects will not be considered herein as they are not considered relevant to the onset and mechanisms of failure. The second feedback relates to the performance of the structural elements and connections. As the structure displaces this could affect the future response. An example of this effect is performance of pierced metal fasteners under wind loads, where failures due to low cycle fatigue occur

(Henderson et al., 2009). Moreover, it is possible that as the connections or elements displace, this will cause a change in distribution of the loads, thereby changing the structural system. The following sections will discuss these four aspects of Figure 1.4 in further detail.

Sections 1.1 to 1.3 outlined the key aspects, shown in Figure 1.4, which influence how a structure responds under wind load. Wind tunnel testing can give us very detailed information on the actual wind loads but cannot predict how the structure will respond to these wind loads. Damage investigations conducted following severe wind events provide valuable information on both what has failed and what has remained intact, however; these investigations can rarely identify how the failures initiated, at what wind speed (failure load), or how the failures progressed. Testing on individual toe-nail

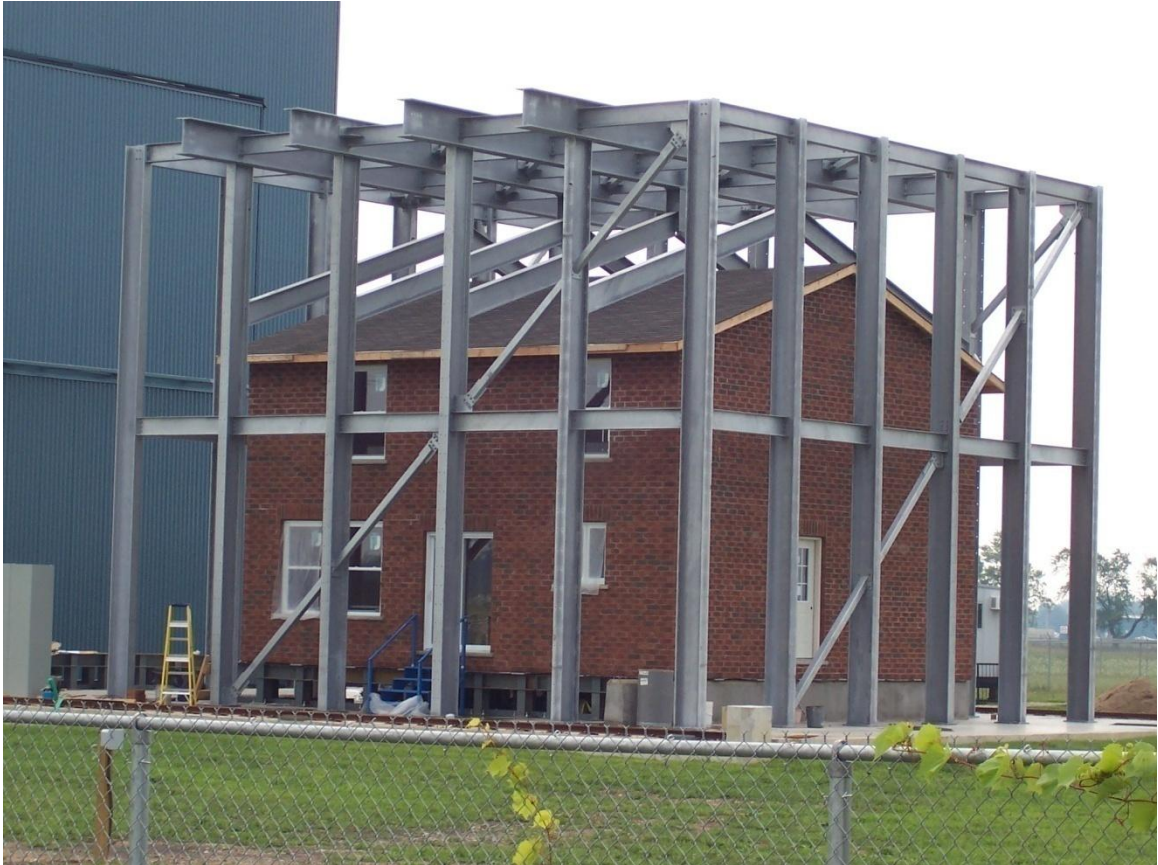
Figure 2.1 Photograph of the test house surrounded by the steel reaction frame used to mount the air bags and PLAs.

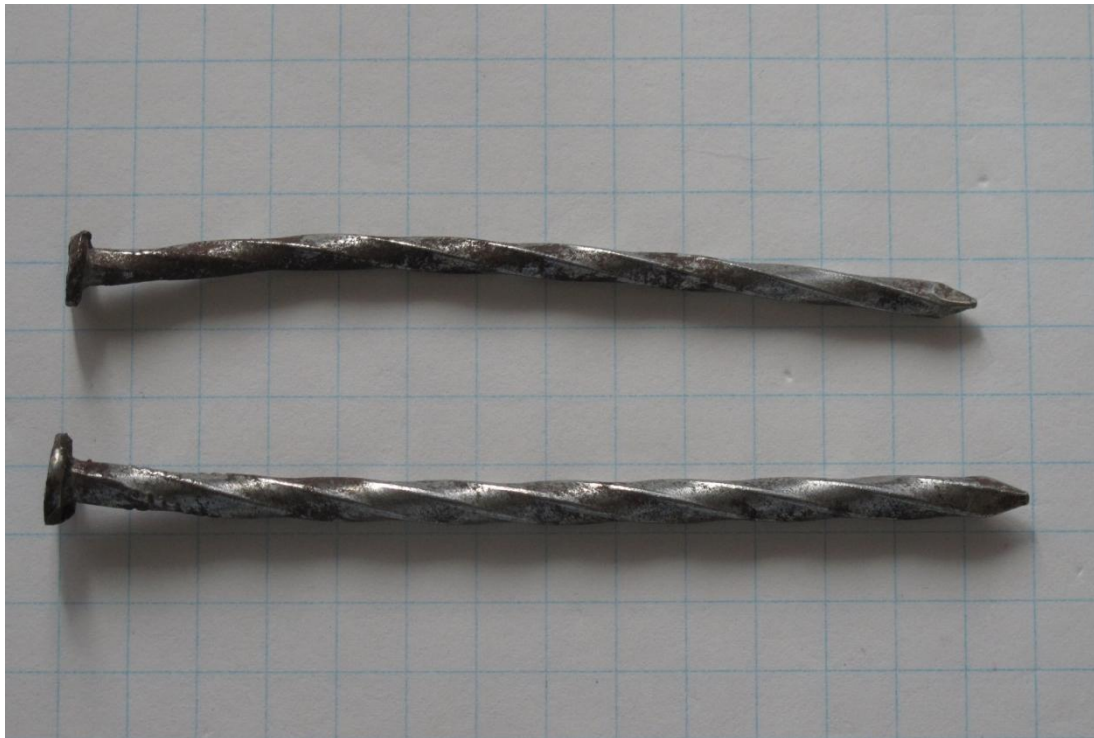
Figure 2.2 Photograph of the two types of nails used for the toe-nail RTWC on the test House. The grid shown is 6mm by 6mm, above is the 12d nail, below is the 16d nail.

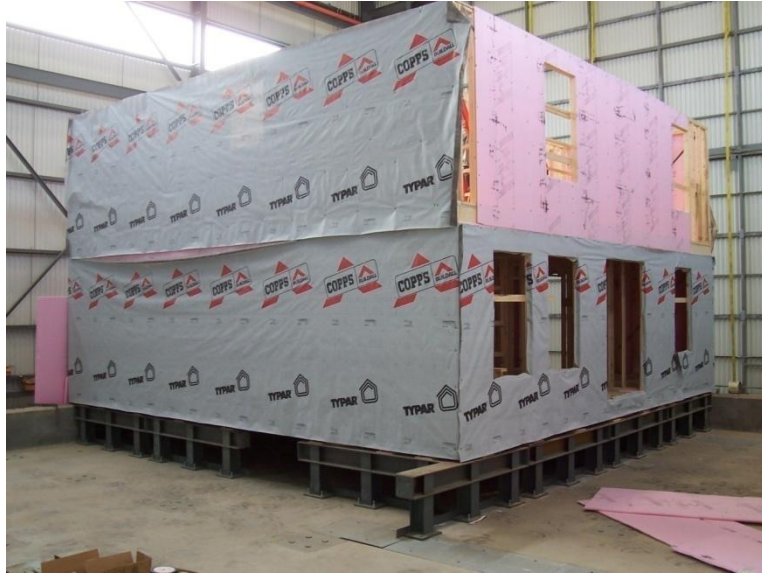
Figure 2.3 Photograph of the test house under construction. Photograph shows the house prior to the installation of the brick veneer and roof trusses.

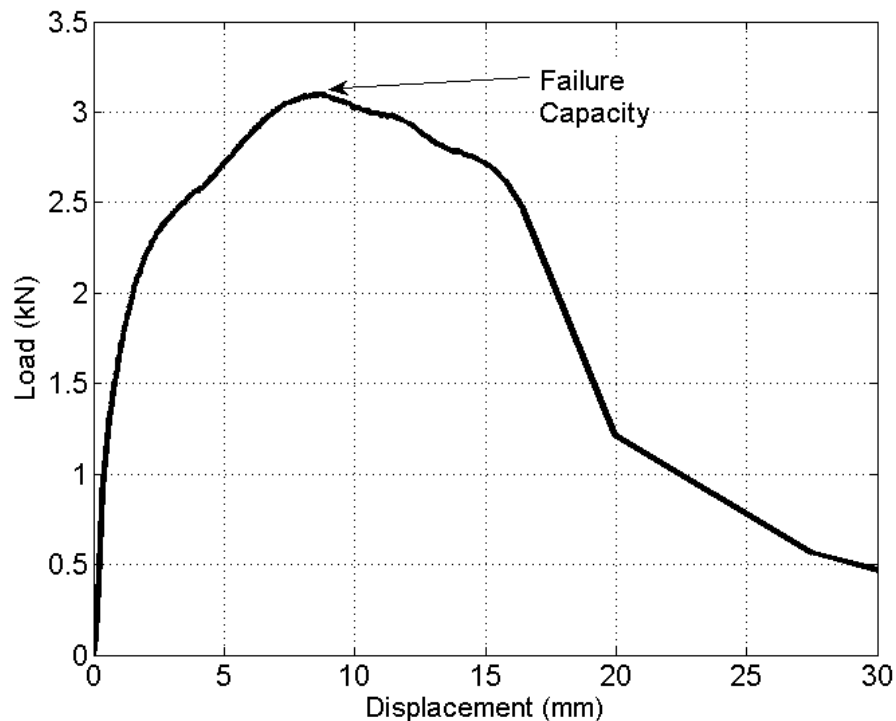
Figure 4.1 Load vs. Displacement relationship for a ramp rate of 8 kN/min

Figure 4.1 shows a typical load displacement relationship for one of the 8 kN/min ramp tests. The failure capacity of the connection is defined as the maximum measured reaction, as indicated in Figure 4.1. After this point, the measured reaction drops as the nails pull-out. Since the current study uses a load control approach, when failure begins to occur it proceeds in an uncontrolled manner; therefore, the data beyond the failure capacity are not used in the analysis.

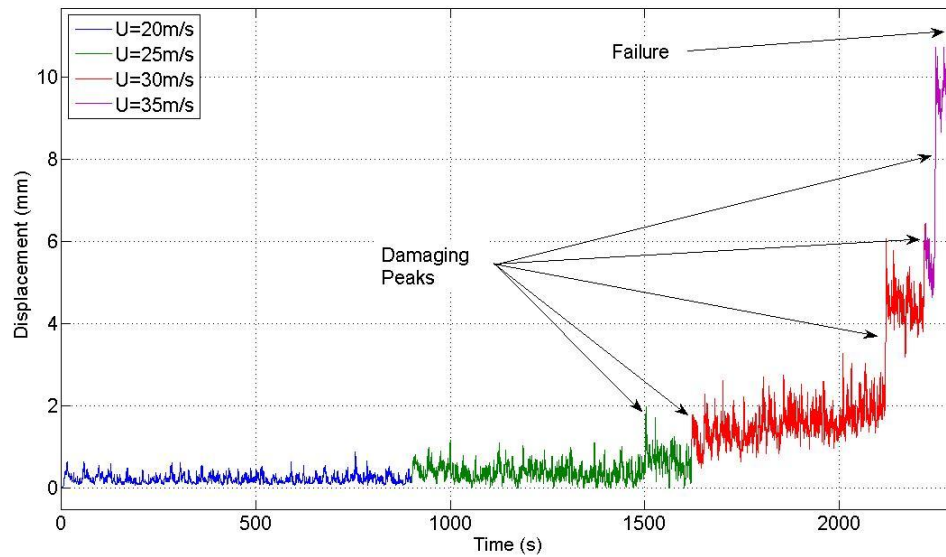
Figure 4.4 Displacement time series of a typical realistic wind loading trace applied to a toe-nail connection. The damaging peaks are indicated in the figure.

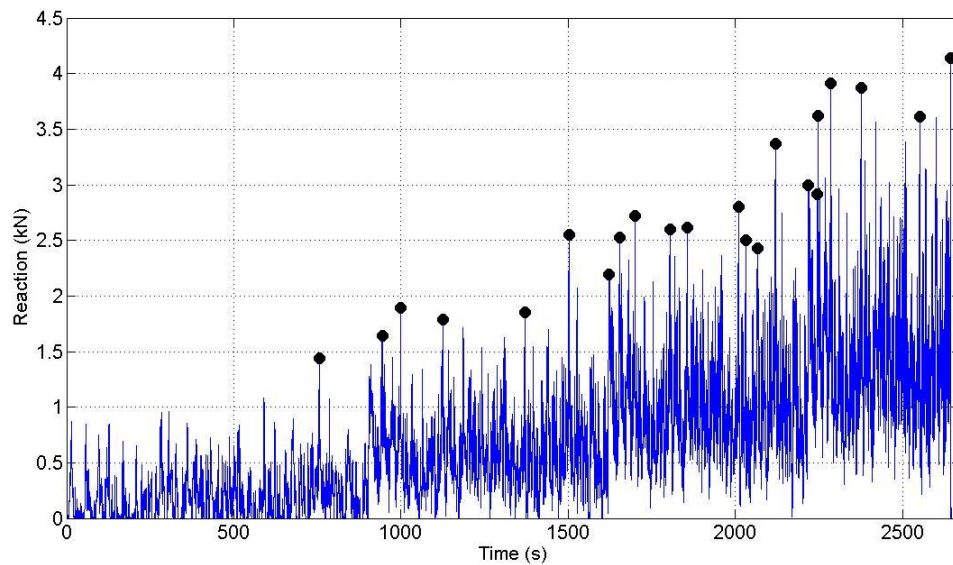
Figure 5.1 Time series of the realistic wind trace used in the nail test rig. The 22 damaging peaks are marked by the black circles.

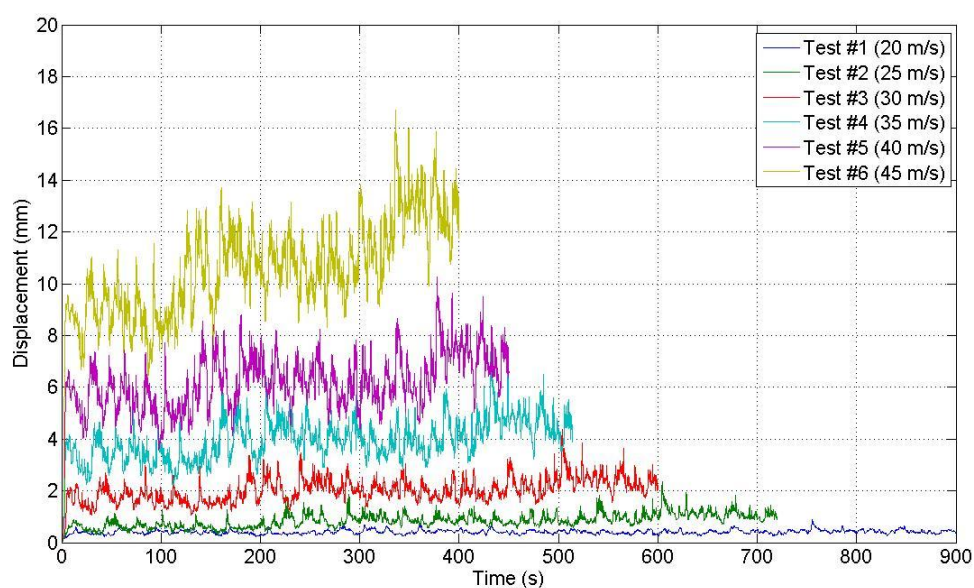
Figure 6.2 Displacement Time Series for all 6 tests for RTWC “S2”

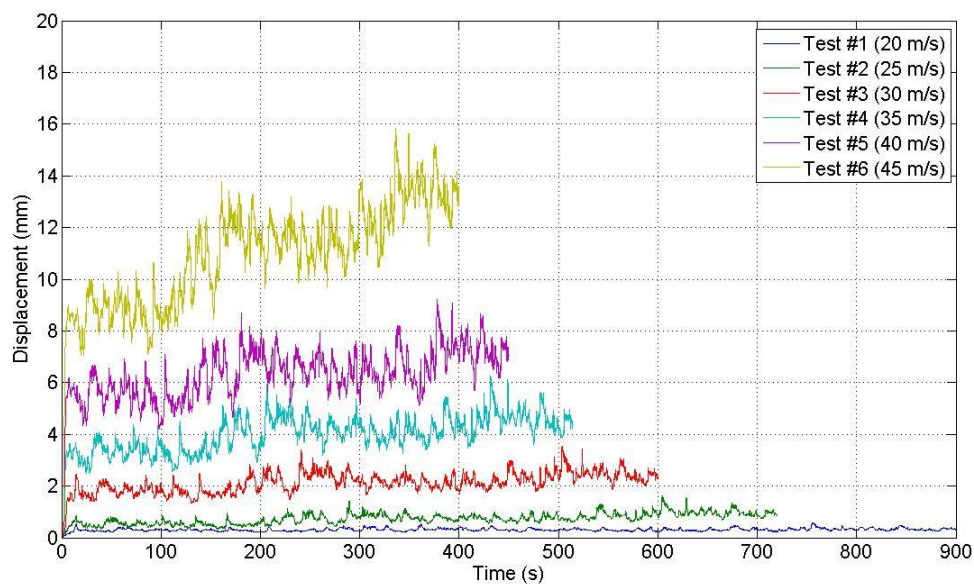
Figure 6.5 Displacement Time Series for all 6 tests for RTWC “S5”

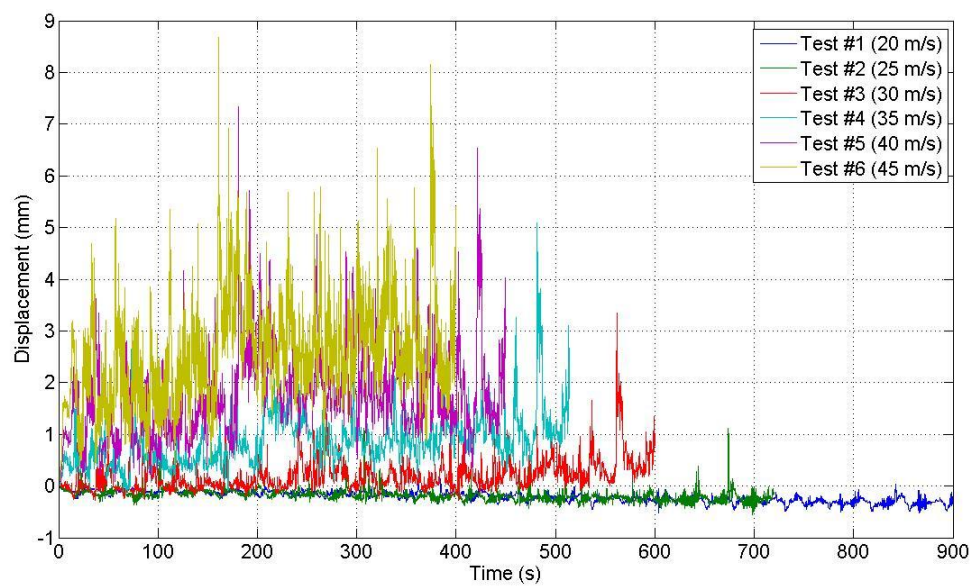
Figure 6.7 Displacement Time Series for all 6 tests for RTWC “N2”

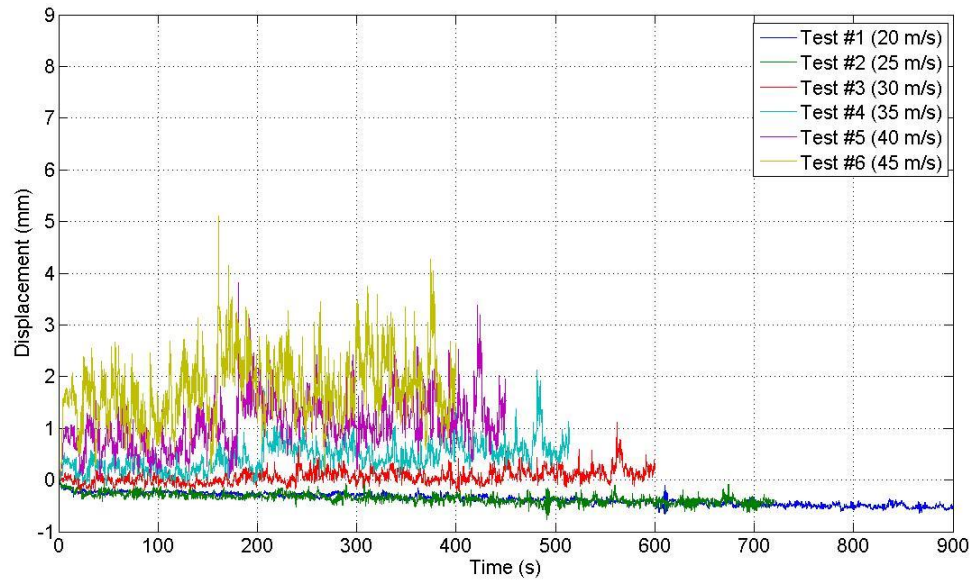
Figure 6.9 Displacement Time Series for all 6 tests for RTWC “N4”

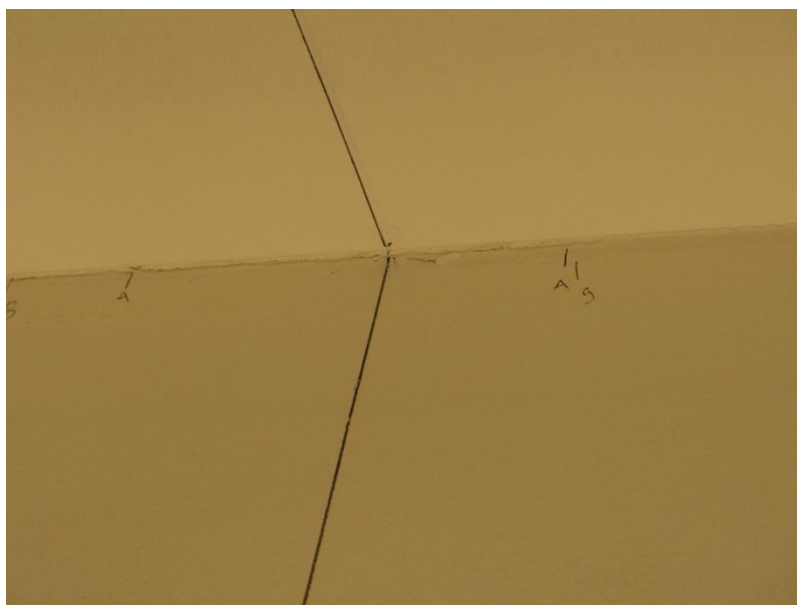
Figure 6.23 Cracks in the drywall below RTWC “S3”. Only minor hairline cracks are observed despite the damage that has occurred to the toe-nail connection directly above it.

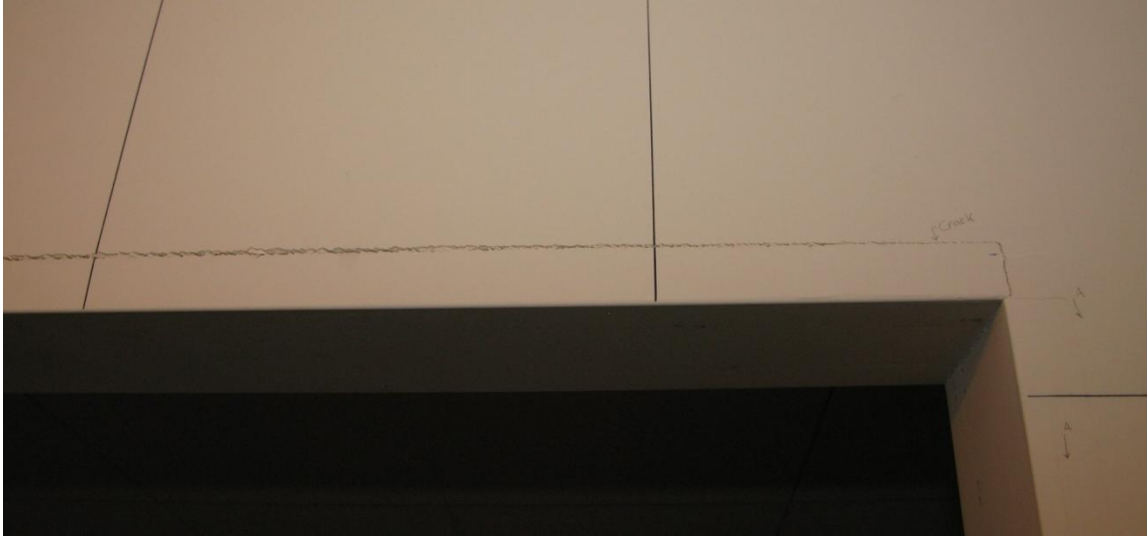
Figure 6.24 Largest crack documented in the test house, which was not the result of structural testing. Distance between vertical black lines is 0.3 m.

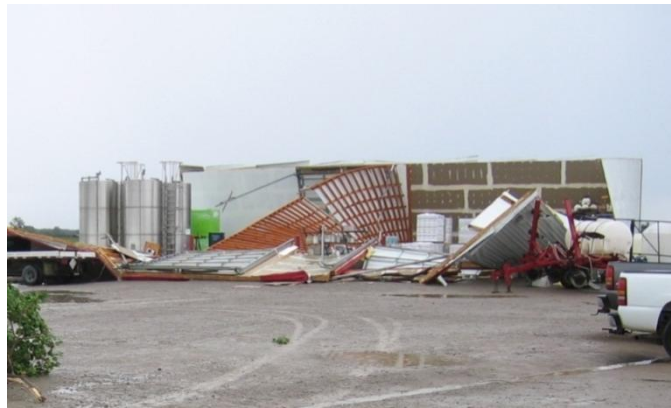
Figure 8.1 Picture of the Building facing South just after failure

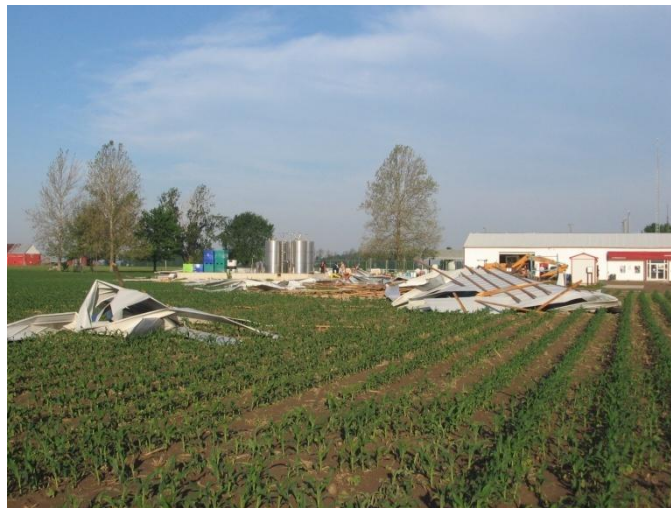
Figure 8.2 Picture of the debris field looking west towards the building

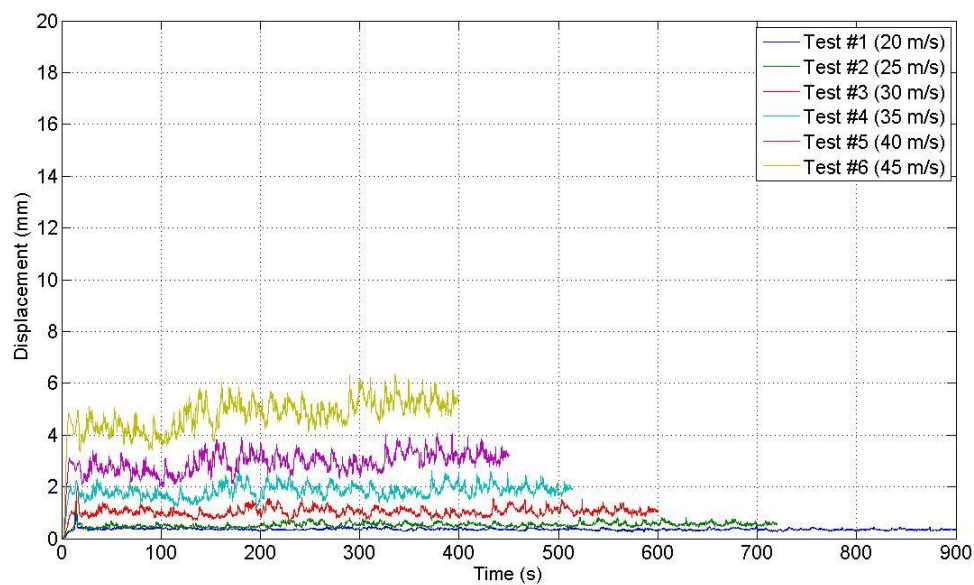
Figure E. 7 Displacement Time Series for all 6 tests for RTWC "S14"
