Erosion Control of Steep Open Channels Using Articulated Concrete Blocks

MohammadOmid Marandi, *The University of Western Ontario*

A thesis submitted in partial fulfillment of the requirements for the Master of Engineering Science degree in Civil and Environmental Engineering

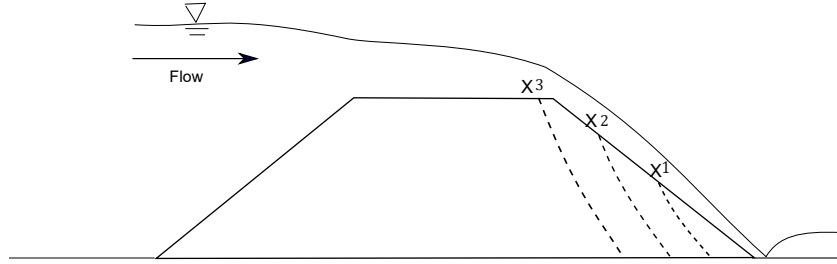
Figure 2.1: Erosion pattern with overtopping flow

As the overtopping flow creates higher flow velocity and shear stress. It creates a strong erosion force. When the overtopping flow is submerged, the downstream side starts to be eroded. Figure 2.1 shows the erosion pattern when overtopping flow causes the scour on the downward side of an embankment. When sediment particles are covered by armors (e.g. stones protection layer), the turbulence caused by wave force makes the subgrade particles agitated causing displacement. Sediment size, wave height, wave period, the ratio between sediment size, and protection layer can play a key role in this displacement. The turbulent water force can reach the gaps of the armor and make the sediments particles winnow out and if a considerable amount of sand is removed failure would happen. The Shields diagram has been widely used to determine the incipient motion of sediment, the critical condition in which the sediment starts to move. As long

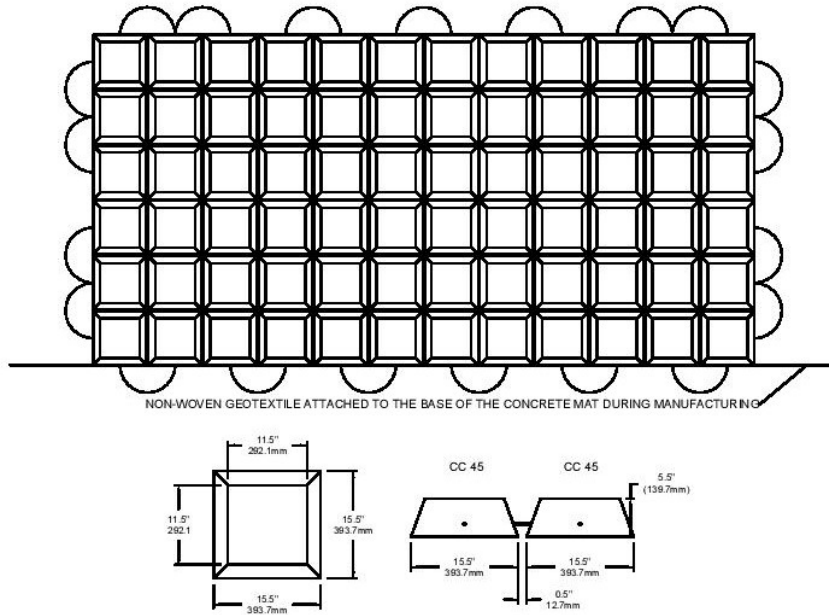
Figure 2.2: Standard CC45 Details (Credit: IECS Inc)

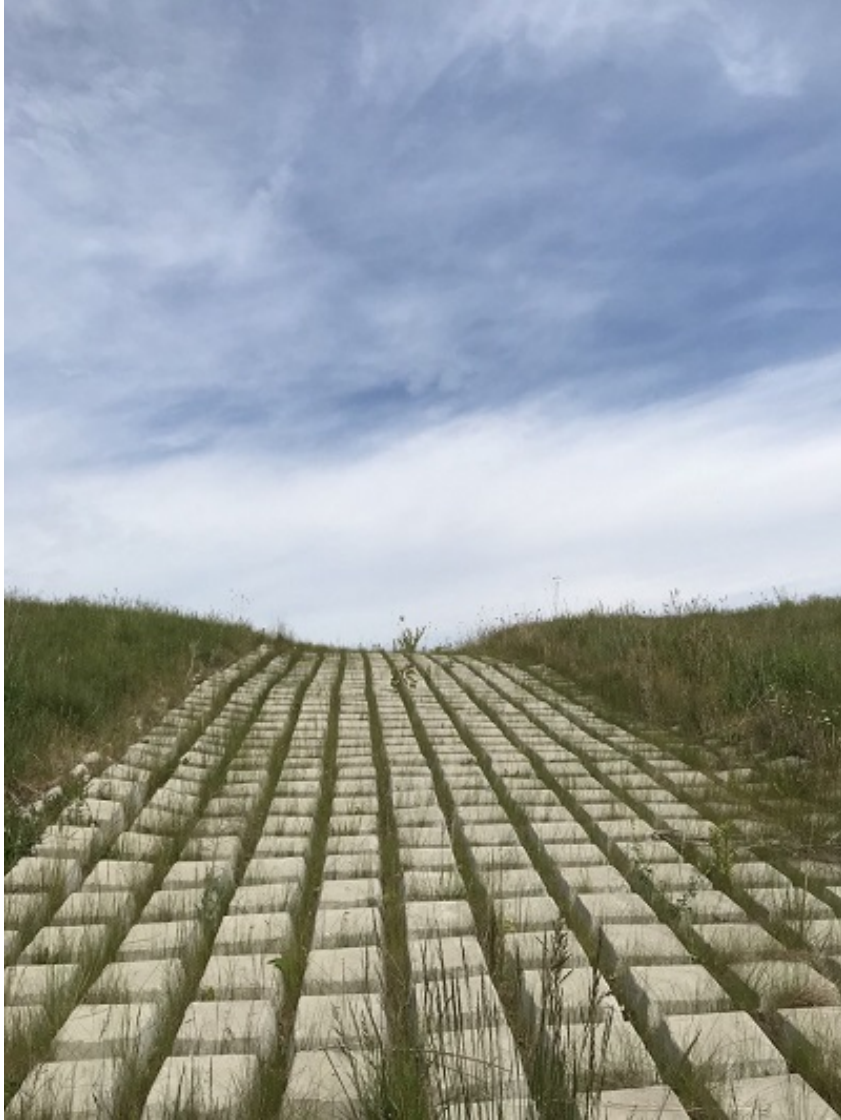
Figure 2.3: An example of ACB protection (Credit: IECS Inc)

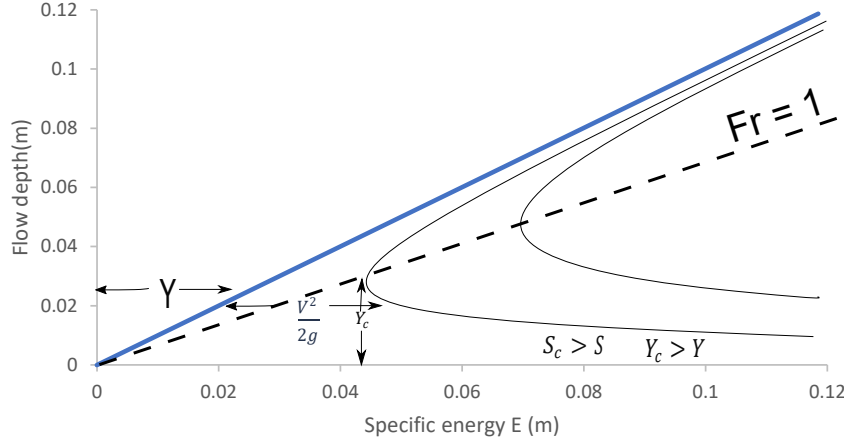
Figure 3.1: E-y curve

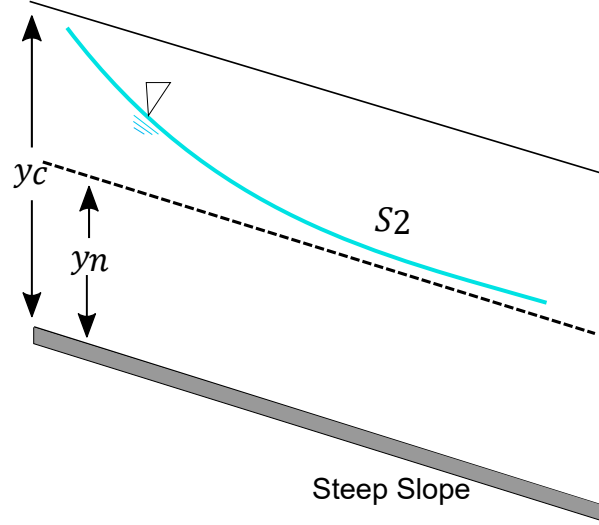
Figure 3.2: Water Surface profile

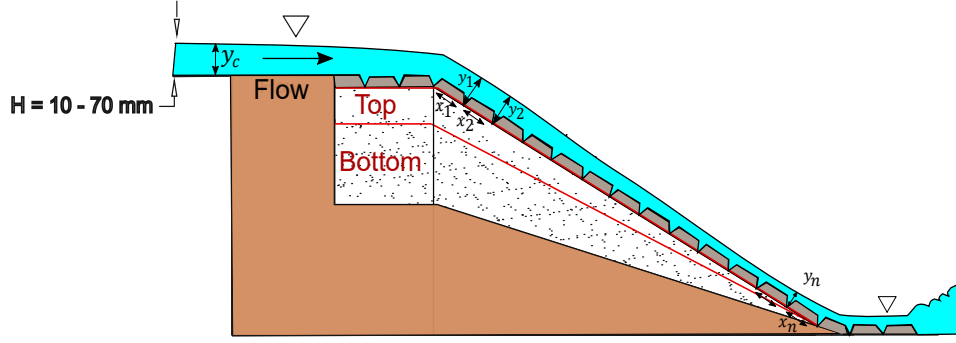
Figure 3.3: Direct step method (the water flow starts from critical depth on the crest and reaches the normal depth on the downstream)

reach was divided into several segments with $\delta y = 0.001$ m per step to get accurate results, and specific energy was calculated and compared at two points. Computations were to proceed from the upstream. On the upstream side of the embankment, the flow condition was critical, in which the mean specific energy was minimum. y_c was measured on the upstream perpendicular to the bed of the embankment. The discharge per unit width was calculated based on the Broad crested weir formula and was verified with the Flowmeter in the hydraulics flume (Chanson, 2004).

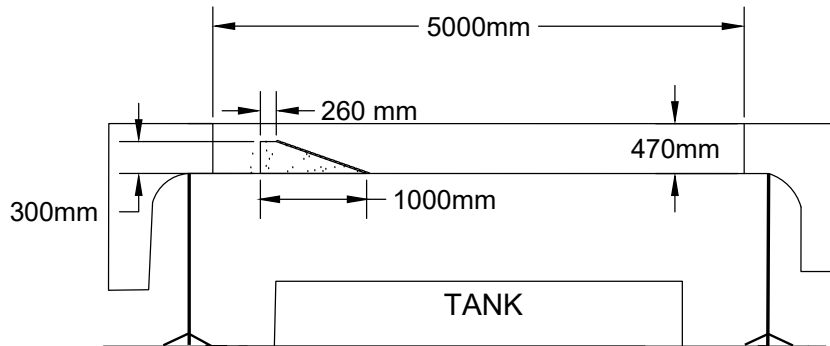
Figure 3.4: Flume schematic

The experiments were conducted in a 5m-long, 31cm-wide flume with a height of 47cm and maximum discharge of $0.014 \text{ m}^3/\text{s}$ in the hydraulics lab of the Civil and Environmental Engineering department at Western University (Figure 3.5). Figure 3.4 shows the schematic of the flume in the hydraulic lab.

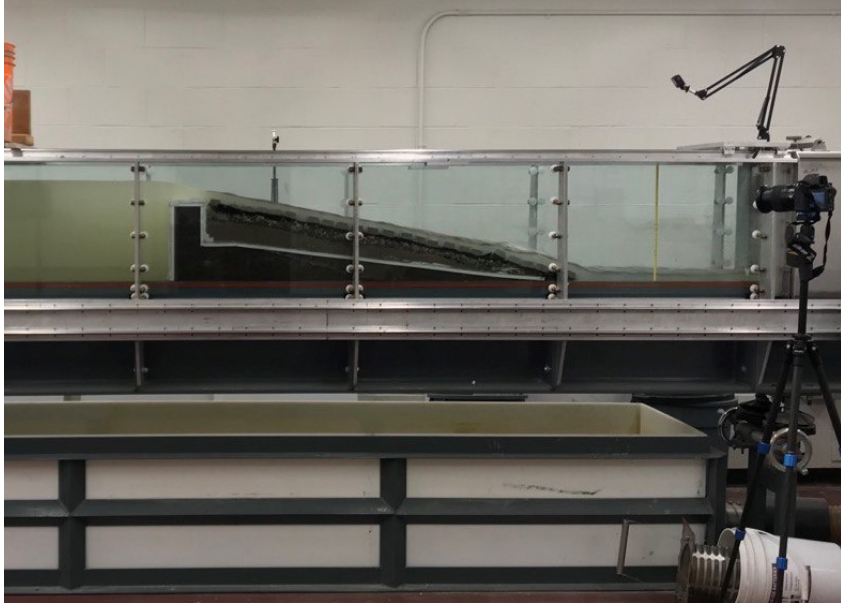
Figure 3.5: Hydraulics Flume at Western University

The experimental tests were conducted using a hydraulics flume to assess the indirect failure mechanisms of the Articulated Concrete Blocks based on the standard installation procedures (based on the prototype conditions) and identify the optimal subgrade configuration. Nine experiments were performed with different soil types but without the protection layer. Afterwards, 31 tests were carried out with the cable concrete and various configurations on two wooden broad crested weir structures considering bed slopes of 14 and 26.6 degrees. Figure 3.5 shows the 14-degree embankment in the hydraulics flume.

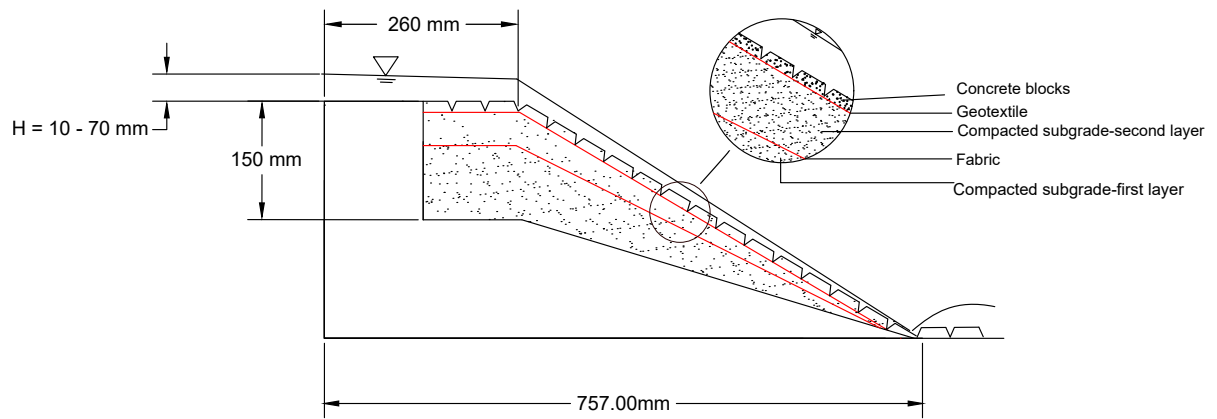
Figure 3.6: Setup for the scaled model test (26.6-degree slope) and the overtopping flow is from the left to the right

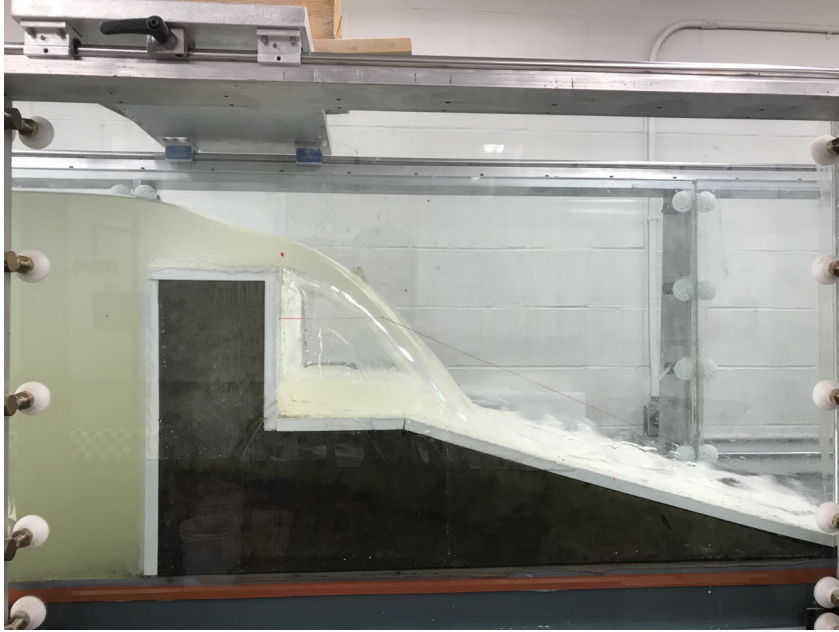
Figure 3.7: Wooden structure

A wooden block with a steep gradient was used to characterize the overtopping flow conditions by reducing the effects of seepage (Figure 3.7). The model tests in the flume were investigated following the prototype conditions. Profile view of the ACB, subgrade and the wooden structure is shown in Figure 3.6. The crest height of the model setup is 300 mm from the bottom of the flume and the length of the crest is 260mm. The length of the downstream slope is 1250 and 520 mm for 14-degree and 26.6-degree slope tests, respectively. The broad crested weir was made out of wood for the tests and the

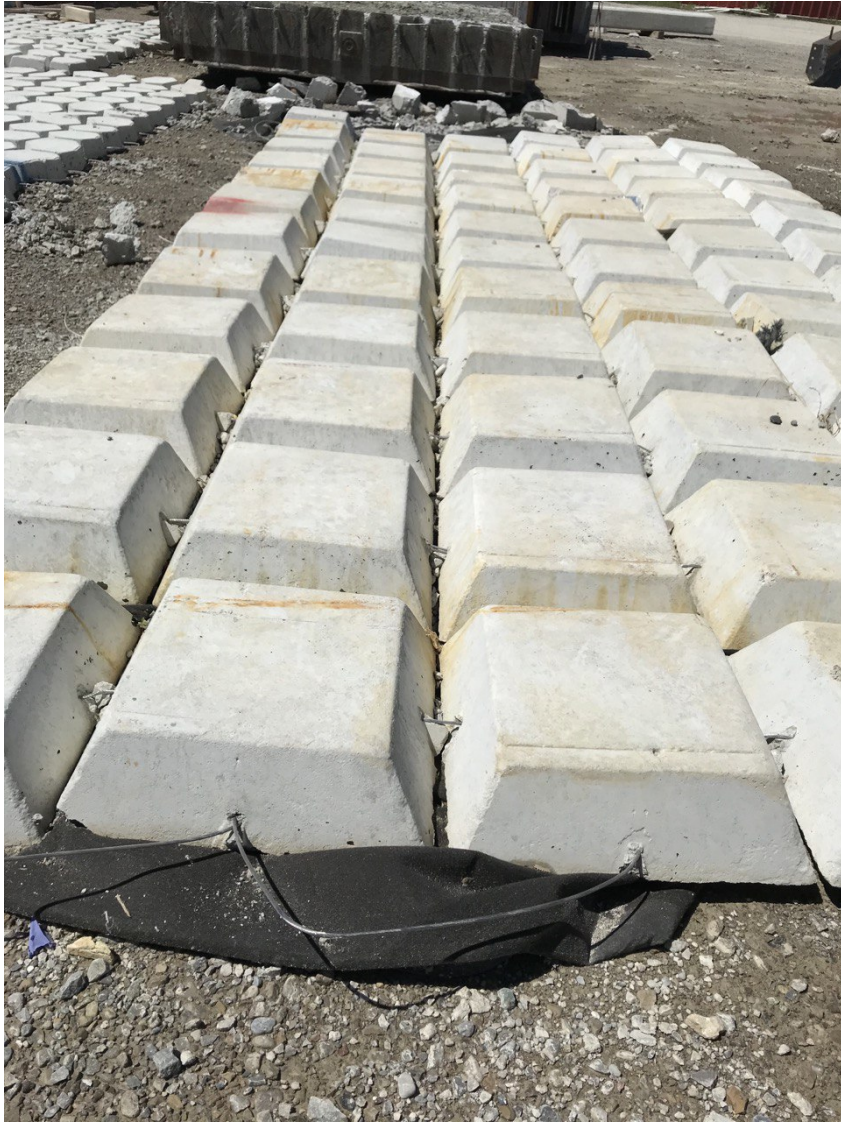
Figure 3.8: Blocks with geotextile attached (Credit: IECS Inc)

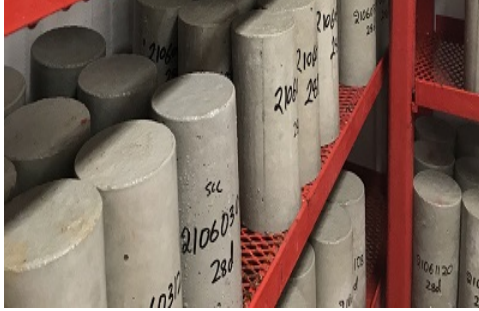
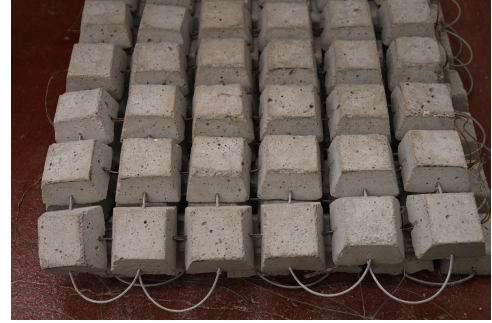
Figure 3.9: (a) Concrete samples based on standards and specifications; (b) Scaled Blocks (Credit: IECS Inc)

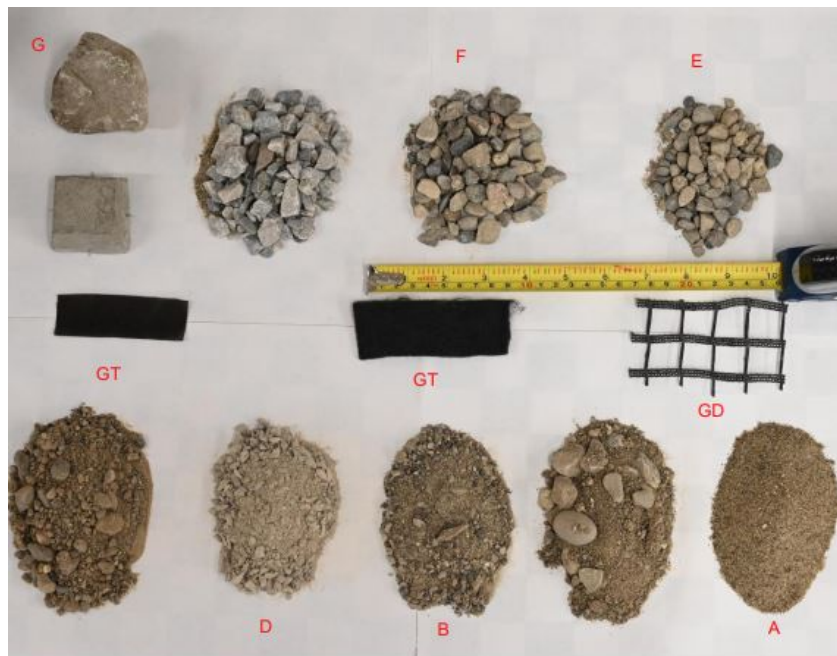
Figure 3.10: Different soil types and fabrics used in the experiments

Different soil types and particle sizes show different erosion resistance behavior. Tests with various configurations and materials were conducted to evaluate the corresponding effectiveness to control scouring and soil loss. Figure 3.10 shows the different soil types used in the experiments.

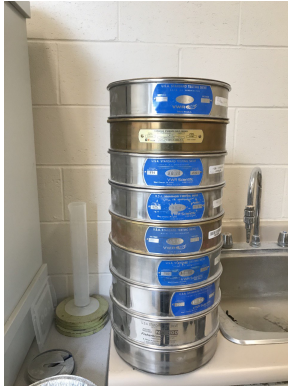
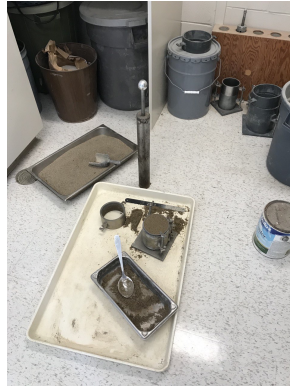
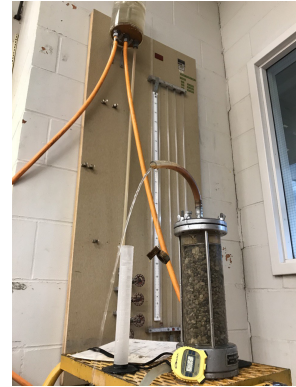
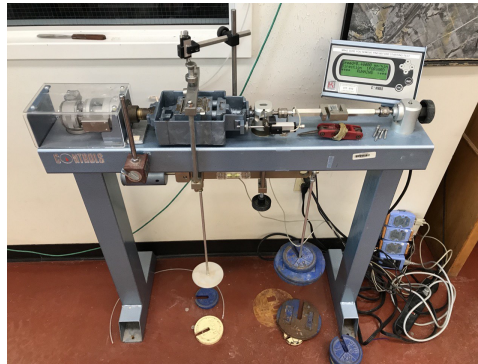
Figure 3.11: (a) Sieve analysis; (b) Compaction proctor test; (c) Hydraulic conductivity; (d) Direct shear

Geotechnical tests (sieve analysis, compaction proctor test, direct shear, hydraulic conductivity, porosity, soil moisture content(%)) were conducted for each soil sample.

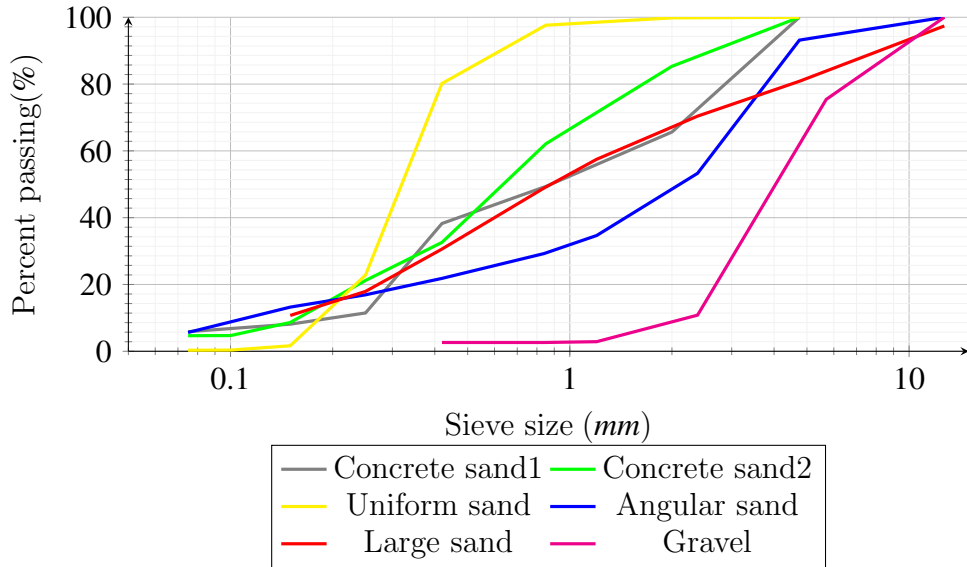
Figure 3.12: Sieve analysis

Sieve analysis was conducted for all the samples based on (ASTM, 2006) as shown in Figure 3.12.

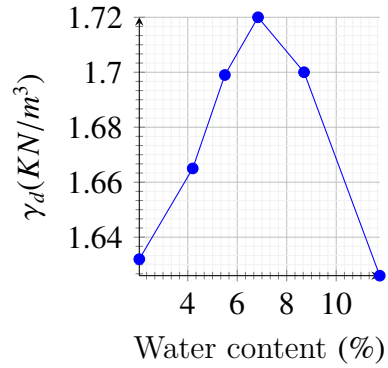
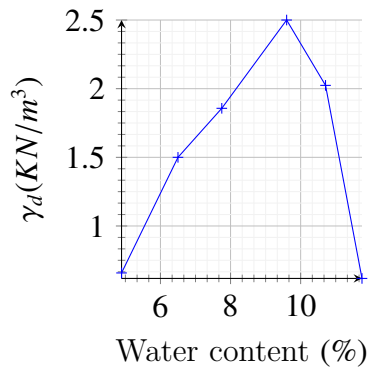
Figure 3.13: Compaction proctor test for two different soil types

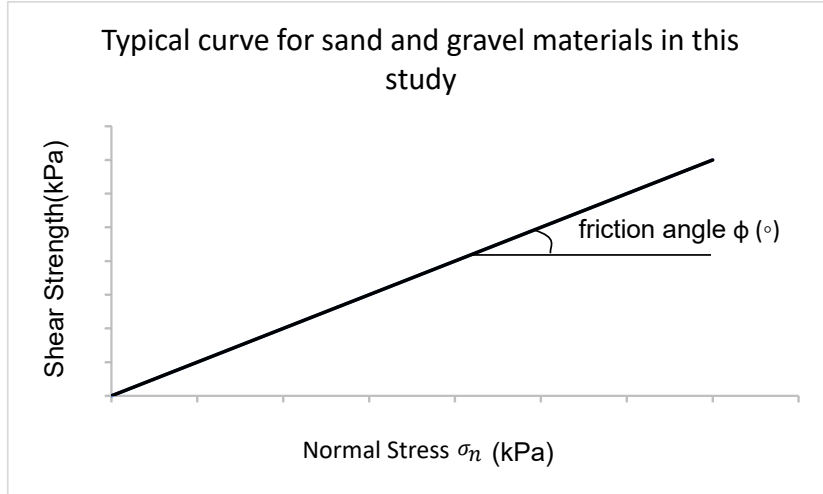
Figure 3.14: Shear strength- Normal stress curve for the materials in this study

The equation represents a straight line on shear strength versus normal stress plot (Figure 3.14). The intercept on the y-axis is the cohesion(c) which is zero for the materials used in this study. The slope of the line is the angle of internal friction(ϕ).

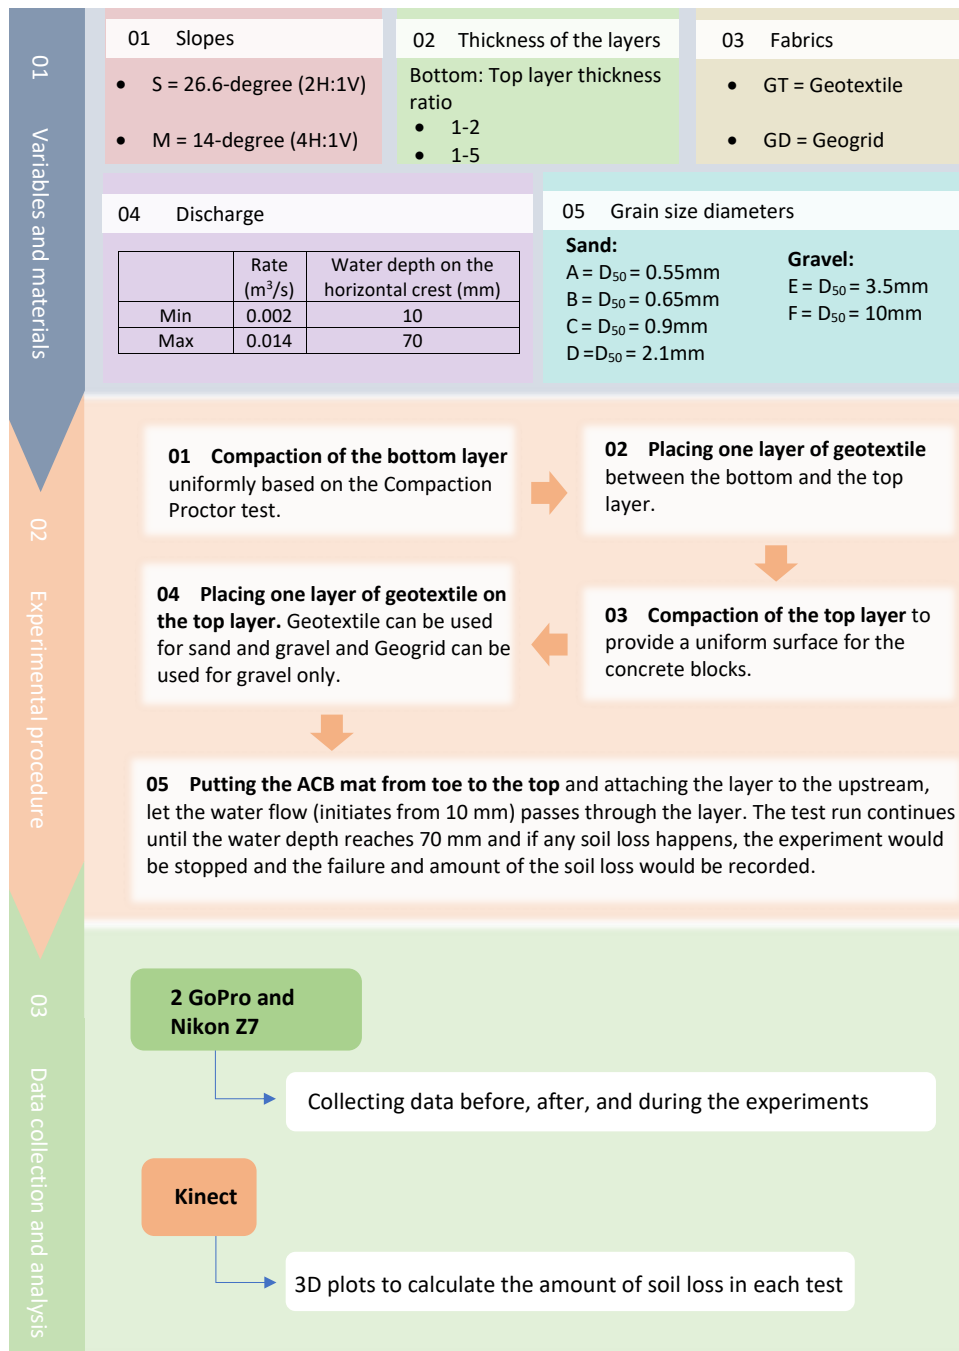
Figure 3.15: Experimental procedure

Figure 3.15 shows the variables and the experimental procedure for the experiments conducted in the lab. The abbreviation of some of the different possible configurations used for the experiments for both 14 and 26.6-degree slopes is shown in Table 3.6. For instance, test “M-GT-B-1-2” configuration include compacted soil with $D_{50} = 2.1$ mm on the bottom layer with the thickness of 100 mm, followed by a layer of geotextile, compacted soil with $D_{50} = 0.65$ mm on the top layer with the thickness of 50 mm, and a layer of geotextile on the top below the ACB mat. For all the experiments, geotextile was used between the bottom and the top layer, and just the fabric below the ACB mat was changed.

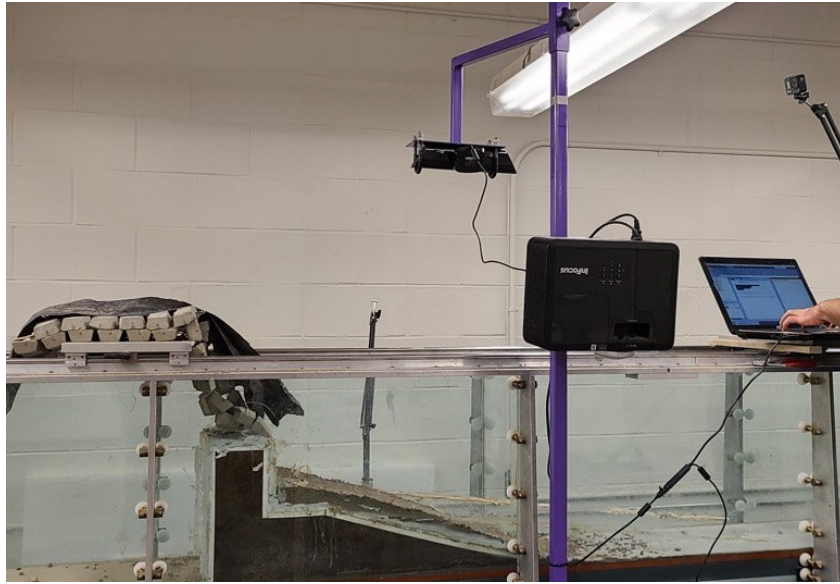
Figure 3.17: Kinect used in each experiment to provide the 3D plots to calculate the amount of soil loss in each trial

Kinect V2 was used in the study to create a 3D model of surfaces before and after each test to measure the amount of soil loss in each test (Figure 3.17). This motion sensor camera helps assess the changes in the morphology of the channel. Kinect simulates spatial data in three different axes (X, Y, Z). By capturing each photo, depth measurements are produced. Data are filtered in MATLAB to extract the DEM. By subtracting the two matrixes of data points (one before and one after the test is conducted), the amount of soil loss is calculated for all the experiments. By doing so morphology of the failed embankment is derived and can be compared with other configurations and setups.

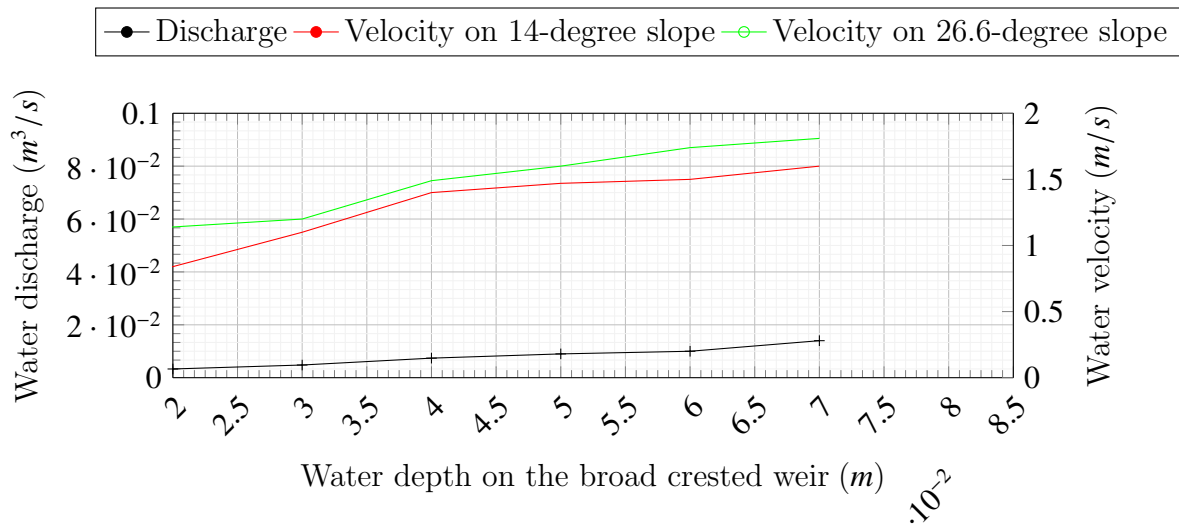
Figure 3.18: Water depth-velocity for 14 and 26.6-degree slopes

The velocity and discharge for different configurations can be shown in graph 3.18. This graph compares the velocity (derived from the direct step method) for both 14 and 26.6-degree slopes according to the same discharge and water depth on the horizontal crest. By increasing the water depth on the crest, the discharge can be derived and compared with the flowmeter underneath the flume.

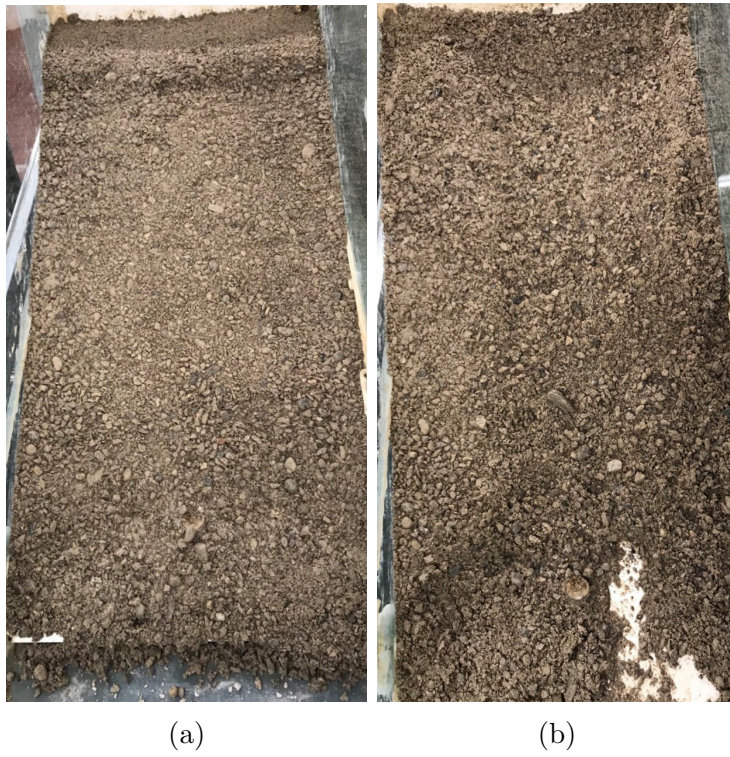
Figure 4.1: (a) Subgrade (sand) before the test was conducted and (b) after the failure

Failure of the setup and the embankment depends on the subgrade configuration and the water flow characteristics. Both the water flow and subgrade features were changed and analyzed in this study. Before and after each experiment photographs and DEM files were taken and recorded with measuring devices to compare the stability of the tests. Figure 4.1 shows the experiment S-GT-D-1-2 in which soil D (see Section 3.3.1) was used on the bottom and top layers on 26.6-degree slope followed by a layer of geotextile and the ACBs. Figure 4.2 illustrates the Kinect outputs for the test with the amount of soil loss calculated using MATLAB. Figure 4.3 presents the experiment S-GD-E-1-5 which was stable during the test and remained unchanged and Figure 4.4 shows the Kinect outputs for this test. Figure 4.5 shows the amount of soil loss using the difference of the matrix of data points before and after each test. The amount of soil loss (δ) derived for each experiment is shown in Table 4.2.

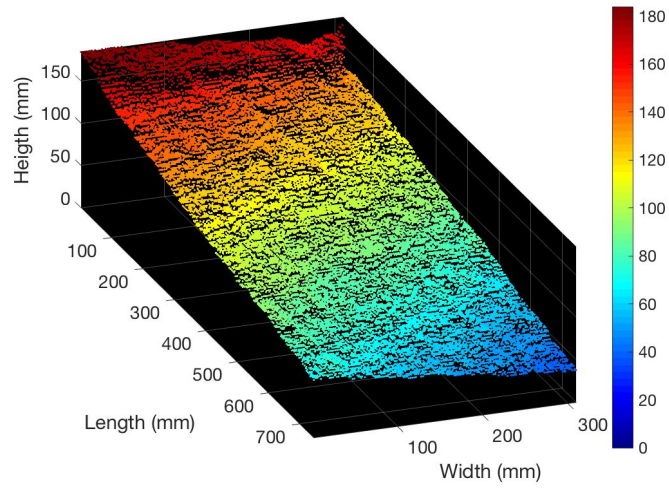
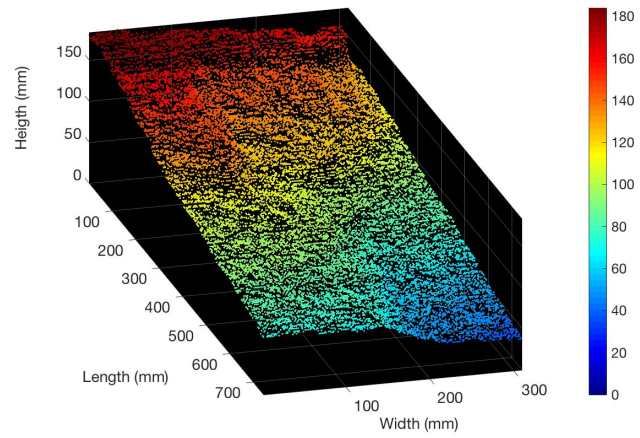
Figure 4.2: Kinect DEM outputs for the sand before the test conducted(a) and (b) after the failure

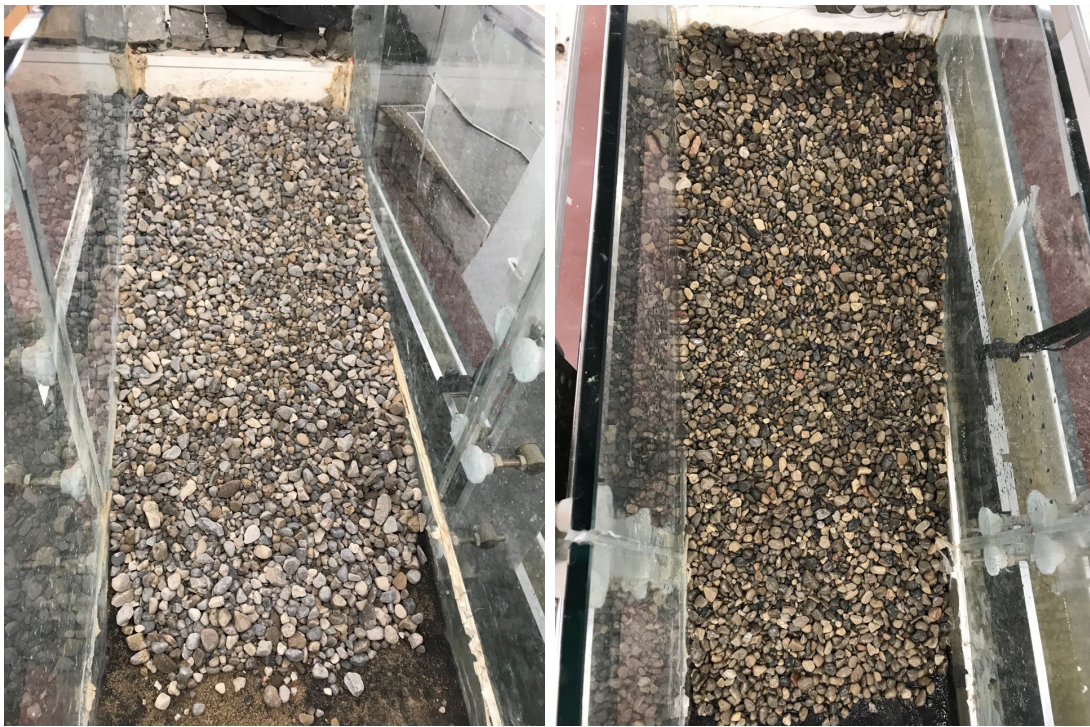
Figure 4.3: (a) Gravel with the $D_{50} = 3.5$ mm after the compaction; (b) shows that the gravel remained stable after the test was conducted and there was not any soil loss happened

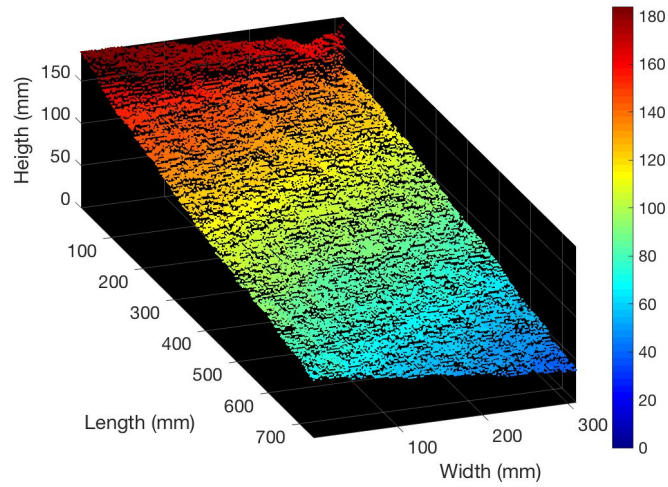
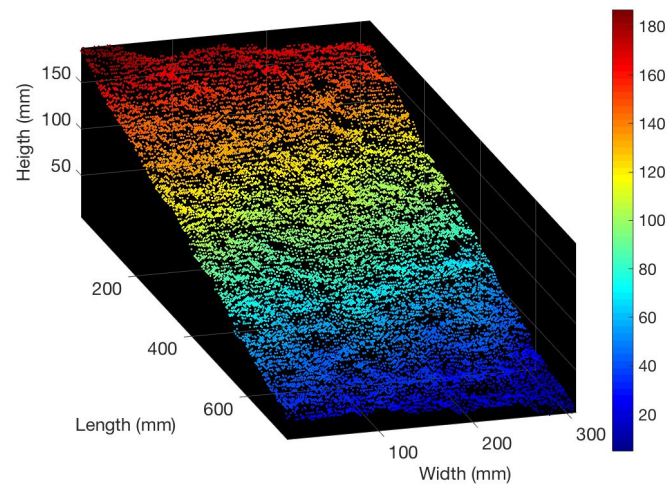
Figure 4.4: Kinect DEM outputs: (a) the gravel with the $D_{50} = 3.5$ mm after the compaction and (b) shows that the gravel remained stable after the test and there was not any soil loss happened

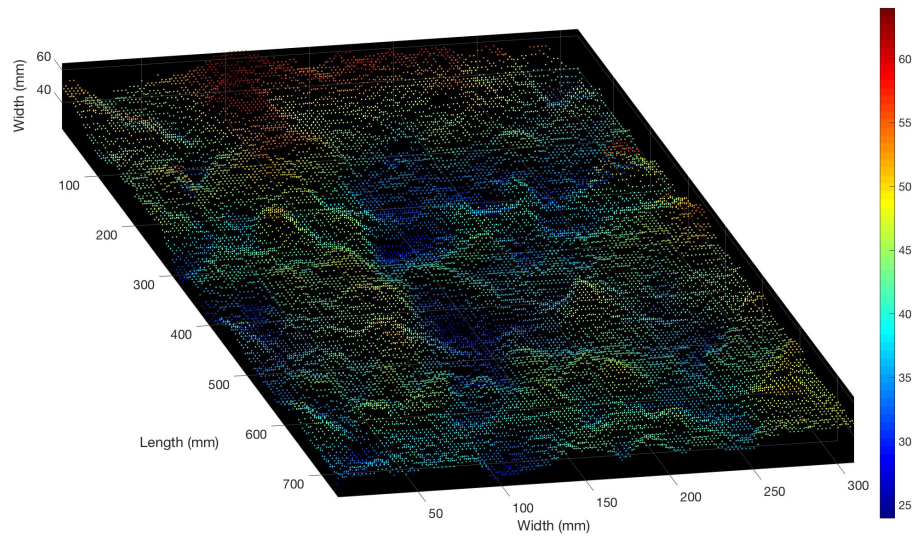
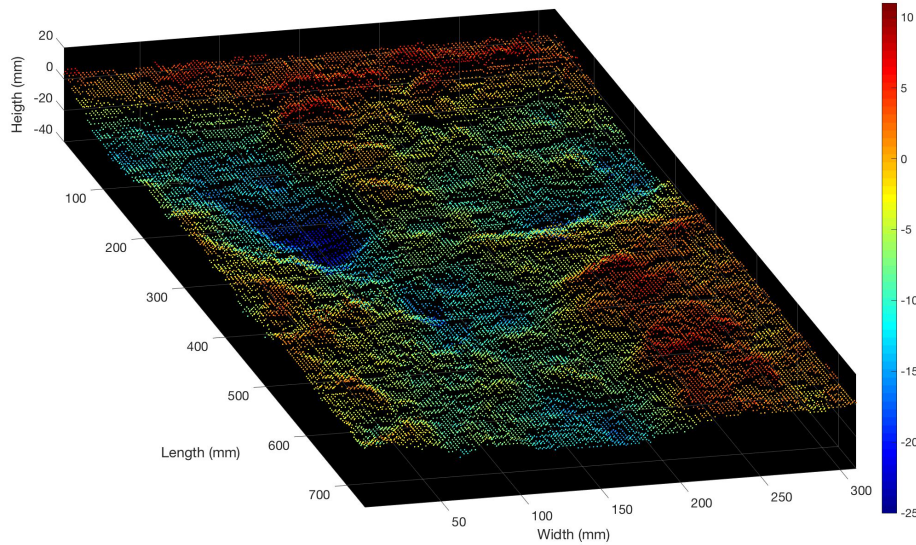
Figure 4.5: Difference in the volume of soil loss when sand and gravel used with the protective layer based on Kinect DEM outputs: (a) shows the difference of the volume of soil loss in setup with sand layer; (b) shows the difference of the volume of soil loss in setup with gravel layer

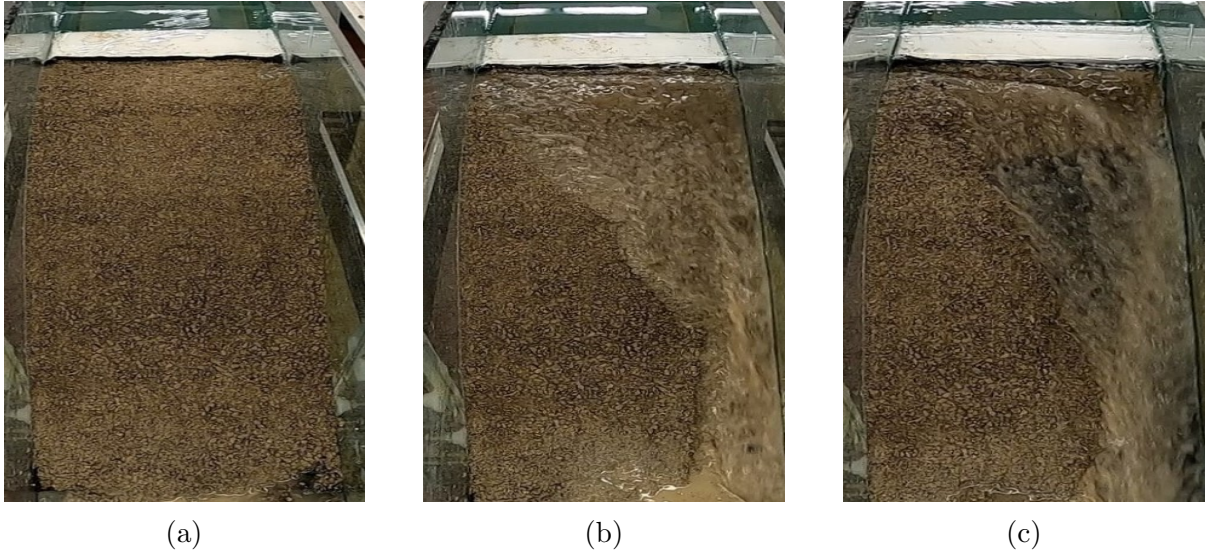
Figure 4.6: Test results corresponding to S-GT-D-1-2 in different time steps (seconds):
a) 00.00; b) 00.06; c) 00.08

Table 4.1 shows the results of the preliminary tests without the blocks for both 14 and 26.6-degree slopes. All the tests failed in less than 10 seconds. As expected, failure took longer in the 14-degree slope compared to the one in 26.6-degree slope. Figure 4.6 shows the test “S-GT-D-1-2” which was conducted without any protective layer. The embankment was washed down in less than 10 seconds.

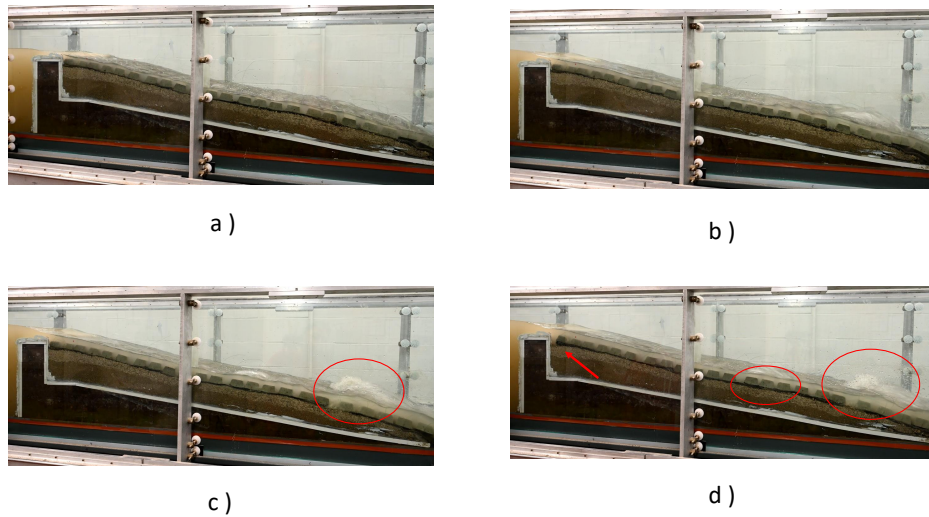
Figure 4.7: Test M-GT-D-1-2 at different stages: (a) 10 minutes with water depth = 10 mm; (b) 10 minutes with water depth = 20 mm; (c) 10 minutes with water depth = 30 mm on the crest; (d) when the water depth reached 50 mm on the crest, the blocks on the downstream overturned and water penetrated below the geotextile on the upstream

Test 4.7 shows the experiment with the ACBs on the 14-degree slope. It is clear that placing the layer of interconnected blocks makes the embankment more stable preventing it from sudden failure. When the maximum discharge reached $0.0075 \text{ m}^3/\text{s}$, the blocks on the downstream overturned and sediment transport initiated. The circles and arrows on the downstream and the upstream of the embankment respectively show the block overturning and water penetration below the geotextile on the crest.

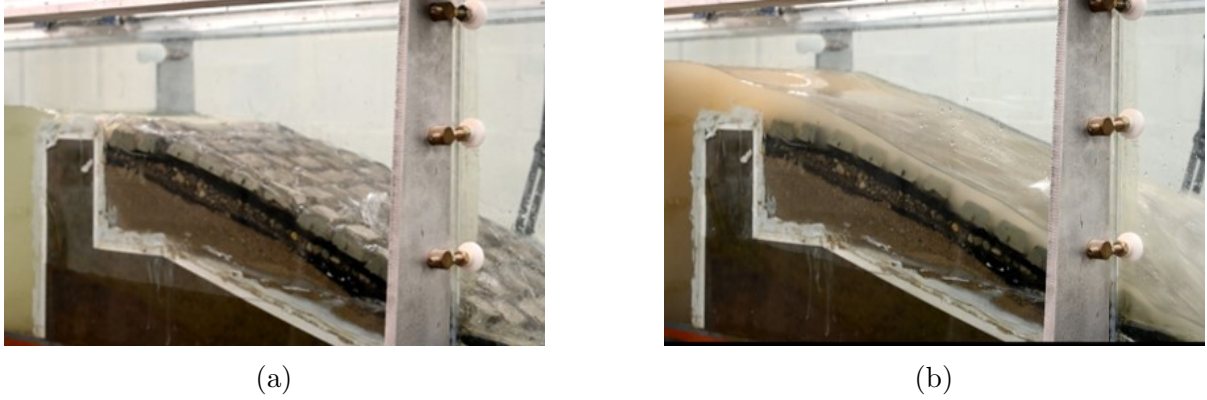
Figure 4.8: Test S-GD-E-1-5 at different stages: (a) water depth = 10 mm on the crest; (b) water depth = 70 mm on the crest

This experiment continued for 10 minutes with the discharge = $0.002 \text{ m}^3/s$ and water depth = 10 mm on the crest, 10 minutes with the discharge $0.0048 \text{ m}^3/s$ and water depth = 20 mm on the crest, 10 minutes with the discharge = $0.0065 \text{ m}^3/s$ and the water depth = 30 mm on the crest. This setup could finally resist the maximum discharge ($0.014 \text{ m}^3/s$) and did not fail and no soil loss or any movement of the blocks was observed.

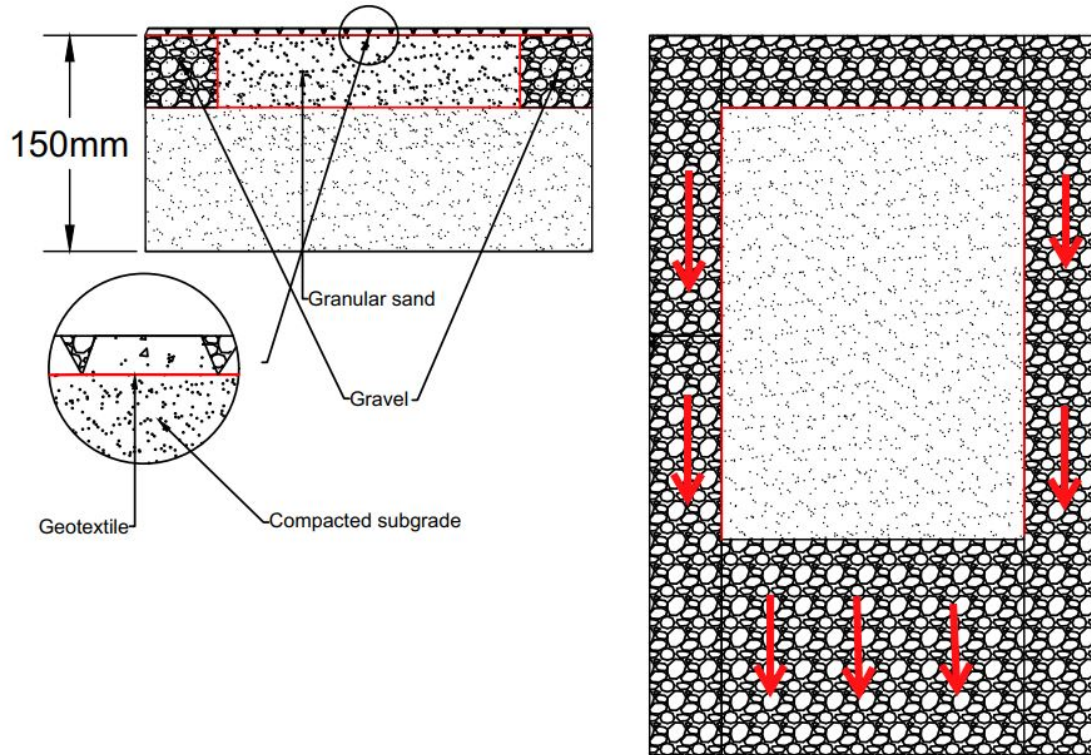
Figure 4.9: Plan of the Trench

the limestone, which could resist the maximum discharge and the failure threshold was not met. The drainage system can be seen in Figure 4.9.

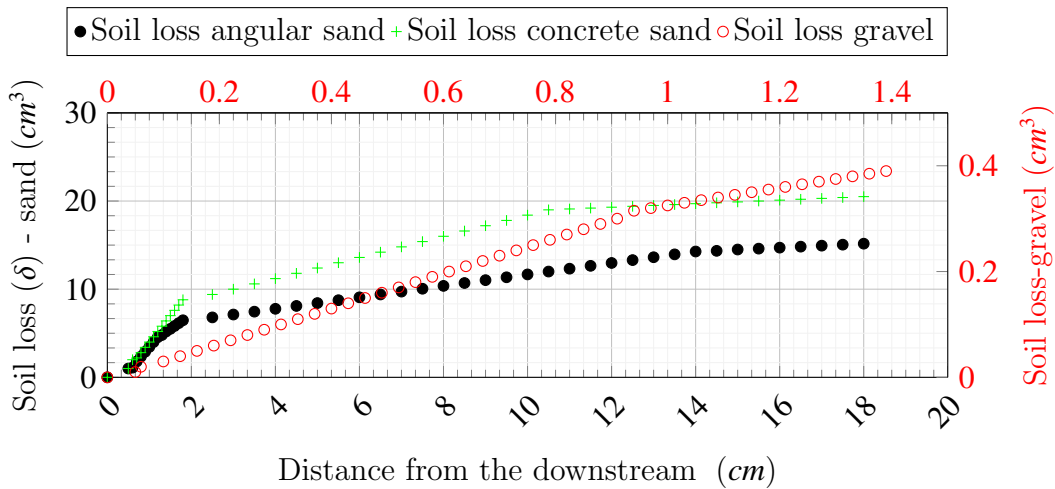
Figure 4.10: Soil loss-Distance from the toe of the embankment on the 14-degree slope

Figures 4.10 and 4.11 show the soil loss at different locations along the embankment for the 14-degree and 26.6-degree slopes. Erosion shows an increasing trend over time but the point being is that distance of the soil loss from the toe of the embankment considerably proceeded as the sediment transport initiated and it gradually grew after it reached a certain point. As an example, the slope of the soil loss-distance increasing curve for the soil D, after 20 mm from the toe on the 14-degree slope, decreases and slightly continues to grow until the system fails. Overall, a clear upward trend can be seen in the graphs for both slopes, and the distance was proceeding on the steeper slope and growing faster. Figure 4.11 shows the distance from the front edge of the embankment for the 26.6-degree slope. Having used sand on the steep slope, the soil loss trend shows a significant increase and it continues to grow until the setup fails. The gravel does not show any difference in the location of the failure for both slopes.

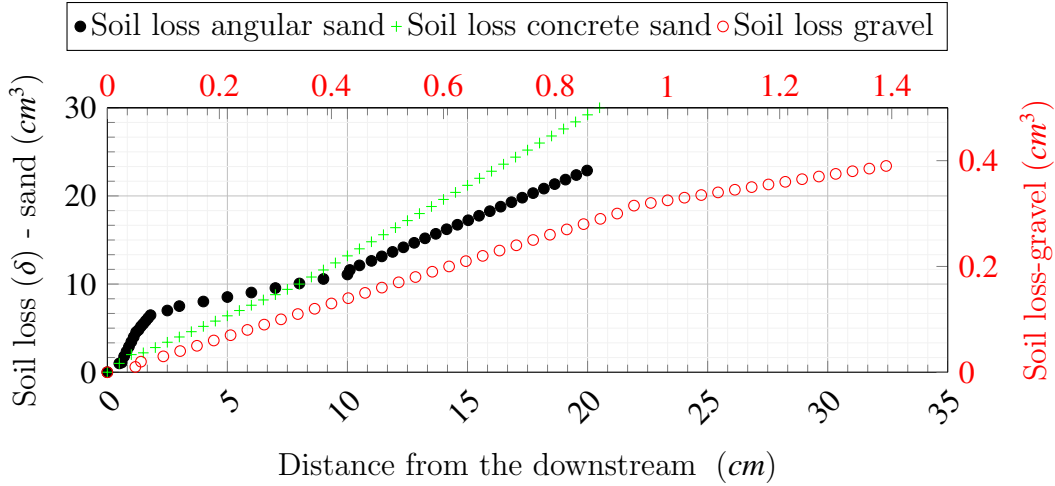
Figure 4.11: Soil loss-Distance from the toe of the embankment on the 26.6-degree slope

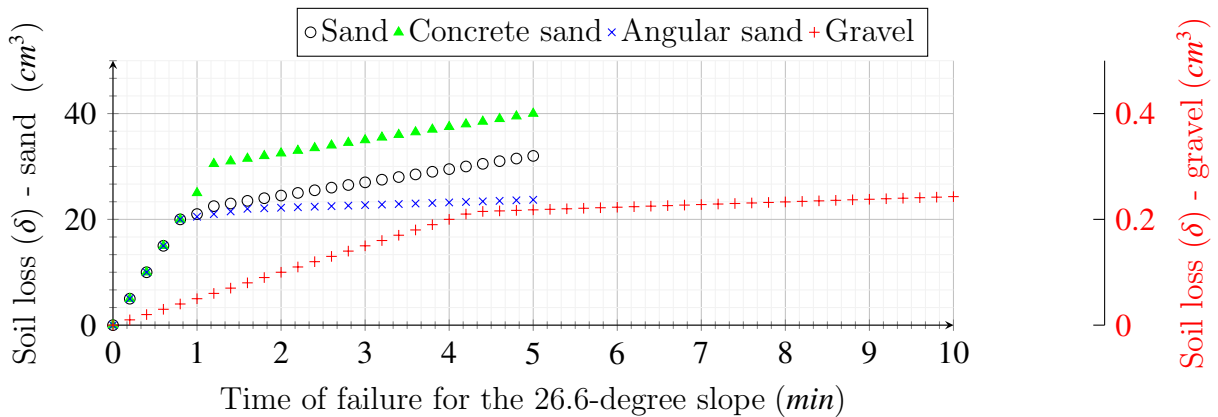
Figure 4.12: Soil loss (cm^3) - Time (min)

Figure 4.12 presents the time of the embankment's deformation for the 26.6-degree slope. Erosion showed to be advanced over time. The point being is, the sediment transport rate increased sharply in the first period of each experiment and grew steadily after this period until the failure of the blocks happened.

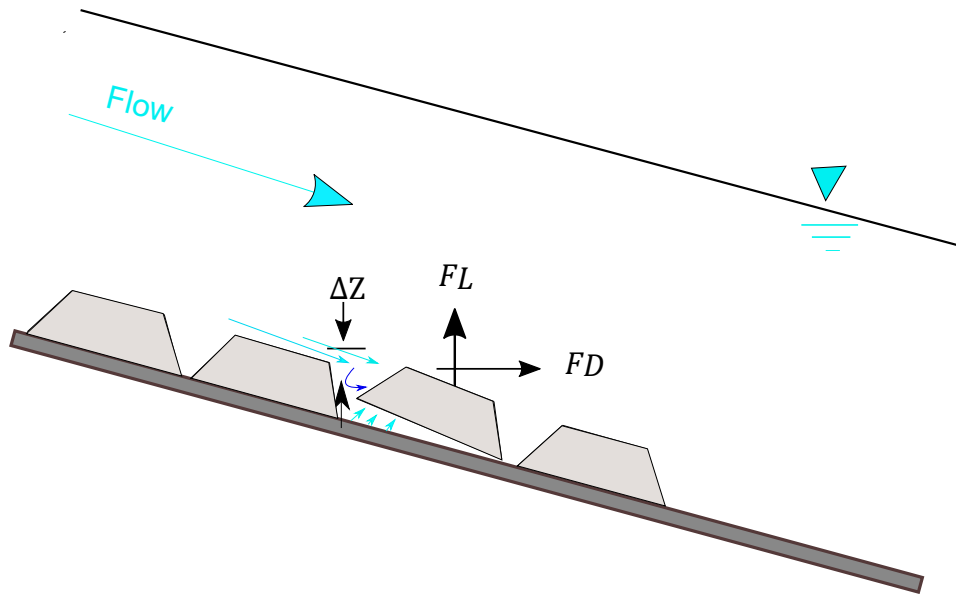
Figure 4.13: Forces on the blocks

Higher velocity and the corresponding shear stress, as well as the uplift force, can move the blocks. Figure 4.13 shows the block movement in the horizontal and vertical direction due to higher velocity and uplift forces respectively as a result of the direct effect of water flow forces. In addition to the direct effect of the water flow, the bedding effect which was the main focus of this study was investigated. In the experiments with coarser gravel, water is drained through the larger void between the grains, and higher hydraulic conductivity of the gravel E and F causes the drainage to happen and helps the embankment to remain stable. Hence, there is no significant uplift force upon the blocks from the subgrade. In the experiments with finer materials, water was trapped in between the grains and cannot find a way to be drained and it makes a force on the blocks. Figure 4.14 (b) shows another form of block failure which happens when the blocks lose contact with their subgrade. When losing contact with subgrade, the blocks are more vulnerable to be moved, overturned, and let more water pass through them and displace them. In addition, when the blocks lose their contact with the fabrics and the subgrade, the system is not working properly and sediments are being exposed to water flow and are more likely to be eroded.

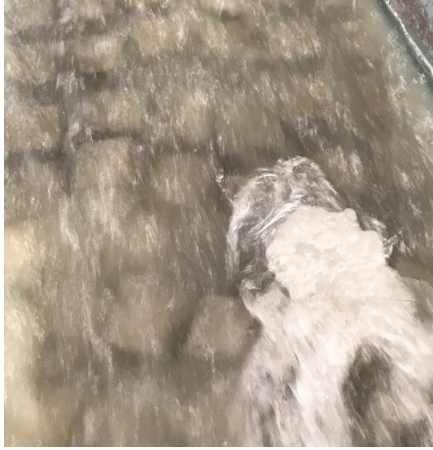
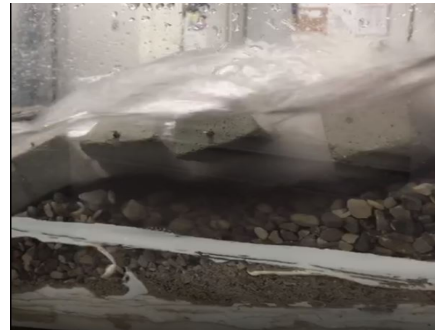
Figure 4.14: Blocks failures
