Erosion Control of Steep Open Channels Using Articulated Concrete Blocks

MohammadOmid Marandi, *The University of Western Ontario*

A thesis submitted in partial fulfillment of the requirements for the Master of Engineering Science degree in Civil and Environmental Engineering

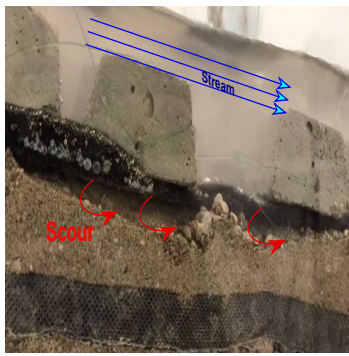
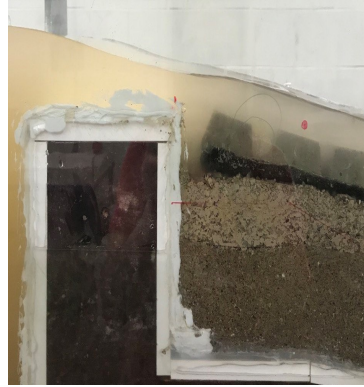
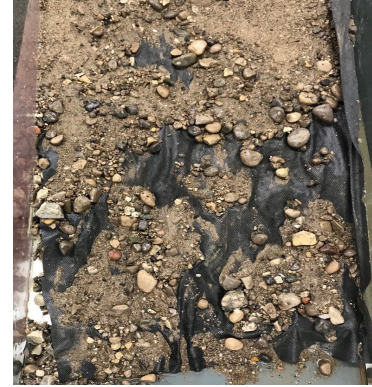
Figure 4.15: Bedding failures

High velocity, increased bed shear stress, turbulent flow on the landward side of the embankment, and soil characteristics according to different configurations play a key role in scouring on the embankment. In the presence of sand layers, the erosion starts at the toe of the embankment, expanding towards the upstream, until the system fails. Figure 4.15 (c) shows the soil loss on the bottom layer after the test when the soil used on the top layer was fine sand. Based on the experiments conducted in the lab for both 14 and 26.6-degree slopes, failures and vulnerabilities are initiated on the sides and the edges of the embankment. Horseshoe-shaped vortices can be generated due to the erosive action of the water flow; these vortices grow on the sides and edges of the setup continuously, until it reaches the maximum depth of the soil layers and fails the setup. Figure 4.15 illustrates the erosive action of the water flow in the mentioned segments. Compaction is another issue which results in stabilizing the embankment. Figure 4.16 (a) shows the configuration of one experiment with angular sand with $D_{50} = 2.1$ mm on the bottom and gravel with $D_{50} = 3.5$ mm on the top followed by a layer of geogrid. After 10 minutes with the maximum discharge ($0.014 \text{ m}^3/\text{s}$) the test was stopped and the ACB mat and the top layer were removed to analyze the amount of soil loss happened in the experiment. Figure 4.16 (b) the importance of the compaction of the soil on the downstream side of the embankment. If the soil is not well-compacted, the toe of the embankment can be more vulnerable to scouring as this area is more exposed to the higher shear stress.

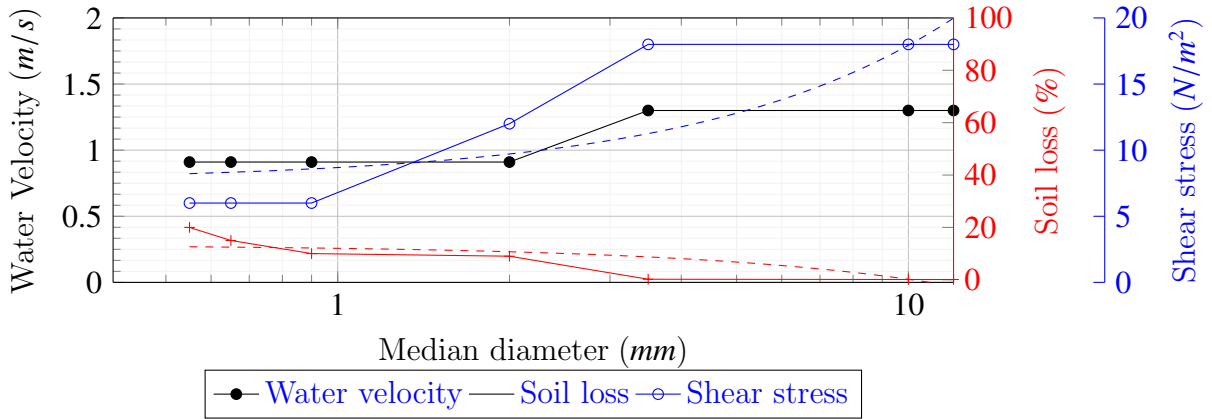
Figure 4.17: Water velocity, shear stress, and soil loss in each test for 14-degree slope

Figures 4.17 and 4.18 show the water velocity, and the percentage of soil loss according to the median diameter in different experiments for both 14 and 26.6-degree slopes. According to the graphs, the percentage of the soil loss in the 26.6-degree slope is higher than that for the 14-degree slope and it gets to less than 1 % for both slopes when gravel is used.

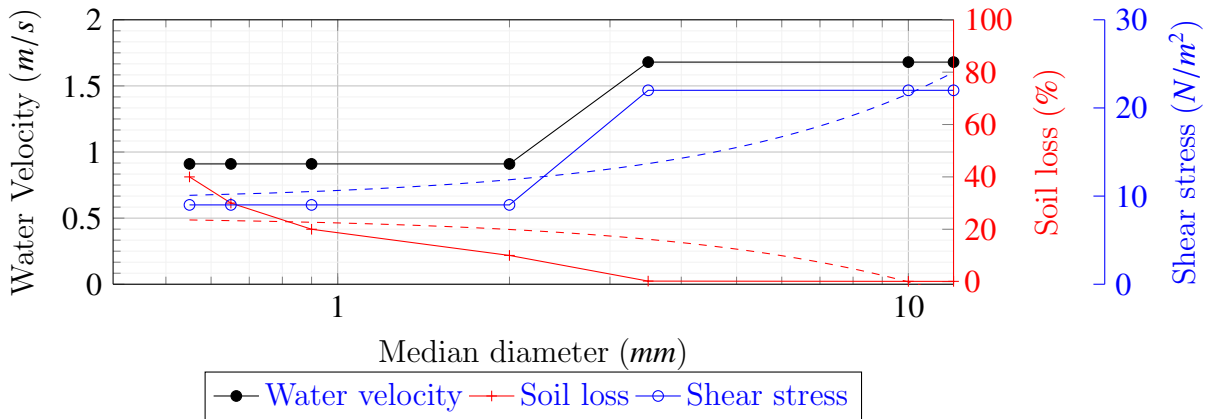
Figure 4.18: Water velocity, shear stress, and soil loss in each test for 26.6-degree slope
