Large-scale Analysis and Automated Detection of Trunnion Corrosion on Hip Arthroplasty Devices

Anastasia M. Codirezzi, *The University of Western Ontario*

A thesis submitted in partial fulfillment of the requirements for the Master of Engineering Science degree in Biomedical Engineering

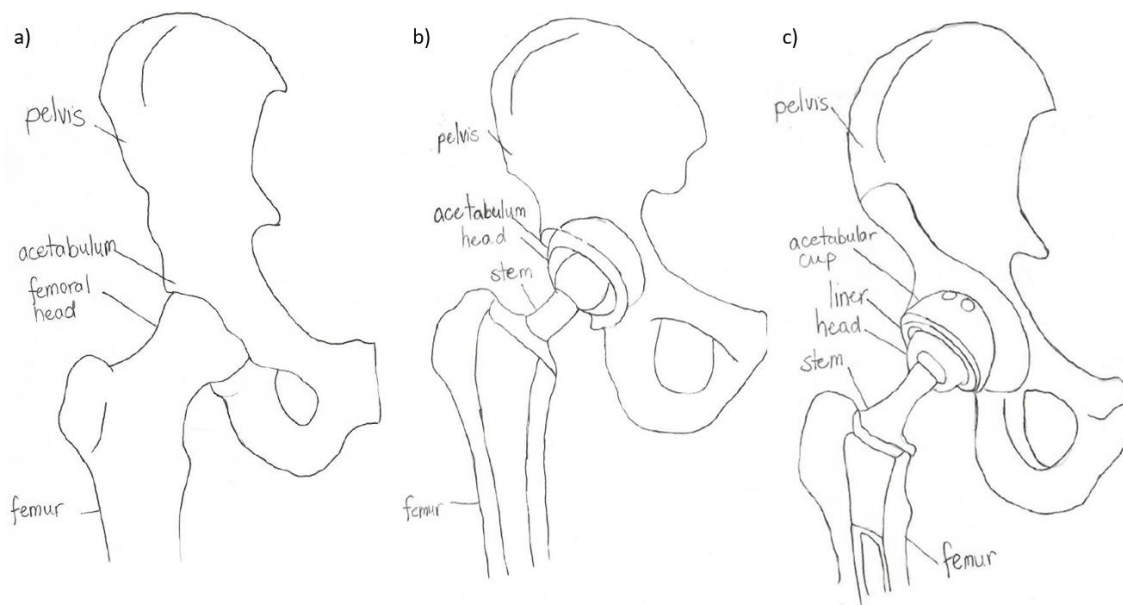
Figure 1: a) Natural hip anatomy, b) hemiarthroplasty, c) total hip arthroplasty

Hip arthroplasty refers to surgery where part of or all of the hip joint is replaced by an artificial implant. Hemiarthroplasty refers to the replacement of half of the hip joint, where the femoral component is replaced with an artificial implant while natural hip socket remains. Total hip arthroplasty (THA) refers to the replacement of both the femoral and acetabular articulating surfaces with an artificial implant (Figure 1). This is most used as a treatment for end-stage degenerative arthritis (primarily osteoarthritis), but other reasons include trauma and hip dysplasia [8]. The goals of hip arthroplasty are to remove the diseased or defective joint and replace it to be as anatomically similar to the patient's original joint as possible [7].

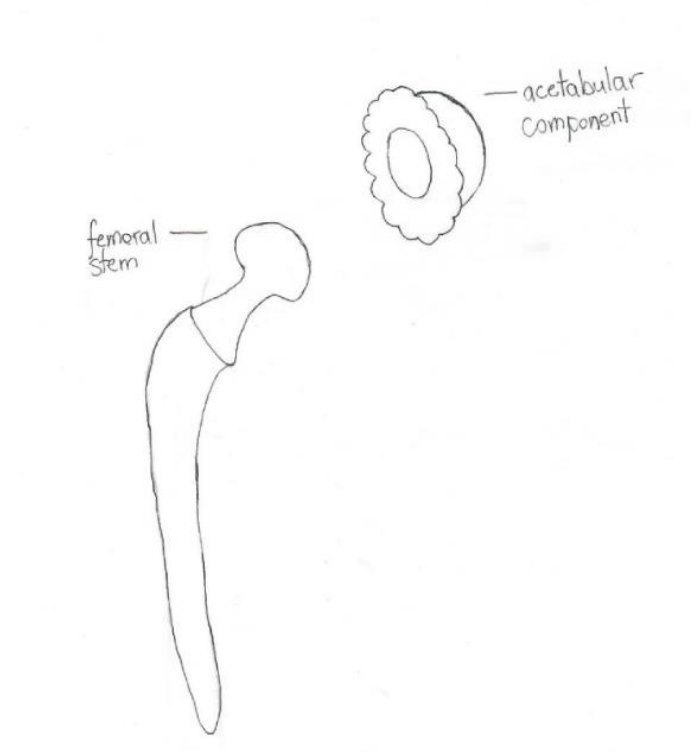
Figure 2: Sketch of the Charnley implant

The earliest reported attempts at hip replacements occurred in Germany in 1891, but modern total hip arthroplasty as we know it today is associated with orthopaedic surgeon Sir John Charnley of the United Kingdom, with the first surgery completed in 1962. It consisted of three parts: a metal femoral stem, a polyethylene acetabular component, and an acrylic bone cement, a sketch of the device is shown in Figure 2 [10].

This design is largely similar in concept to the total hip arthroplasty devices used today. Major design changes include advances in materials design and usage, geometry of the implants, segmentation of the stem into modular components, and the inclusion of the acetabular cup in the pelvis.

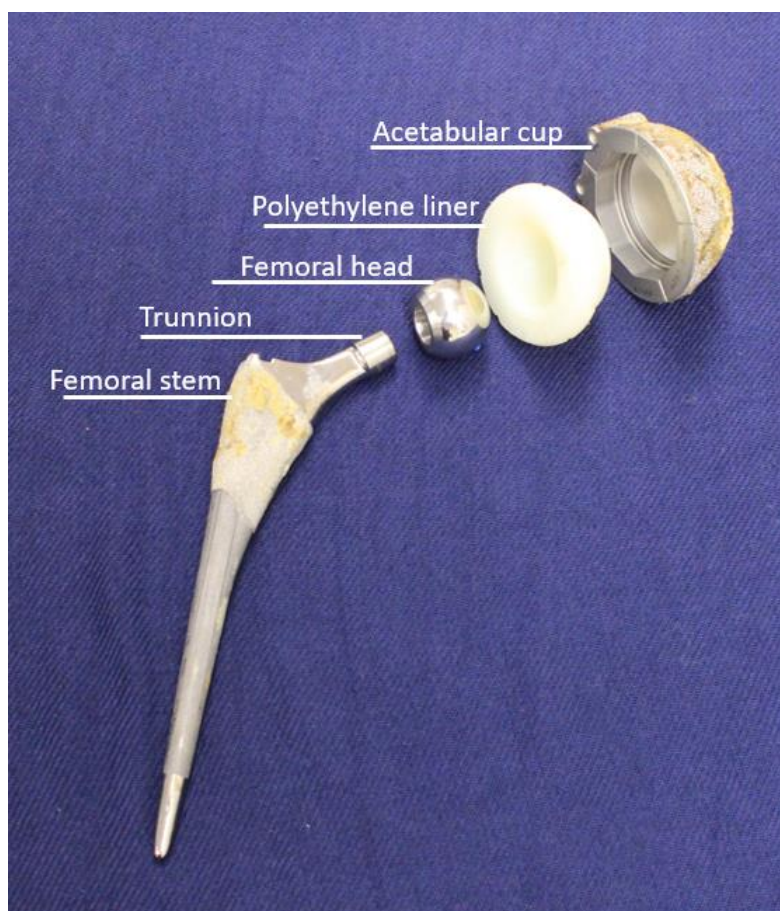
Figure 3: Modern Total Hip Arthroplasty Design, showing a modular stem and a metal-on-polyethylene bearing surface.

Today, most devices are now modular (stem and ball are separate pieces), with a metal-on-polyethylene design (Figure 3) being the most common in Canada [9]. According to the Canadian Agency for Drugs and Technologies in Health, these implants are considered the “gold standard” in total hip prosthesis [11].

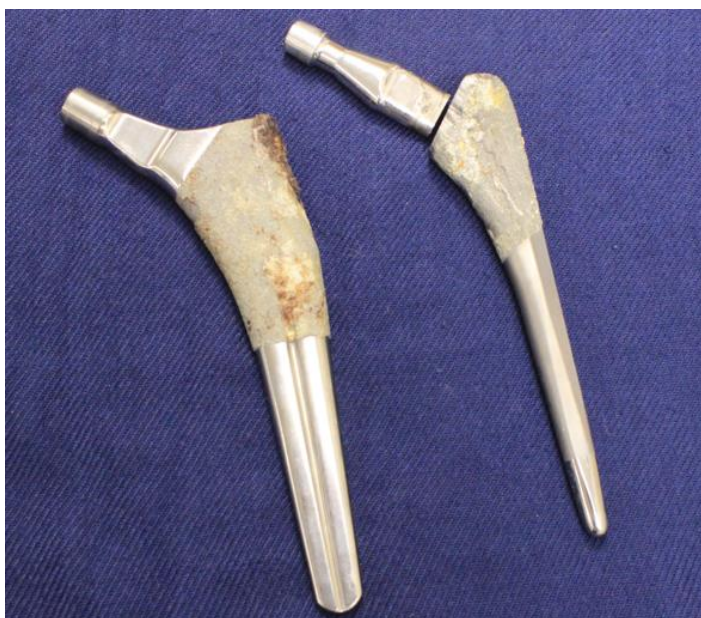
Figure 4: Modular stem (left) beside a dual modular stem (right) showing modularity at the base of the neck.

In modular implants, the femoral component consists of the stem and the head. Stems are typically manufactured from stainless steel, cobalt-chromium alloys, or titanium alloys. There are two main versions of the stem, modular and dual modular. Modular refers to the stem and ball being separate components whereas dual modular typically refers to the ball, neck, and stem being separate components (Figure 4). Modularity can exist in other locations, but their use is typically reserved for implants in revision cases.

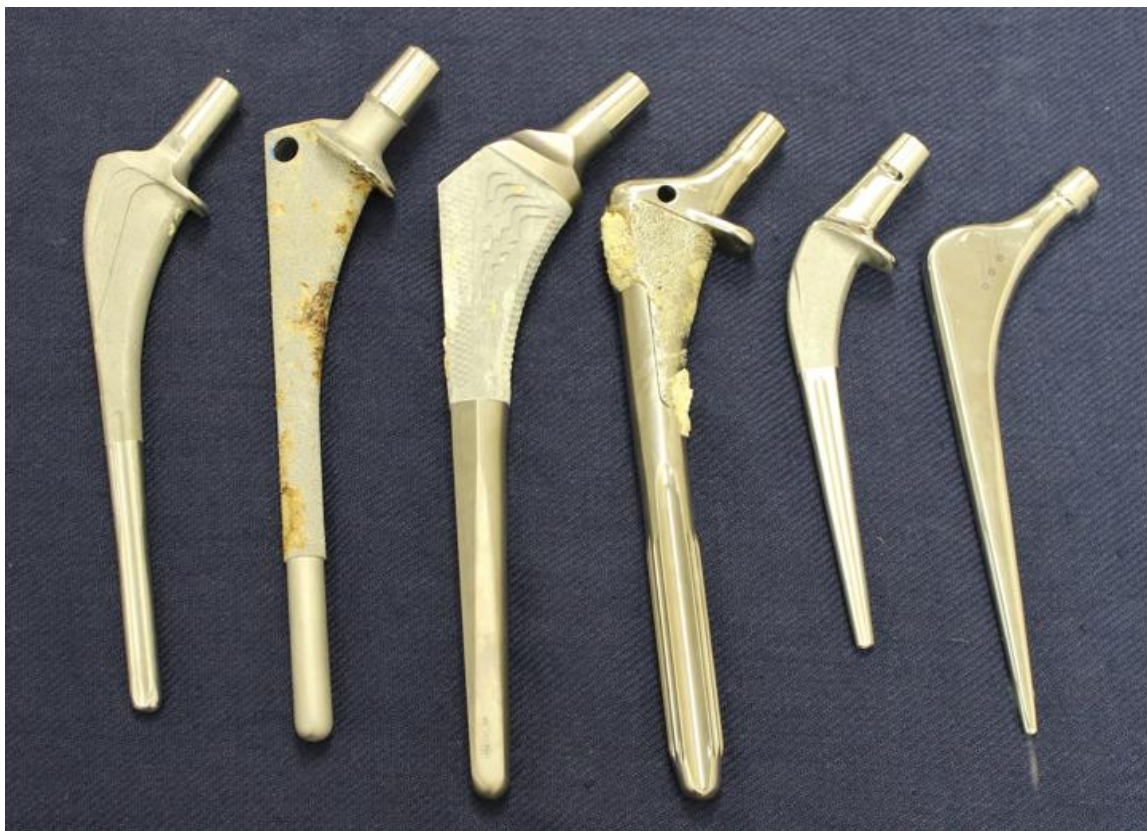
Figure 5: A variety of available stems, showcasing major design differences in the distal stem component of the device.

There is no one perfect stem design, as patient factors such as anatomy, bone quality and structure, and stature, all widely vary. There are two major places for variation: the distal stem design and the trunnion/taper design. Figure 5 shows just a few of the widely available stem models from different major manufacturers.

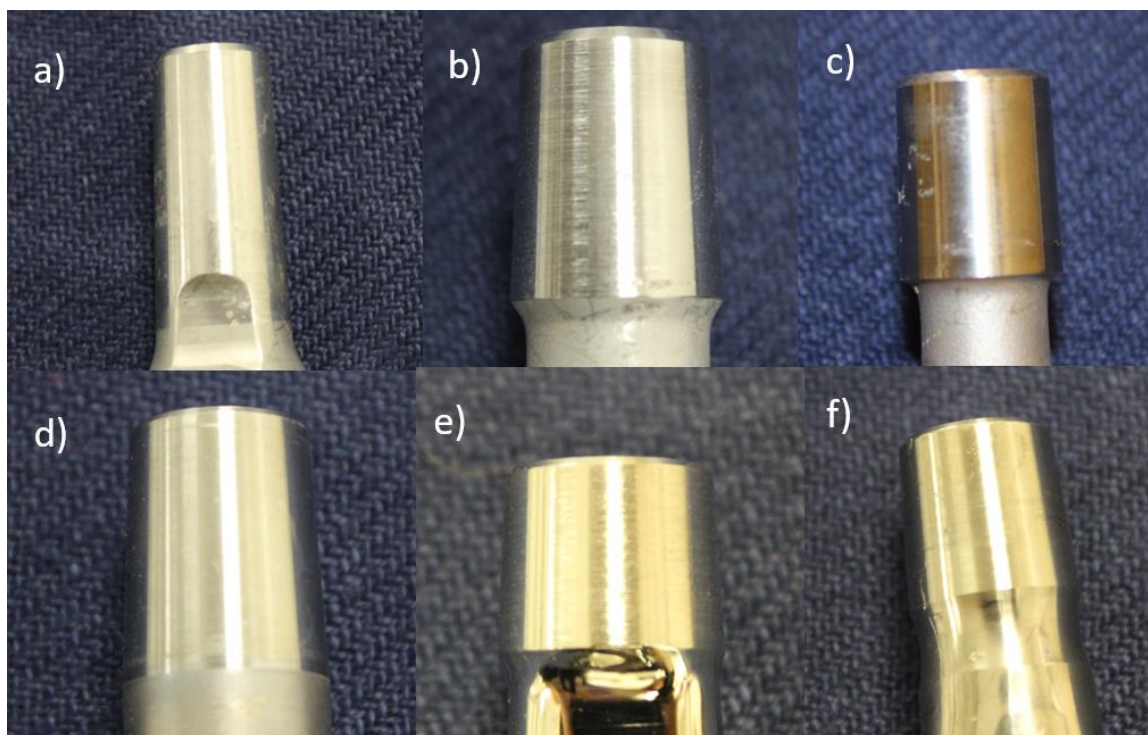
Figure 6: a) Zimmer Biomet Type-1, b) DePuy 12/14, c) Stryker PCA, d) Stryker C-taper, e) Stryker V40, f) Zimmer Biomet 12/14

Taper geometry and design can widely vary even within manufactures, although most companies try to limit the taper geometries produced and sold simultaneously. Figure 6 shows variation in the taper design with popular implants. Taper design may change when the distal stem design has not, most notably when a company acquires a device from another company. An example of this is the Exeter stem which has had the same distal stem design since 1988 but saw a change in its taper geometry in 2000 after the stem was acquired by Stryker [14]. Taper design has been considered a significant factor for implant wear [15]. Machining lines (also called microgroove finish), parallel lines on the trunnion surface, are present on some taper designs, but this specific design factor has not been

found to be a significant factor for implant wear [16]. Figure 6 shows variation in taper designs, including machining lines.

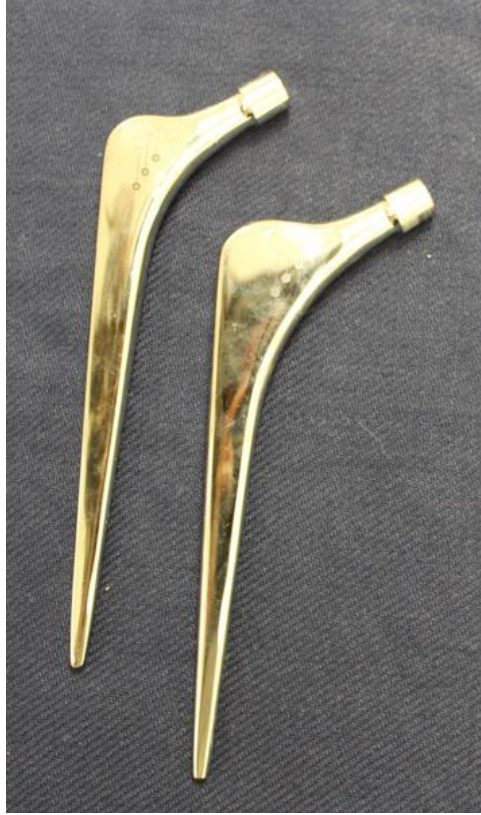
Figure 7: Exeter stems showcasing two different offsets.

Beyond the specific stem and taper design, there is a wide variety of different versions of the same stem with different sizes and offsets. Figure 7 shows the same stem model and two of its possible offset (distance from the center of the rotation of the femoral head to a line bisecting the long axis of the femur) offerings. Generally, the same stems are used for both hemi- and total hip arthroplasty, with a select number of stems being more common for usage in hemiarthroplasty.

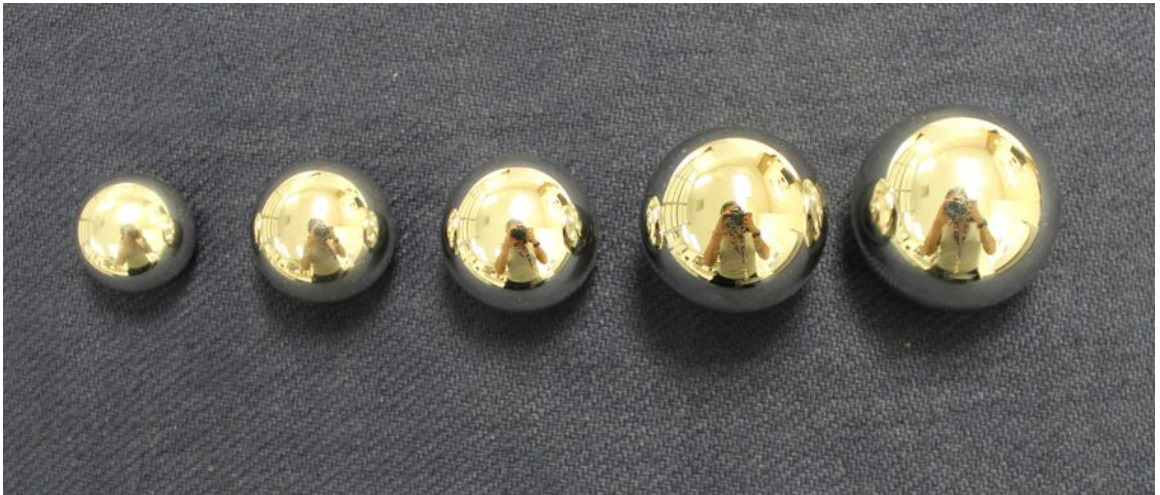
Figure 8: Different head sizes, from left to right: 22mm, 26mm, 28mm, 32mm, 36mm.

The head is typically made of chromium cobalt or ceramic and all designs are spherical, but similar to the stem, there is variance in ball height and diameter, as well as trunnion designs. Similarly, they are available in different outer diameter sizes (Figure 8) and have an offset to match the stem selection.

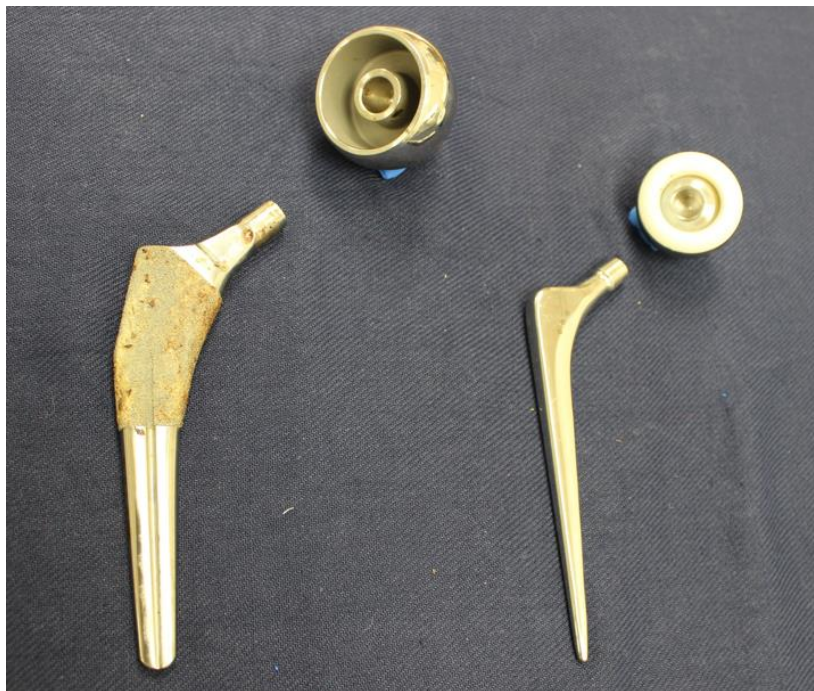
Figure 9: (left) Hemiarthroplasty device utilising a large head, (right) hemiarthroplasty device utilizing a head within a head with a polyethylene liner between.

Total hip arthroplasty devices have the head fit into the acetabular component, while hemiarthroplasty devices make use of a larger head or a head within a larger head (Figure 9) with a liner between them and placed into the natural acetabulum.

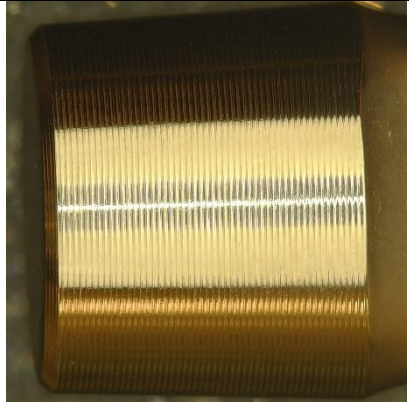
Severity of Corrosion	Score	Criteria	Example
None	1	No visible corrosion observed

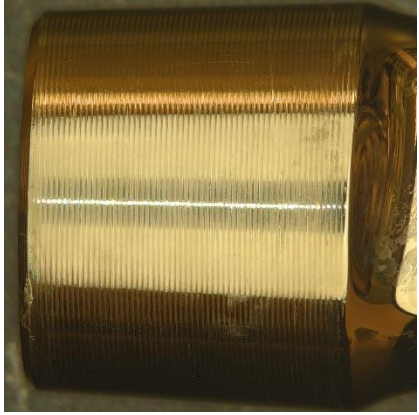
Mild	2	<30% of taper surface discoloured or dull

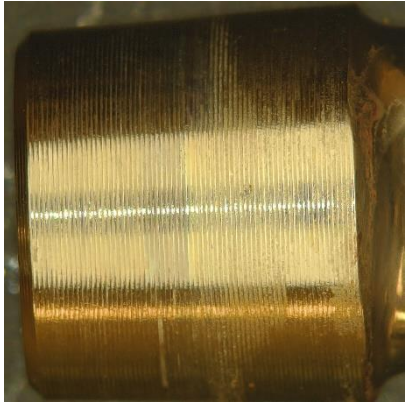
Moderate	3	>30% of surface discoloured or dull, or, <10% of taper surface containing black debris, pits, or etch marks

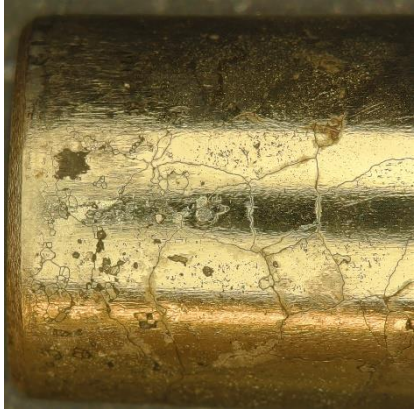
Severe	4	>10% of taper surface containing black debris, pits, or etch marks

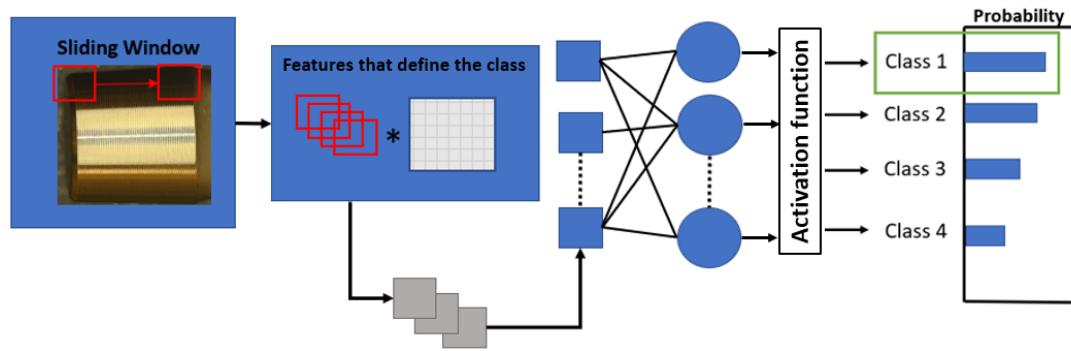
Figure 10: Example of a CNN for classifying a trunnion. The first two blocks extract features that can be used to identify different features (shapes, colour, brightness, etc.) and how they can be associated with the different classes. The knowledge from the last block moves forward to the next, then all the information is gathered together, and the system makes a statistical guess of the class. Image adapted from [40].

Convolutional neural networks for image classification contain both a feature extractor and a classifier. In a supervised problem, the network is fed labelled information (typically images) that belong to a series of classes. The model then trains itself by moving filters over the images to create feature maps. The values of the maps are then associated with different features of the images, then the results are summarized and passed to the next layer. The final stage of the network is the classification, where it takes all the information gathered from the feature maps associated with different classes and statistically calculates the probability of it being in each class. It then labels the image with the class that had the highest probability, and it checks its answer against the true label. If the label is correct, the network accepts its summaries of the feature maps as accurate and does not update. If the label is incorrect, the network updates its summaries of the feature maps to correct the network classification [40]. This is done through calculating the loss function and penalizing the network for incorrect classifications and feeding this back through the network layers (a concept called “back-propagation”). A visual example of a CNN for classifying an object is shown in Figure 10.

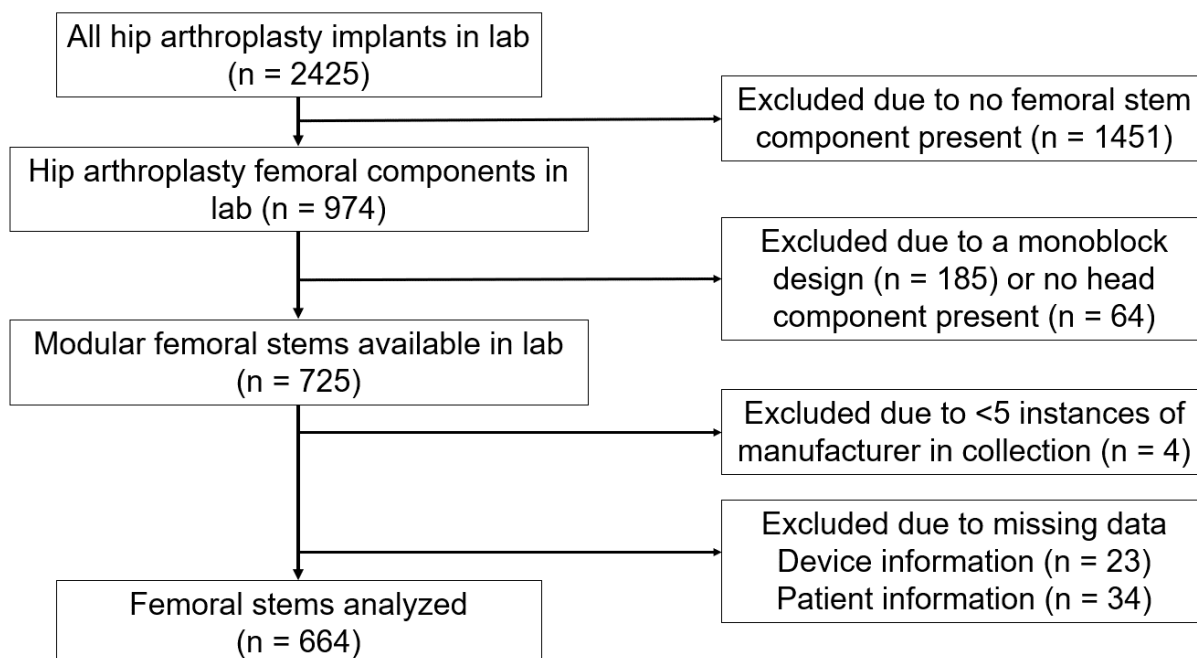
Figure 11: Study design

Institutional research ethics board approval was obtained for review of patient charts and implant retrieval analysis. All hip implants in our institutional implant retrieval laboratory were reviewed for inclusion (Figure 11). Implants included for analysis were designs with a modular head-neck taper where the femoral head and stem were retrieved at the time of revision surgery. Excluded were implants that were non-modular, cases where the femoral stem was not retrieved or had gross taper failure, and when there was fewer than five instances of a particular femoral stem model. Patient information including sex, age at implantation, hip joint laterality (left or right), reason for revision, and length of stem implantation were obtained from chart review. Implant information including taper design, stem material, head material, head size, stem model, and manufacturer was collected from the institutional implant retrieval laboratory catalogue and analysis of the device.

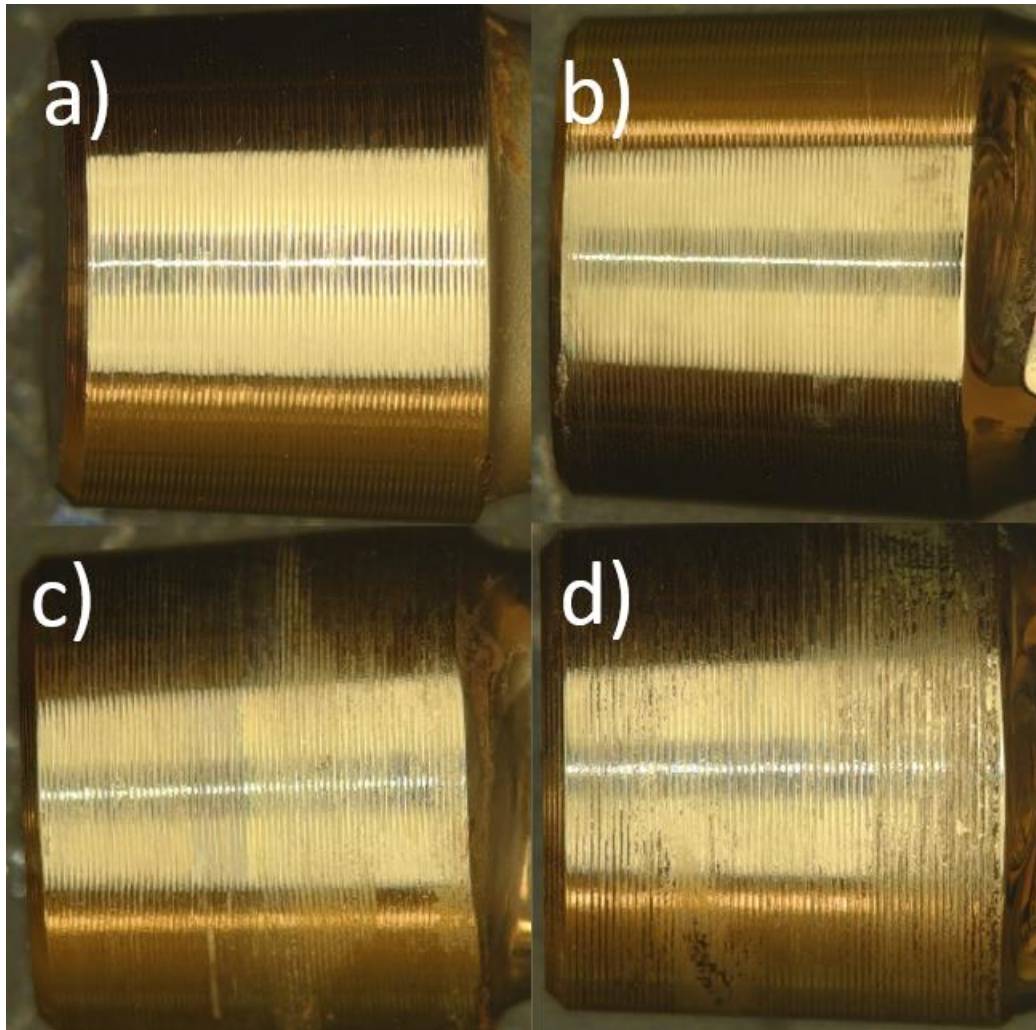
Figure 12: Representative images of each class (a) class 1, (b) class 2, (c) class 3, (d) class 4

Each stem was imaged using a digital microscope at 20x magnification (DSX1000, Olympus Corporation, Tokyo, Japan). The surface was divided into four areas (medial, lateral, posterior and anterior) each represented by one image. The images (Figure 12) were then examined and assigned a corrosion score using the method of Goldberg et al., described in Table 4 [18]. A single score was assigned to each image and recorded; the maximum score observed on the implant from the four sides of the taper was used as the score for statistical analysis. All scoring was done by a single observer (A. Codirenze).

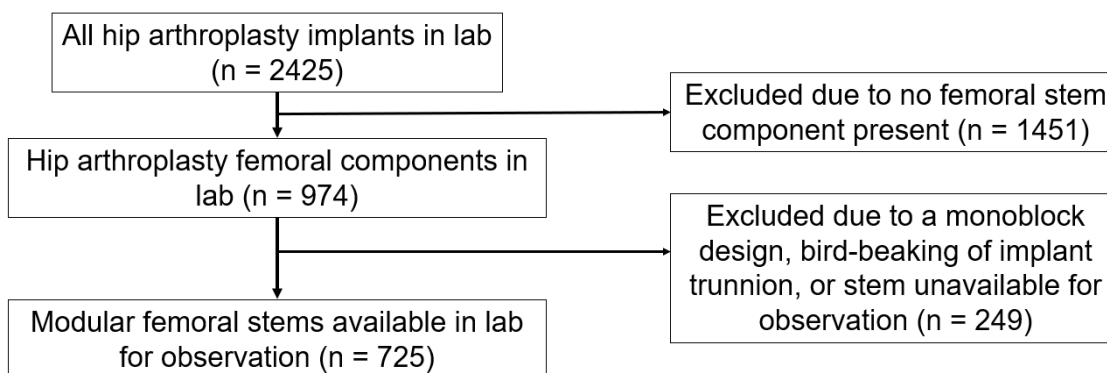
Figure 13: Study design for implant inclusion

All hip arthroplasty implants in our institutional implant retrieval laboratory were reviewed for inclusion (Figure 14). Implants included for imaging were designs with a modular head-neck taper where the femoral stem was retrieved at the time of revision surgery. Excluded were implants that were non-modular, and cases that had gross taper failure (“bird-beaking”). Each stem was imaged using a digital microscope at 20x magnification (DSX1000, Olympus Cooperation, Tokyo, Japan) at 1200x1200 and in RGB colour. The surface was divided into four areas, with each area represented by one image. Images were taken with the aid of an image diffuser when possible, as this minimized the amount of metallic glare. The images (Figure 2) were then examined and assigned a corrosion score using the method of Goldberg et al, described in Table 9. A single score was assigned to each image and recorded. Images were scored independently of other images in the trunnion set. Images were excluded if they were not of sufficient quality (unfocused, glare that obstructed view of 30% or more of the surface). A subset of 100 images from the test set was provided to a secondary observer to check for reliability of scoring between observers and calculated using the interclass correlation coefficient with a 95% confidence level.

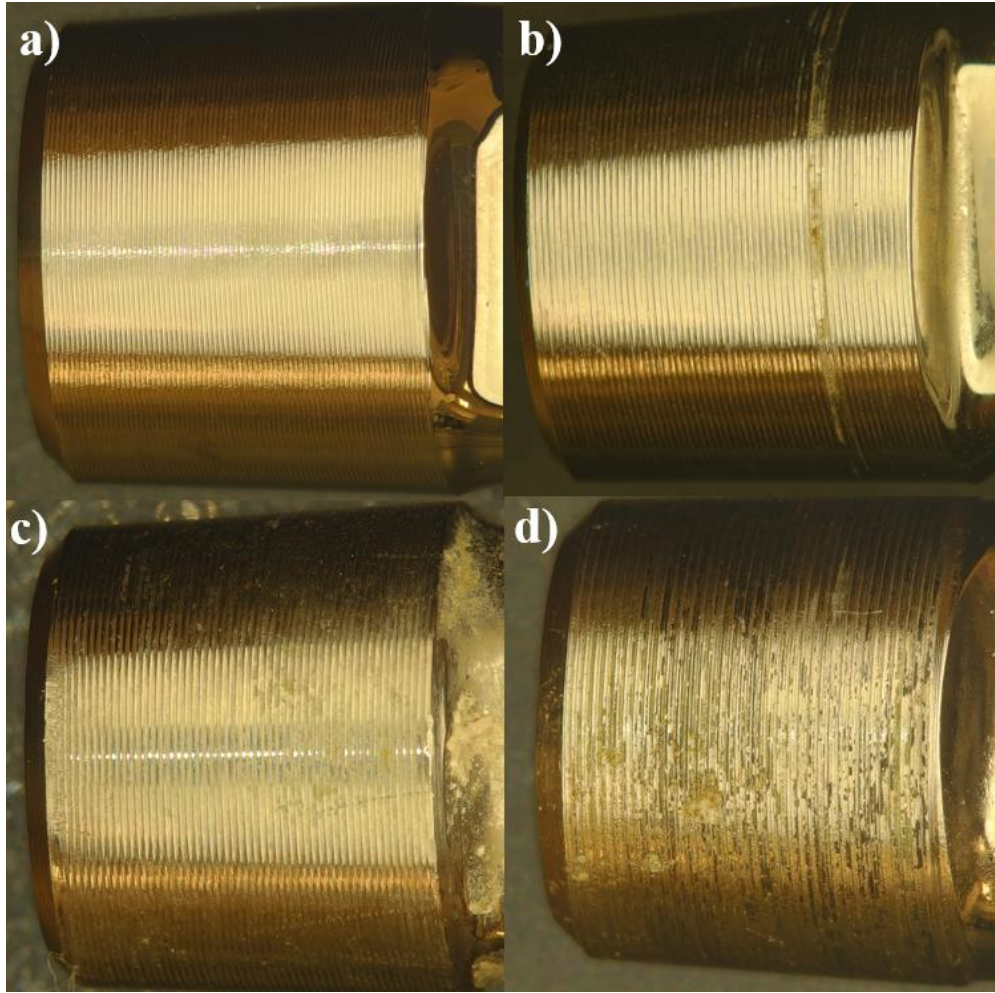
Figure 14: Representative images of each class (a) class 1, (b) class 2, (c) class 3, (d) class 4

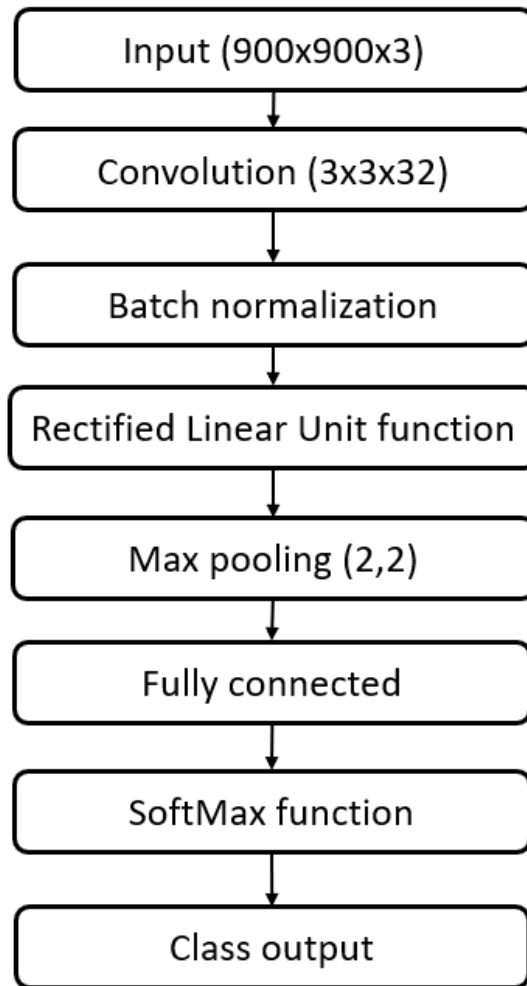
Figure 15: Convolutional neural network architecture. The neural network is comprised of an input of 900x900 images with RGB colouring. It then has a convolutional layer with a filter size of 3x3x32. Batch normalization was then employed. Then had a rectified linear unit activation function. That led to a max pooling layer with a filter size of 2x2 and a stride of 1,1. Then it had the fully connected layer, SoftMax function, and the output layer.

A convolutional neural network was designed and trained from scratch using MATLAB's DeepNetworkDesigner application (MATLAB for Windows, version 2021b). The network architecture was based off the concept of starting with a small network and expanding outward using a trial-and-error method, first using extreme cases (ie. Class 1 versus Class 4) and then including intermediate cases. A network diagram for the network used in this study is shown in Figure 15. It utilizes a single convolutional layer for feature learning. The same network architecture and training parameters were used for all datasets.

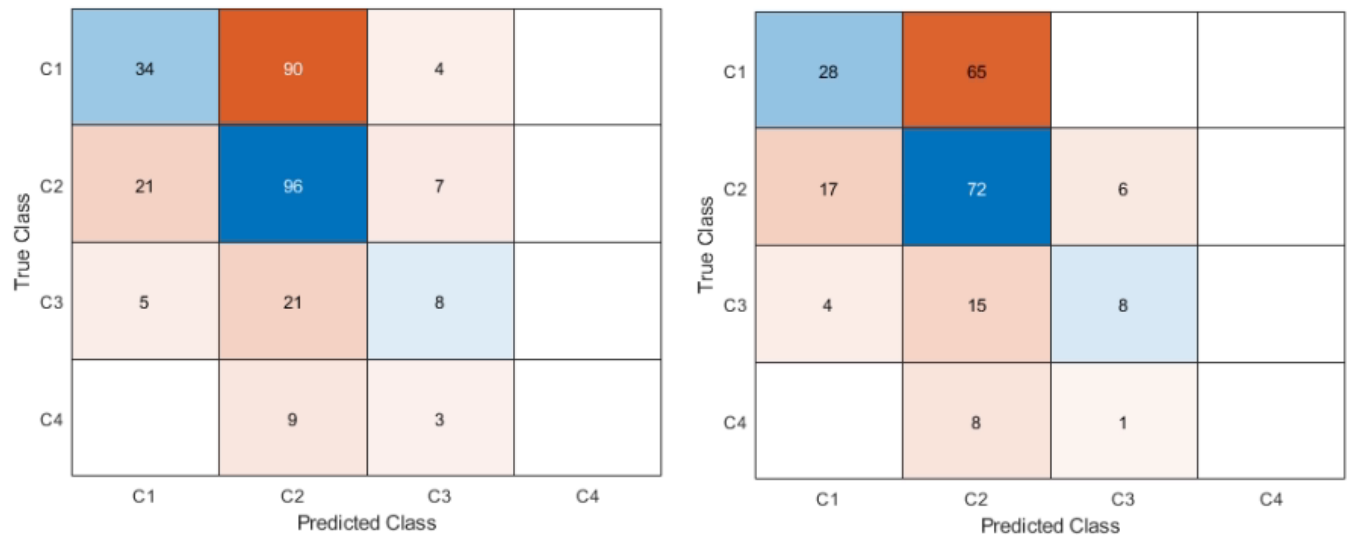
Figure 16: Confusion matrix for dataset 1 (class 1 versus class 2 versus class 3 versus class 4). Left is all images, right is with glare removed. The blue diagonal shows correct classifications (predicted class matches the true class) while the orange off-diagonal shows misclassifications. Intensity of colour is based off count in each category.

The confusion matrices are shown in Figures 16-18. Figure 16 shows the confusion matrices for dataset 1 (C1 vs C2 vs C3 vs C4). In both cases, the network failed to classify any test images as class 4 and the most common misclassification was classifying as class 2 when the true image class was class 1. Class 1 never misclassified an image on the other end of the spectrum from it (ie class 4 images were never misclassified as class 1, and class 1 images were never misclassified as class 3). Figure 17 shows the confusion matrices for dataset 2 (class 1 versus class 2, 3, 4). There were similar amounts of misclassifications for both classes.

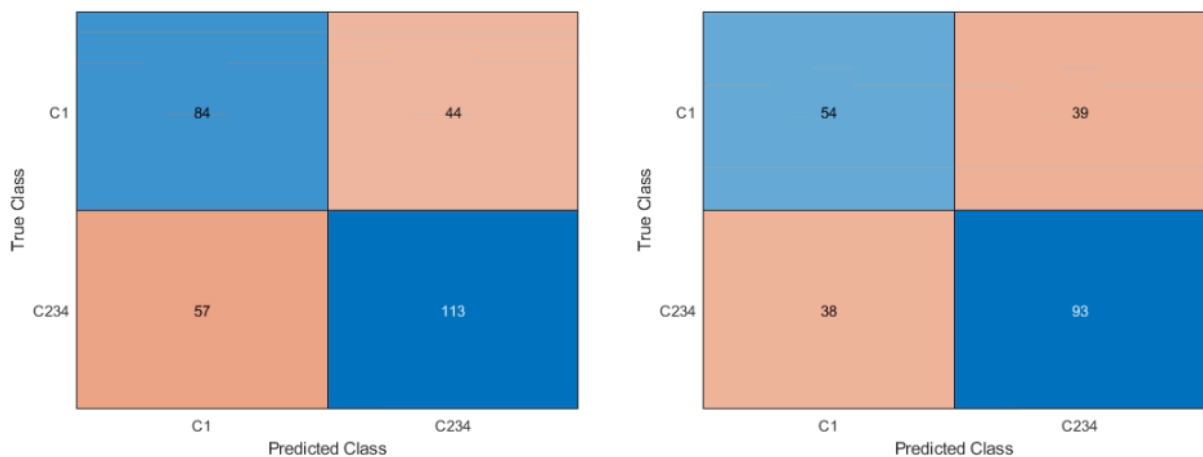
Figure 17: Confusion matrix for dataset 2, class 1 versus class 2,3,4. Right is all images, left is with glare removed. The blue diagonal shows correct classifications (predicted class matches the true class) while the orange off-diagonal shows misclassifications. Intensity of colour is based off count in each category.

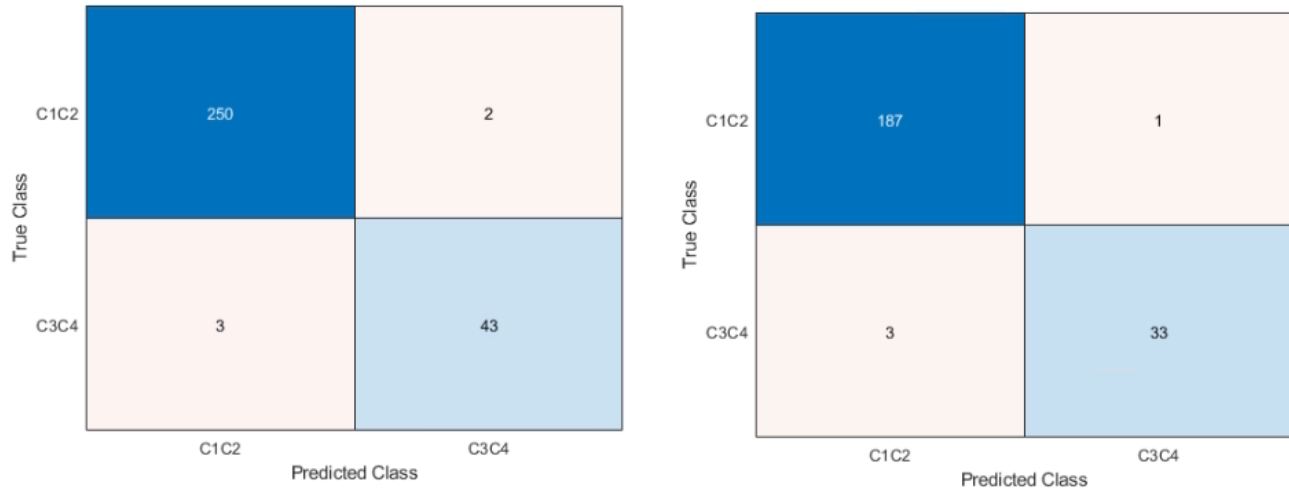
Figure 18: Confusion matrix for dataset 3, C12 versus C34. Right is all images, left is images with glare removed. The blue diagonal shows correct classifications (predicted class matches the true class) while the orange off-diagonal shows misclassifications. Intensity of colour is based off count in each category.

Figure 18 shows the confusion matrices for dataset 3 (class 1 and 2 versus 3 and 4). This dataset had the fewest number of misclassifications, with little difference between if images with glare were included or not.

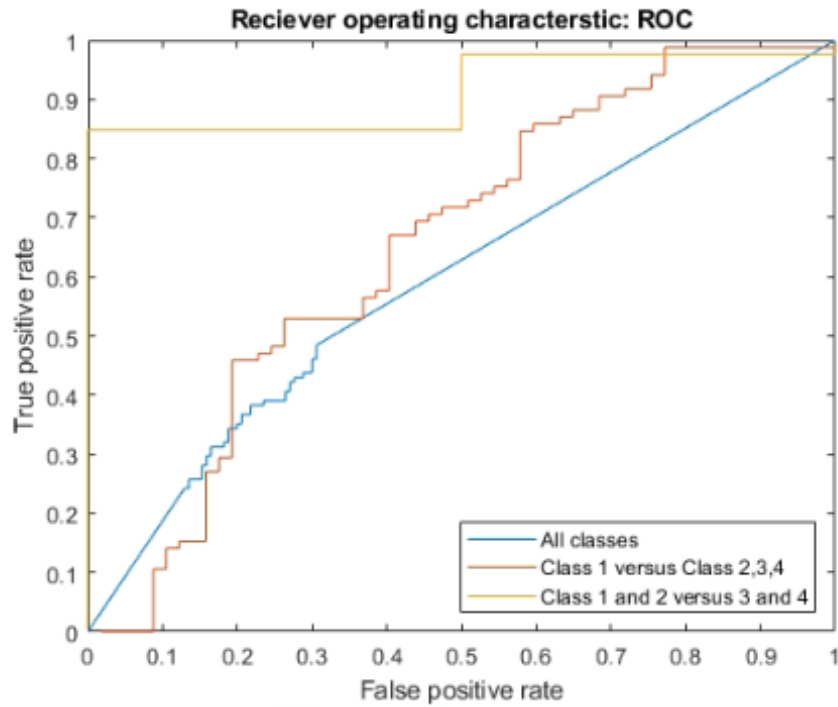
Figure 19: ROC for all datasets, with all images included

The receiver operating characteristic was plotted and the plots for all datasets with all images are shown in Figure 19. Classes 1 and 2 versus 3 and 4 (dataset 3) show the highest area under the curve and has the fewest individual points, showing that the network made guesses with similar probabilities for many of the images. Class 1 versus 2, 3 and 4 (dataset 2) had a much lower area under the curve, but showed many more points, showing a range in the probabilities for different guesses. Class 1 versus 2 versus 3 versus 4 (dataset 1), had the lowest area under the curve and showed a number or probabilities guessed, but significantly fewer outside the center of the graph.
