TORNADO PROJECT SUMMARY SHEET

TORNADO in DOWNSVIEW ONTARIO

Investigation, photographs and report by Steven Leitch.

THE METROPOLITAN TORONTO TORNADO

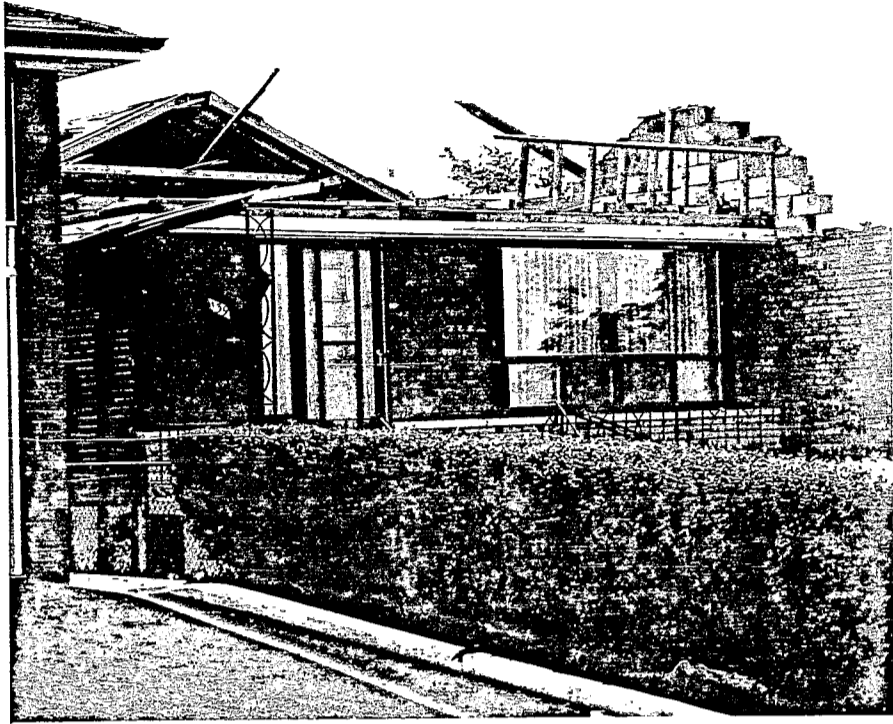
139 Honeywood - roof removed by storm

7) Honeywood Road. At 139 Honeywood, on the east side of the road, the west half of the house roof and all of the garage roof was removed and blown across the road where it crashed into the front centre of the house at 138 Honeywood. ( See photos opposite and above )

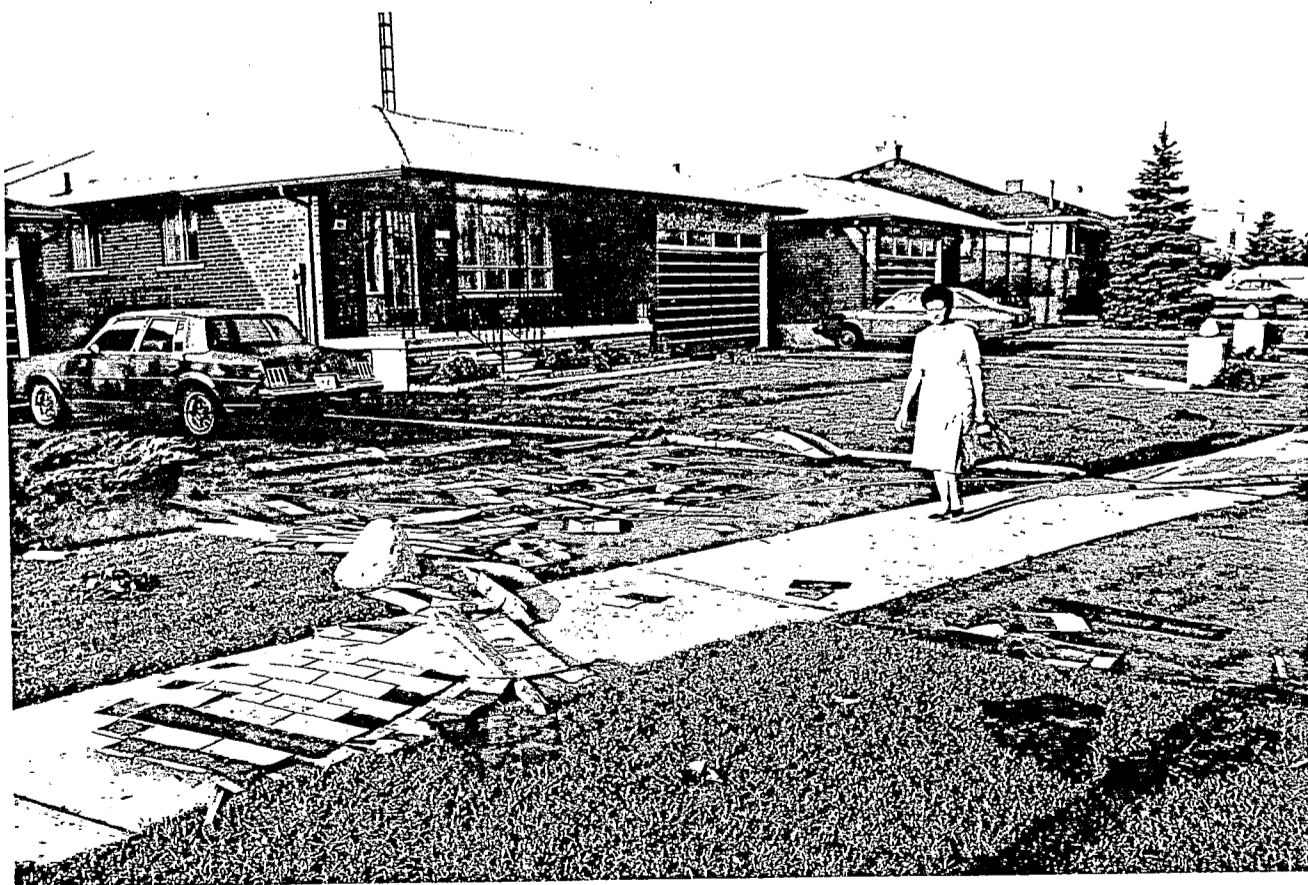
(ABOVE) Some of the roofing debris was also carried south on Honeywood and strewn about the road and lawns.

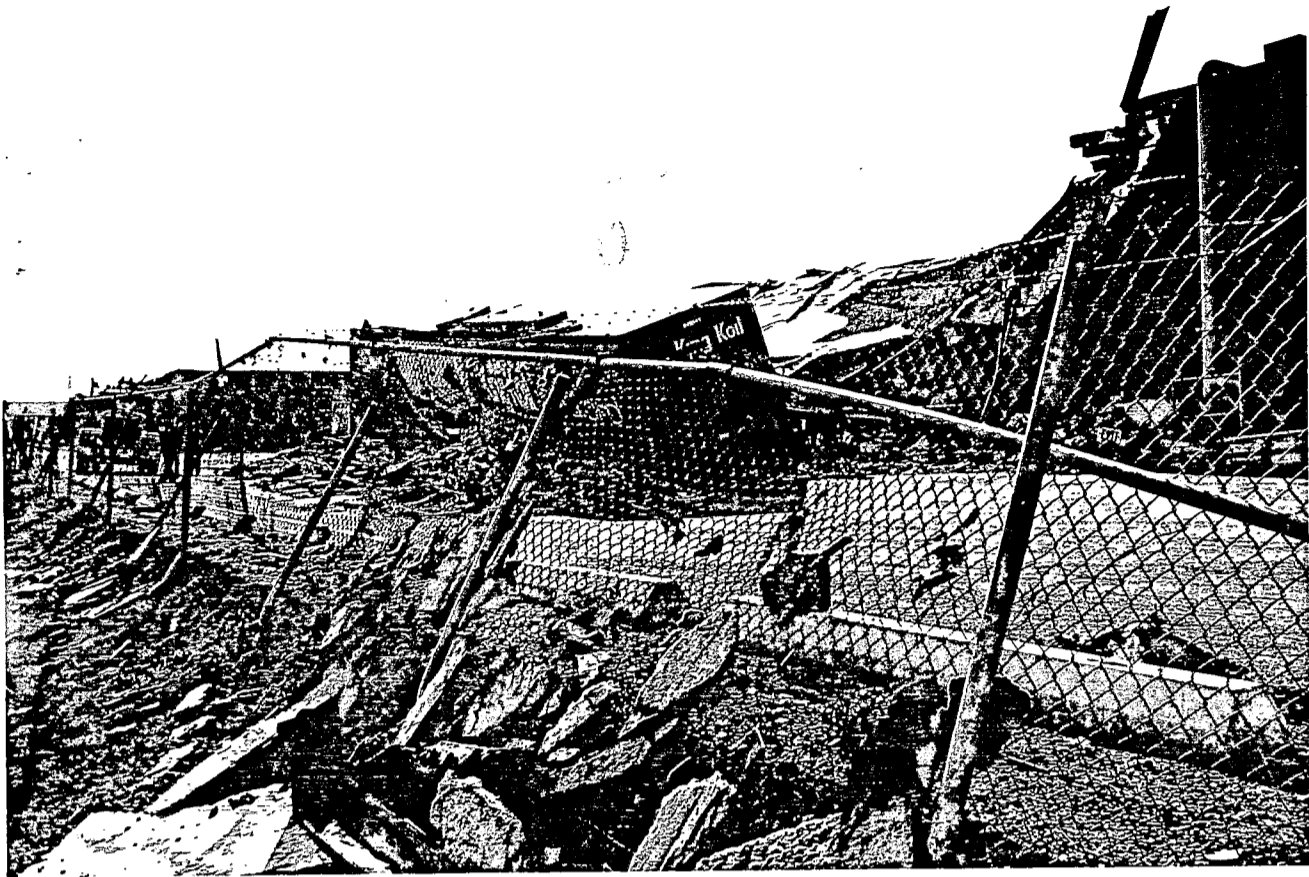
Damage to the Bedford Bedding and Upholstery Ltd  
North wall of factory collapsed onto parked trailer

- 13) Bedford Bedding and Upholstery Ltd - 3035 Weston Road. The north wall composed of block and brick collapsed outward onto a parked trailer and much of the roof collapsed. A chain link fence was badly beaten by the storm and littered with fiber board roofing from this and other up-track warehouses. ( See another view on the opposite page ) Tree tops in the area had large limbs broken off and other large trees, in a residential back yard, had been uprooted approximately west.

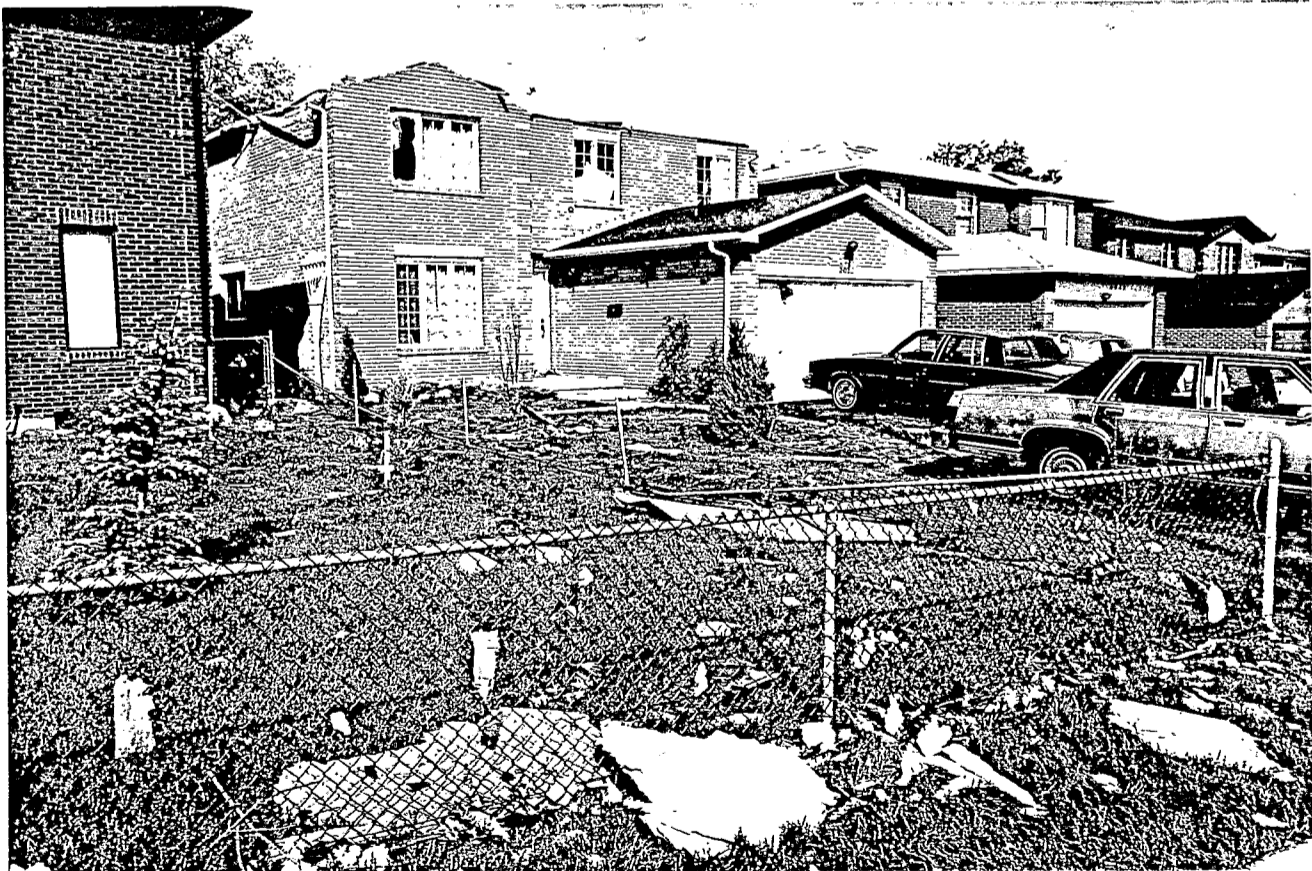
Part of the roof removed at 3022 Weston Road.  
Fiber board, in the foreground, from the Bedford Bedding factory.

- 14) Weston Road at Burgundy Ct. Part of one house was unroofed at 3022 Weston Road. ( See the photo on the opposite page ) There was less roof damage to homes on Burgundy Court - shingles were removed and alot of debris was scattered about. I spotted a crumpled aluminum garden shed on the east side of Weston Road. I measured the FO damage width, here, at a little more that 100m.

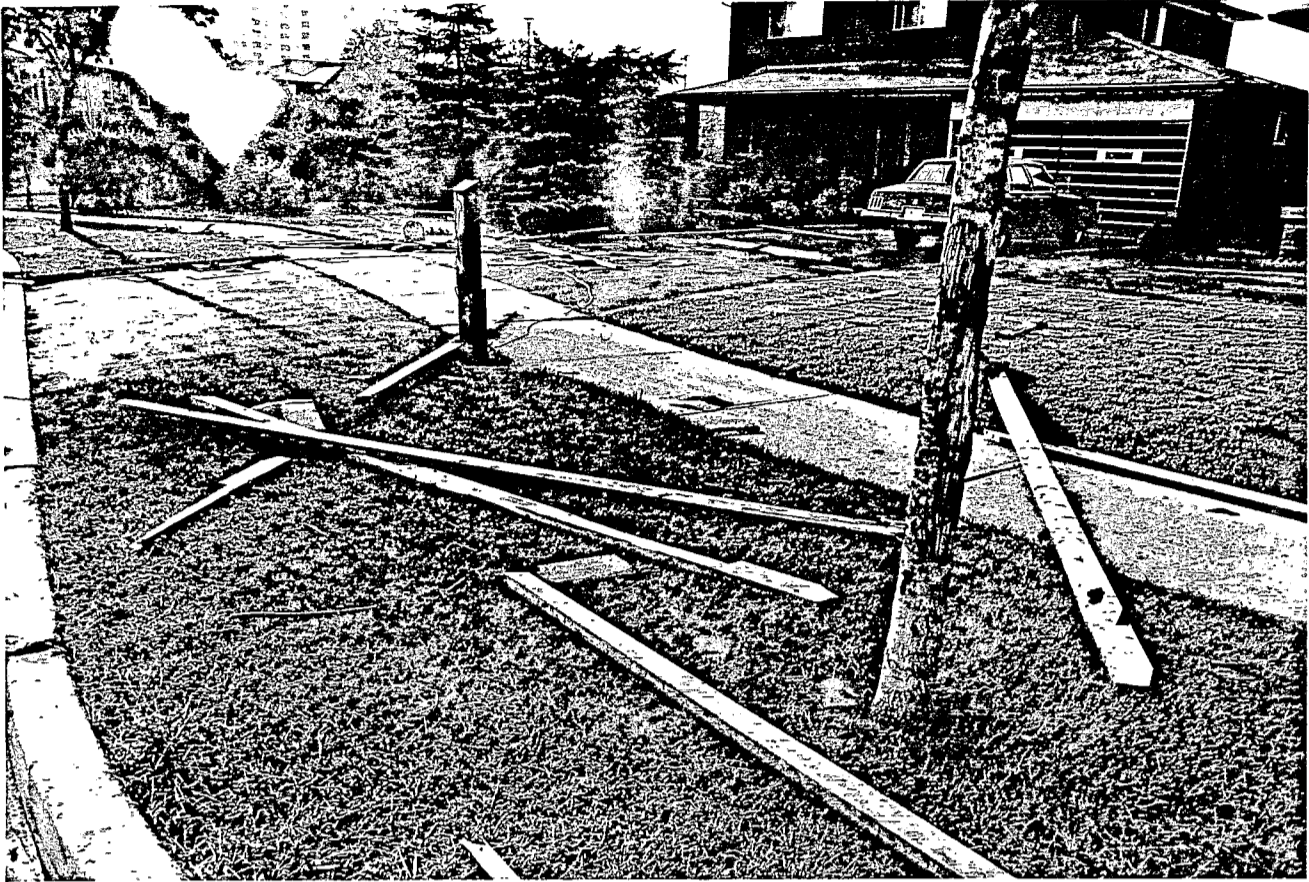
These are a couple of extra photos taken on Honeywood Road.

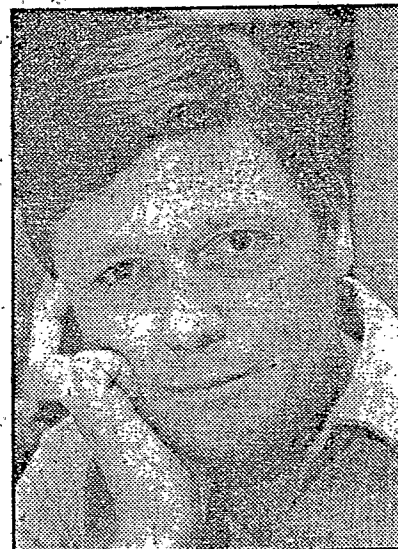
**Eyewitness:** Mike Jellen, who took the photo above, watched storm from his apartment.

- 15) Looking southwest down into the Humber river valley I saw a narrow section of tree tops broken westward.
- 16) From the 21<sup>st</sup> floor of 236 Albion Road Mike Jellen photographed the funnel as it came down the Humber river valley toward him. See the Toronto Star account at the back of this report. I estimate that the funnel was at the position on the map marked X when Jellen took his photo.

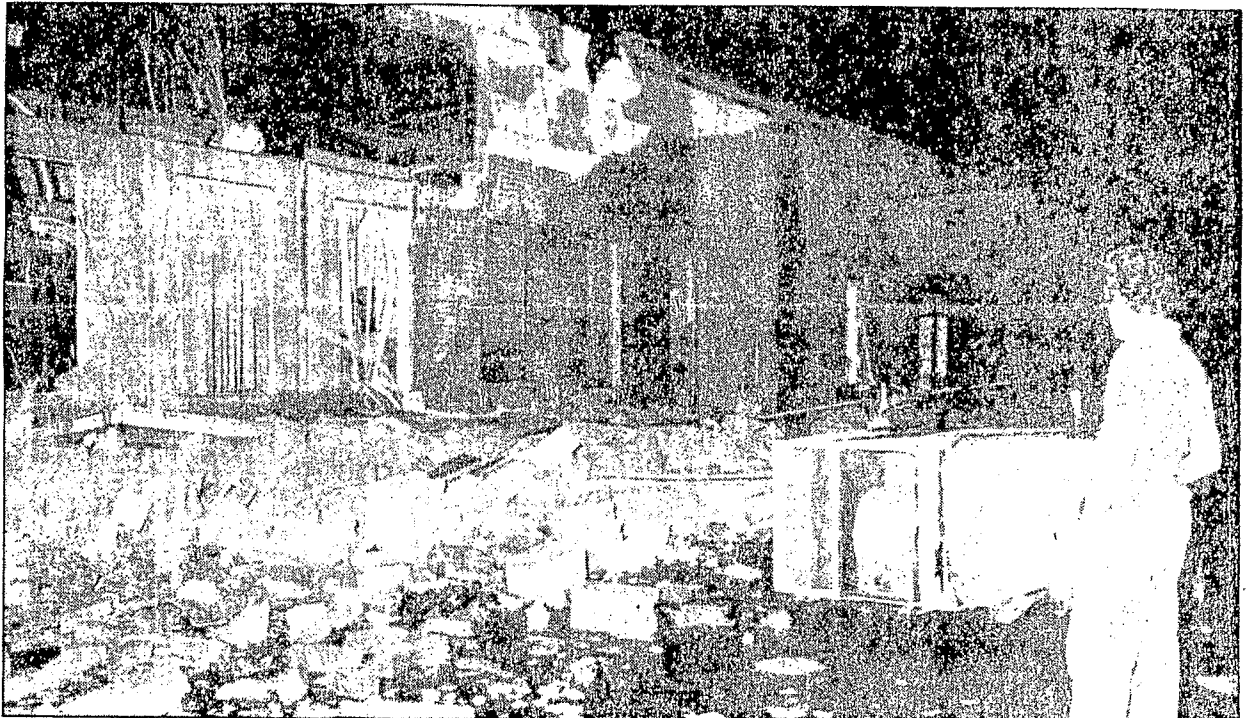
**Business hit:** Allen Snow, an employee at the Bedford Bedding and Upholstery Ltd. plant, surveys the damage at the Weston Rd. factory hit by last night's high winds, which destroyed part of the building, ripped the roof off

and demolished several cars and trucks in the parking lot. Not far away the roof was torn off an Eaton's warehouse store and shattered plate glass windows while startled shoppers and employees watched.
