**Confirmed Tornado  
Mildmay, Ontario  
July 8, 2007**

## **Tornado F-Scale Assessment**

## Severe Weather Investigation – Mildmay Ontario July 09, 2007 (for the storm on July 08th)

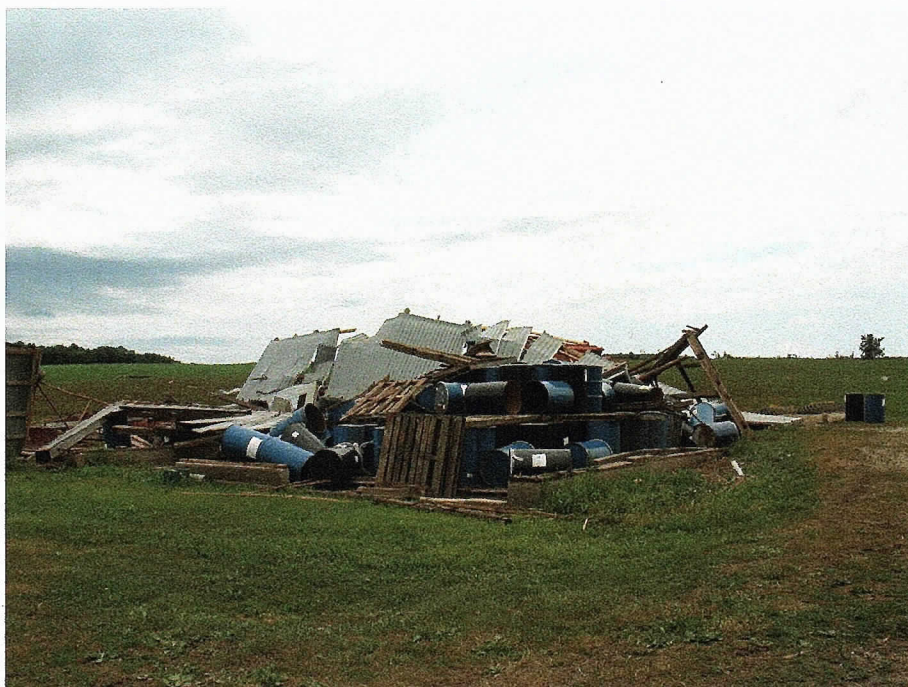
Facing 080 Degrees.  
Outer walls and roof  
have been completely  
removed.

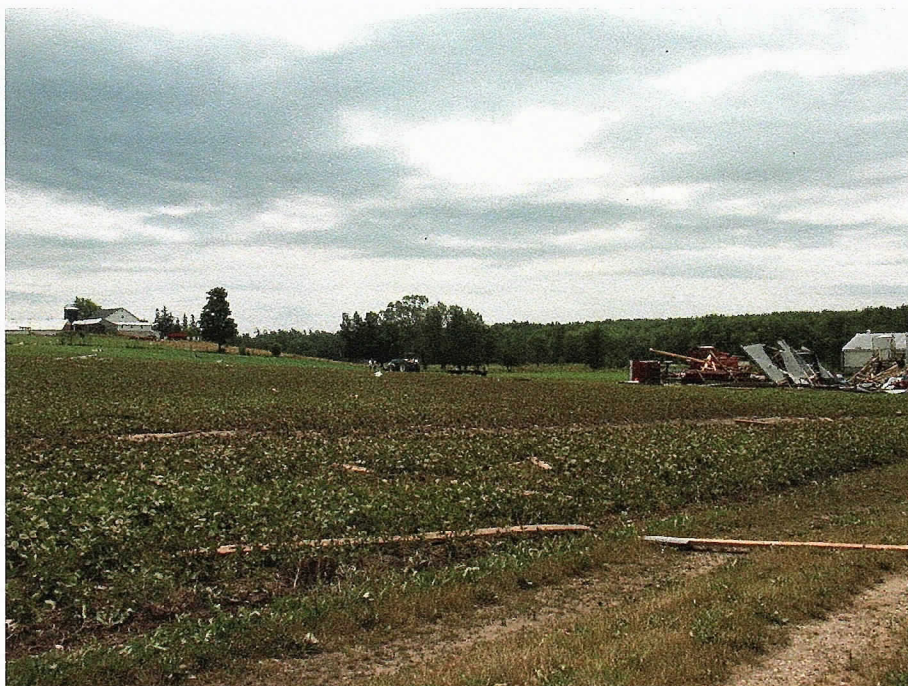
Facing 195 Degrees.  
Destroyed building can  
be seen to the right.  
Track of the tornado is  
from this point to the  
stand of trees distant  
centre. Soybean field  
was completely scoured.  
Wrap-around debris can  
be seen in the near  
foreground.

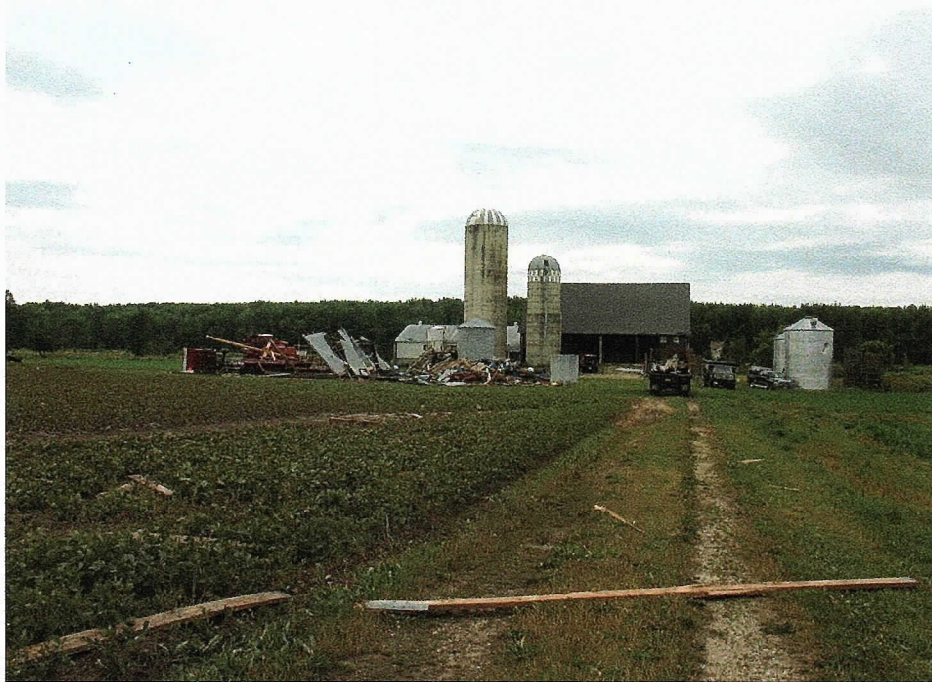
Facing 210 Degrees.

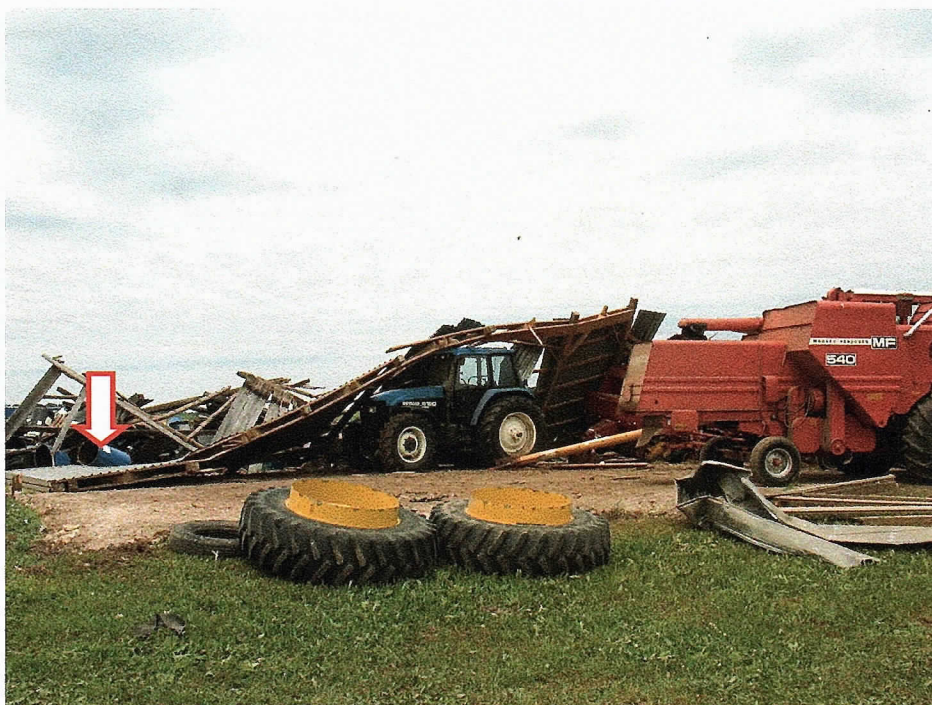
Facing 290 Degrees.  
Combine (red) was  
pushed to this location  
from the south wall  
(shown by arrow)

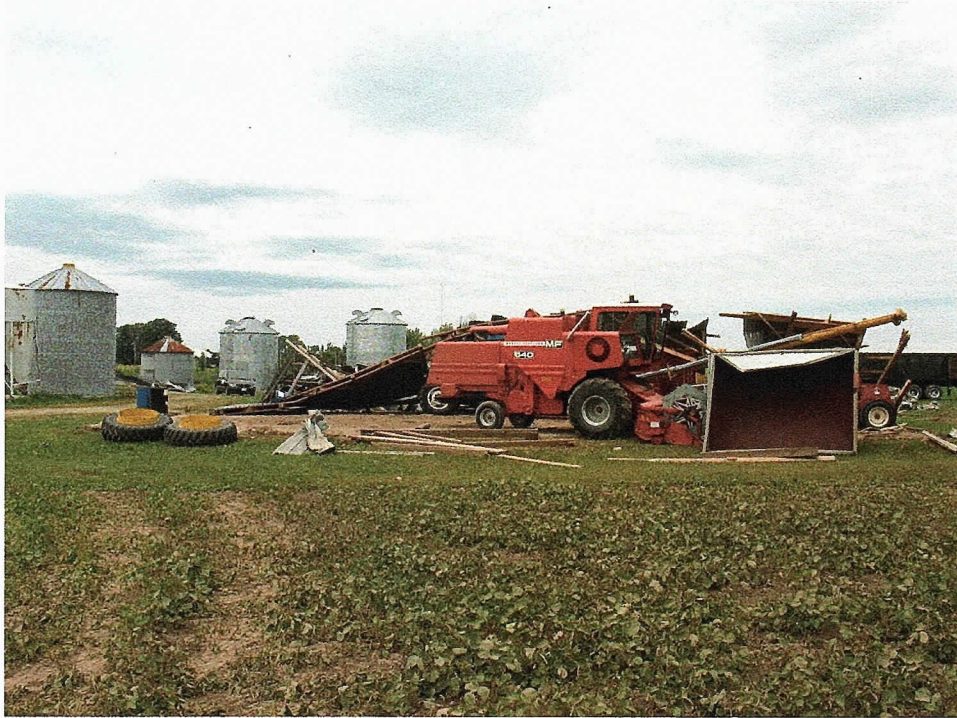
Facing 270 Degrees.
