**Confirmed Tornado
Gravenhurst, Ontario
August 20, 2009**

Tornado F-Scale Assessment

OSPC Storm Damage Survey Report

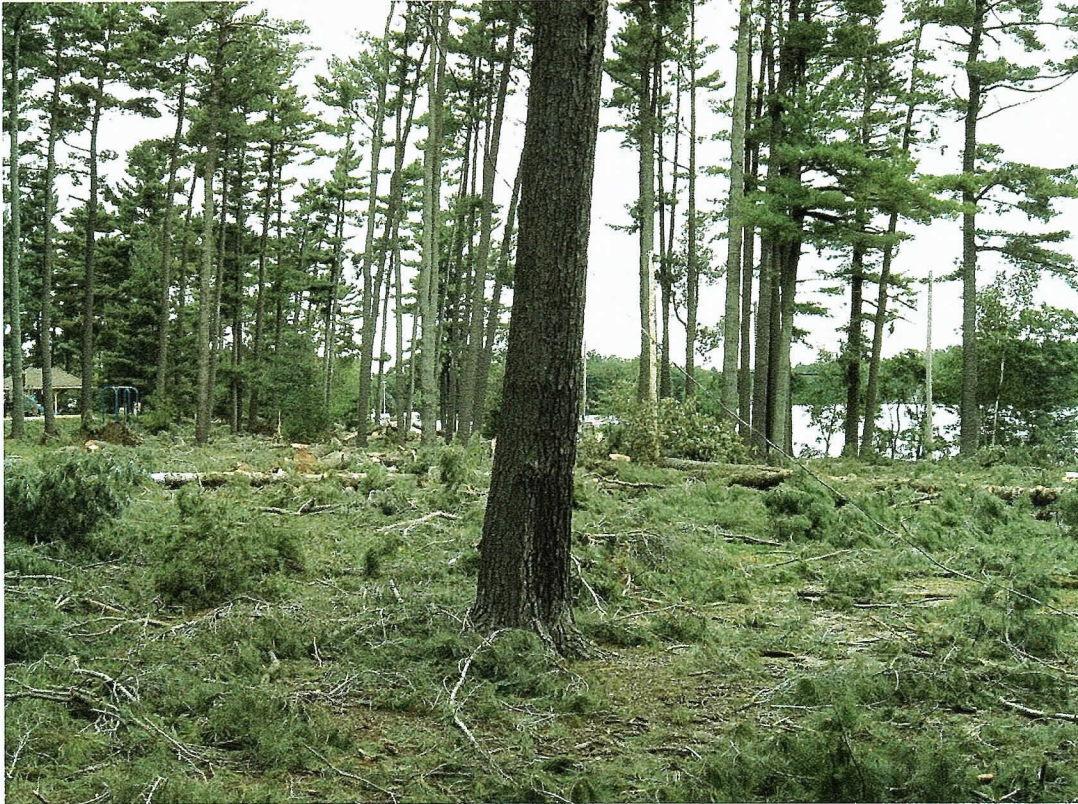
Facing NE - Numerous white pines fallen to the southeast in Gull Lake Park in Gravenhurst

WP140 - in same area as above - quite a few large white pine/some birch fallen (2 pics)

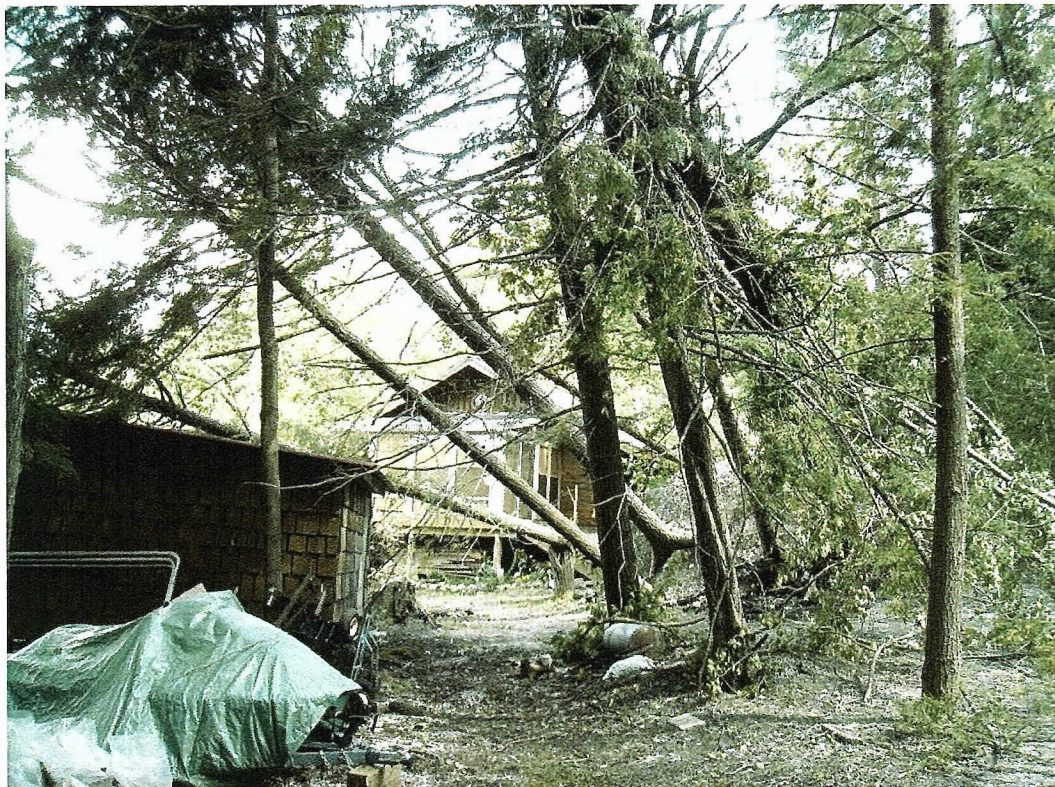
Probably facing S - Several white pines down on 4250 Riverview Drive (initial touchdown)

WP149 possible starting point....end of Kilworthy Rd

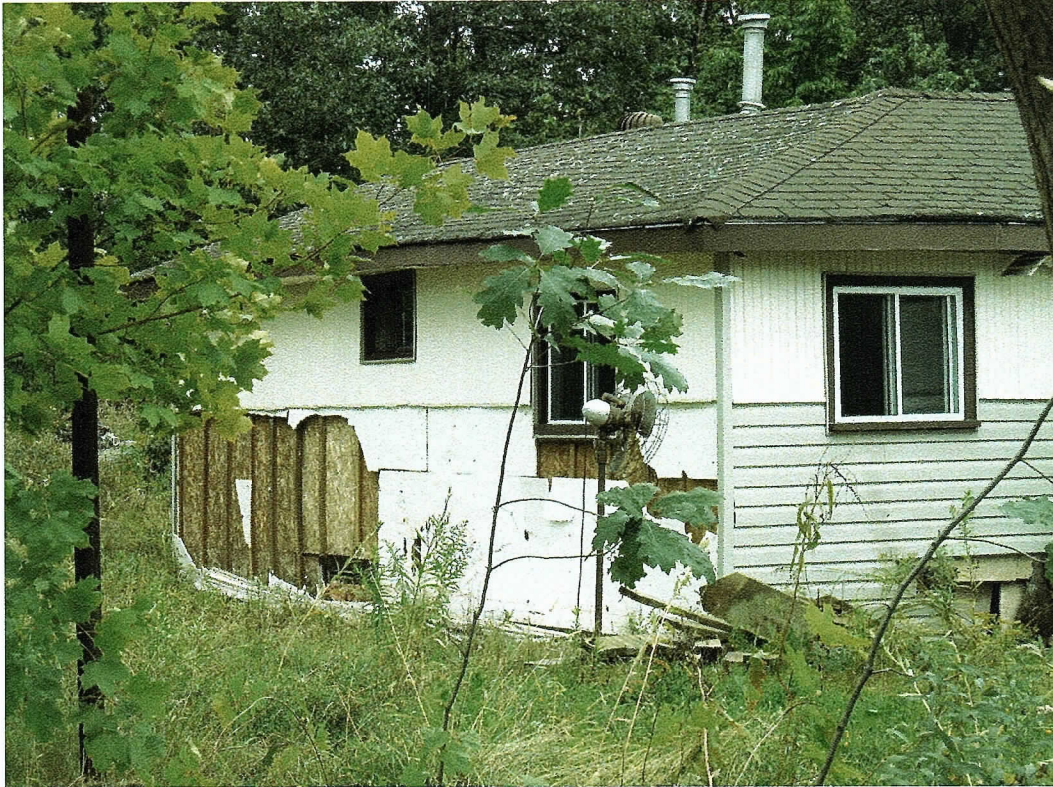
Facing E - damage to a house in Gravenhurst (not caused directly by falling tree damage)

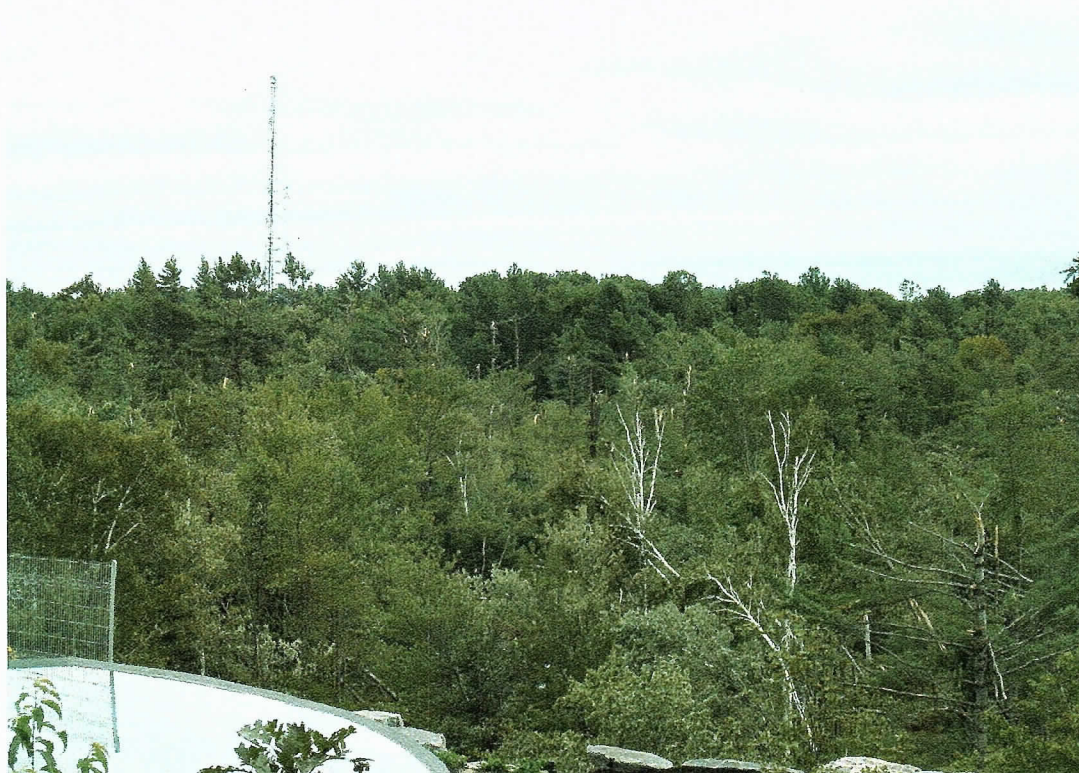
Facing E - swath of tree damage in golf course just west of Gravenhurst

WP143 - Muskoka Bayclub Golf Course - swath of damage/snapped off trees...
