Analysis of Framing Failures in Wood-Frame Residential Roofs Under Wind Load

A thesis submitted in partial fulfillment of the requirements for the Master of Engineering Science degree in Civil and Environmental Engineering

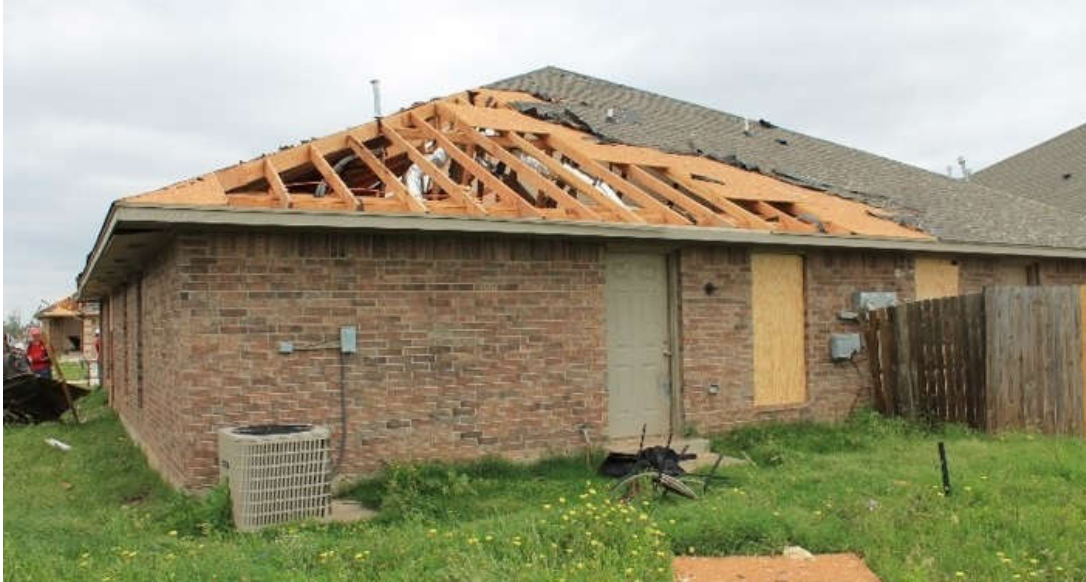
Figure 1-1: Example of roof sheathing failure, corresponding to DOD-4 (Image provided by Dr. David Prevatt of University of Florida)

failure modes. Figure 1-1 shows an example of typical sheathing failure, and Figure 1-2 shows failure of the RTWC. The current understanding of DOD-6 is limited to research focused on RTWC failures.

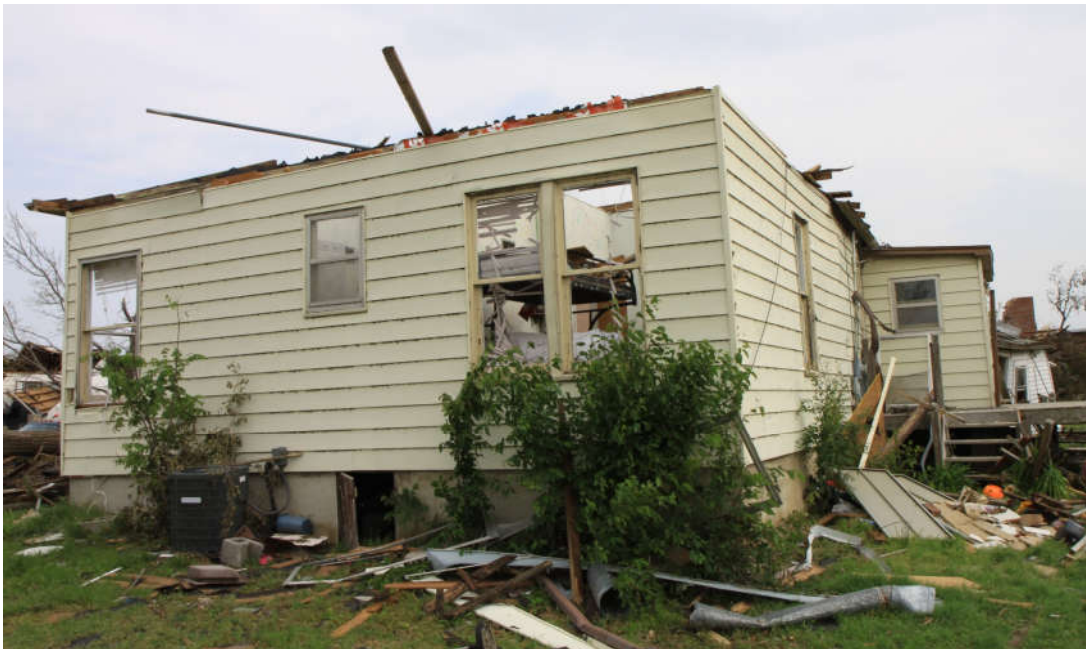
Figure 1-2: Example of roof-to-wall connection failure, corresponding to DOD-6 (Image provided by Dr. David Prevatt)

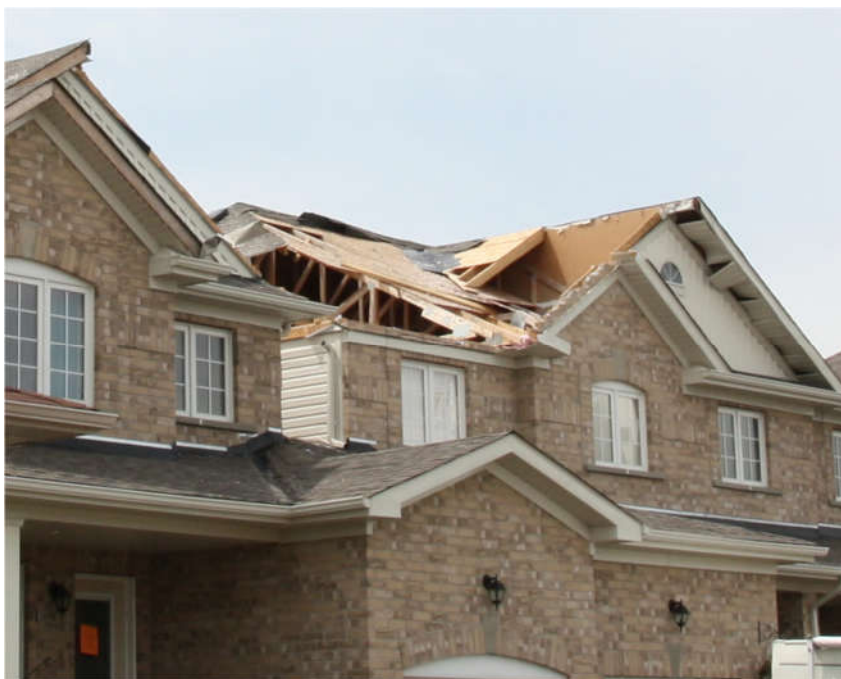
Figure 1-3: Partial hip roof failure observed following EF2 tornado in Angus, Ontario, June 2014. (Image provided by Dr. Greg Kopp)

An example of a partial hip roof failure from the Angus tornado is shown in Figure 1-3. This failure does not appear to have occurred simply as sheathing failure or failure of the RTWC. At the left corner of the damaged house there is an opening where it appears that a portion of the roof has been removed. Inside of the opening intact trusses are still visible. This suggests either that hip trusses near the edge of the roof have failed, or that smaller framing members making up the corner of the roof have been removed. In either scenario, partial failure of the roof frame has occurred, though it may have been initiated by failure of the RTWC at the corner. Several other observed failures which do not clearly fall into the sheathing or RTWC failure categories will be introduced in the following section, providing further background and justification for the current research.

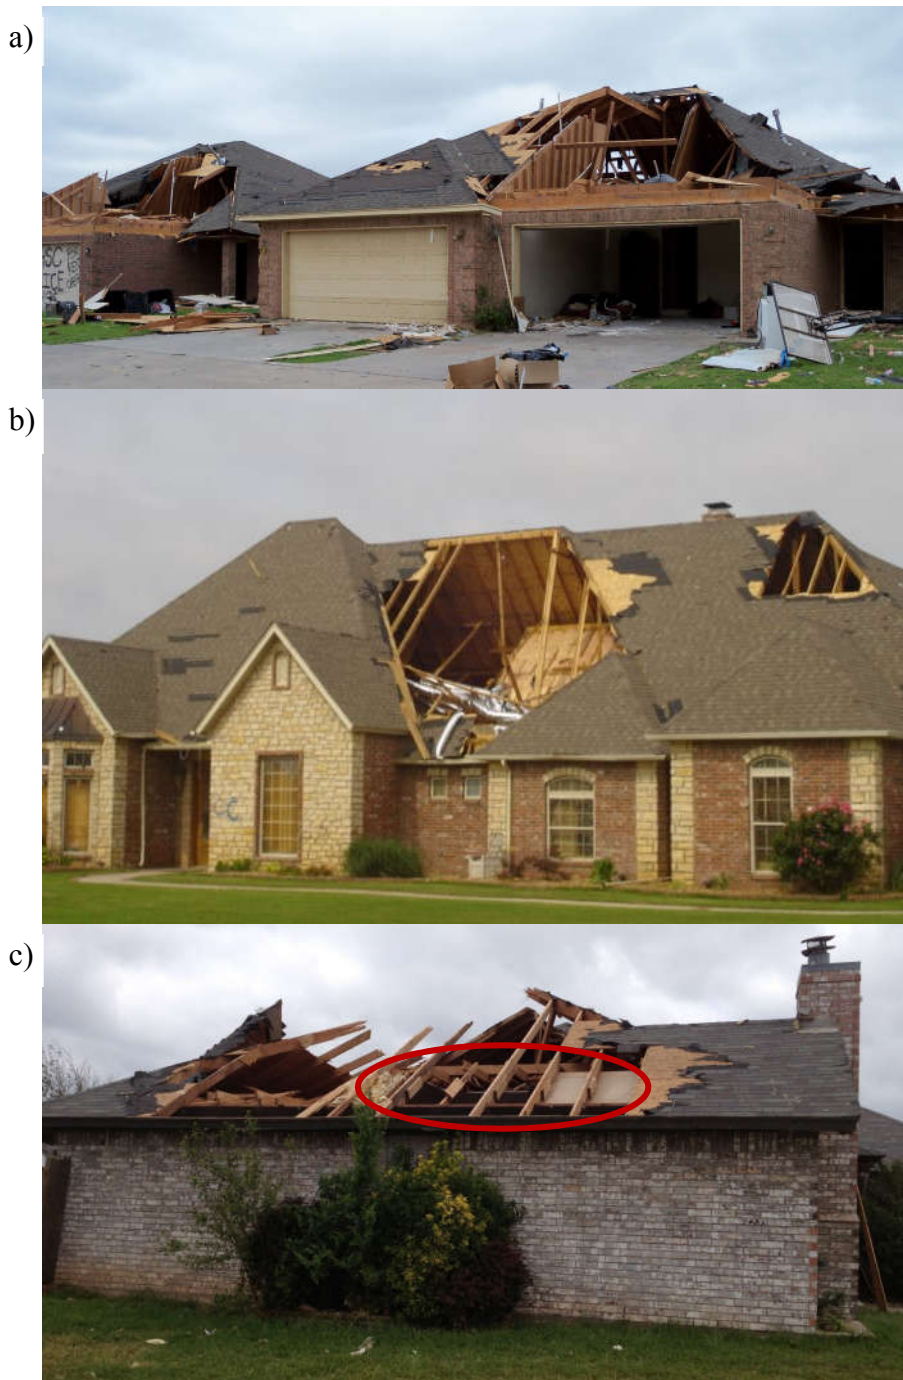
Figure 1-4: Hip roof failures in Moore, OK following the EF5 Tornado of May 21, 2013. a) Framing failure of similar, neighboring hip roofs b) Framing failure of steep, stick-frame hip roof c) Hip roof displaying material failure of the wood framing members (Images provided by Dr. David Prevatt)

Figure 1-4(a) shows neighbouring hip-roofed homes that exhibit similar failures of the front face of the roof. The RTWC appears to be intact around the remaining perimeter of the roof and it is apparent that several members of the roof frame have failed or been removed, in addition to the sheathing covering this portion. At the right side of the photo the remaining part of the roof is sagging, which further indicates that the underlying frame has failed. The houses shown in Figure 1-4 (a) were located along Kyle Drive at the western edge of Moore, OK. Several houses along this short stretch had similar failures of hip roof framing. The houses in this area had similar structural configurations and were built around 2006 (Graettinger, et al., 2014). Inspection of the damage photos from this neighborhood indicated that, of houses experiencing DOD-4 or DOD-6 roof damage, 40% appeared to

have failed through similar partial failures. In these cases, it appears that the frame failed at the nailed connections between the members, as no broken lumber is visible. The following section will present additional statistics and observations from two selected neighborhoods following the Joplin, MO tornado.

Figure 1-4(b) shows a similar failure to that in 4(a) but of a much steeper roof. The RTWC appears to be intact, and a large open cavity is visible where both framing members and sheathing have been removed. Similar to 4(a), it is apparent that this roof did not exclusively suffer sheathing loss, although the smaller area of sheathing loss at the right side of the photo should be noted. The lack of visible internal members in the cavity, especially those supporting the intact opposite face of the roof, strongly suggest that this roof was built as a stick-frame structure as opposed to one containing prefabricated trusses. Many of the failed hip roofs in the available data appear to have used stick-framing. The trussed and stick-frame construction methods will be described in Section 1.3.

Figure 1-4 (c) shows a partial failure of a combined hip/gable roof. This failure is unique from those shown in Figures 1-4(a) and 1-4(b) because material failure of the wood members is apparent. The RTWC appears to be intact, with the lower part of the roof having lost only sheathing on the right side, and framing members in addition to sheathing on the left. Near the peak of the roof, the frame has failed on both faces. This structure appears to contain either trusses or stick-framing with robust connections. As indicated on the figure just above the RTWC, the members were connected or otherwise reinforced using nailed wooden plates.

Upon inspection of the failures shown in Figure 1-4 and similar damage in the available photos, it becomes apparent that partial framing failures are another possible, repetitive mode of failure occurring in hip roofs. When comparing these hip roof failures to nearby structures from the data, it was determined that framing failures such as those shown in Figure 1-4 may govern in hip roofs at EF2 wind speeds, rather than RTWC failures or sheathing loss. It was also noted that the construction of the roof may be important. The observed stick-frame failures especially suggest that the performance of stick-frame roofs may need to be distinguished from that of trussed structures in analysis and design, as well as in the present research.

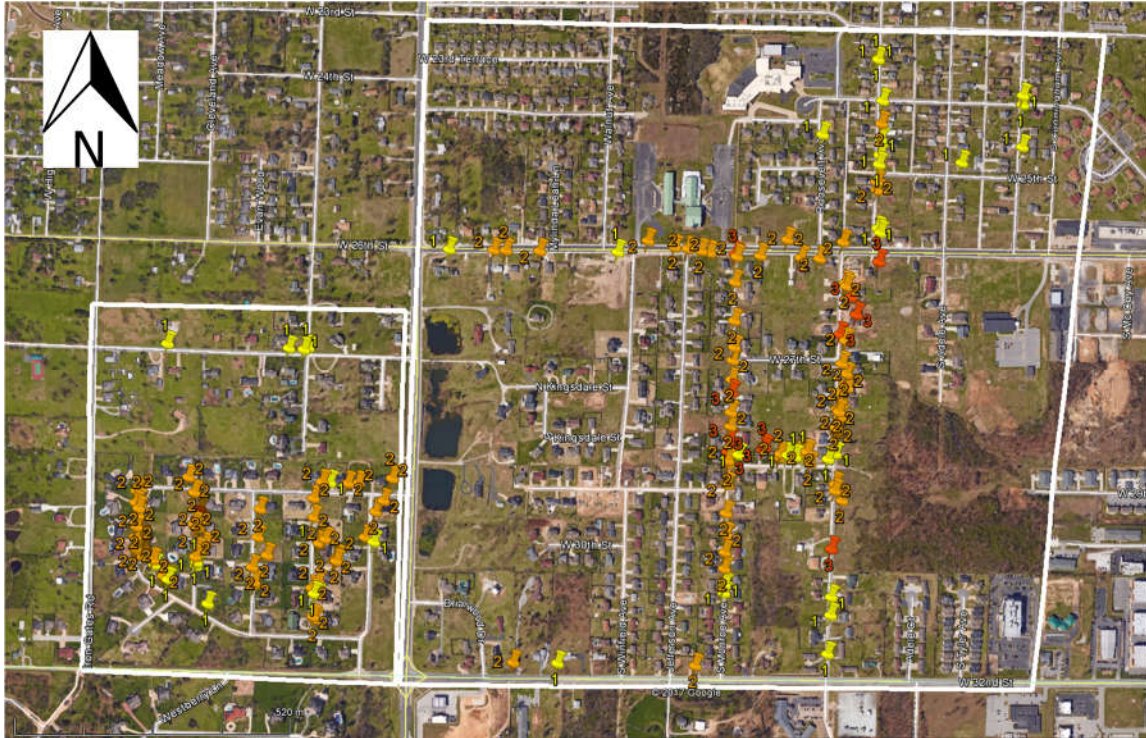
Figure 1-5: West end of tornado damage path following the May 22, 2011 tornado in Joplin, MO; two present study regions are shown by white outlines

EF3 damage was analyzed because these rankings correspond to the DOD-4 and DOD-6 wind speeds for residential roofs. In the figure, EF1, EF2, and EF3 rankings are represented by yellow, orange, and red pins, respectively.

Two study areas, outlined in white on Figure 1-5, were analyzed and the occurrence of different failure modes can be compared across them. The damage photos at the marked locations in each region were inspected and the perceived mode of failure was noted. This pass through the data marked each separate residence based on whether the damage appeared to be wall, RTWC, sheathing, or framing failure. Wall failures corresponding to DOD-7 were included because the expected wind speeds causing this failure mode falls under the same EF category as DOD-6. The study areas were selected based on the characteristics of the houses in each. Region 1, on the left side of Figure 1-5, was found to contain houses that appeared to be newer, most with steep-sloping hip roofs and large building footprints. The homes in Region 2 mostly appeared to be older, masonry homes with shallow wood-framed roofs.

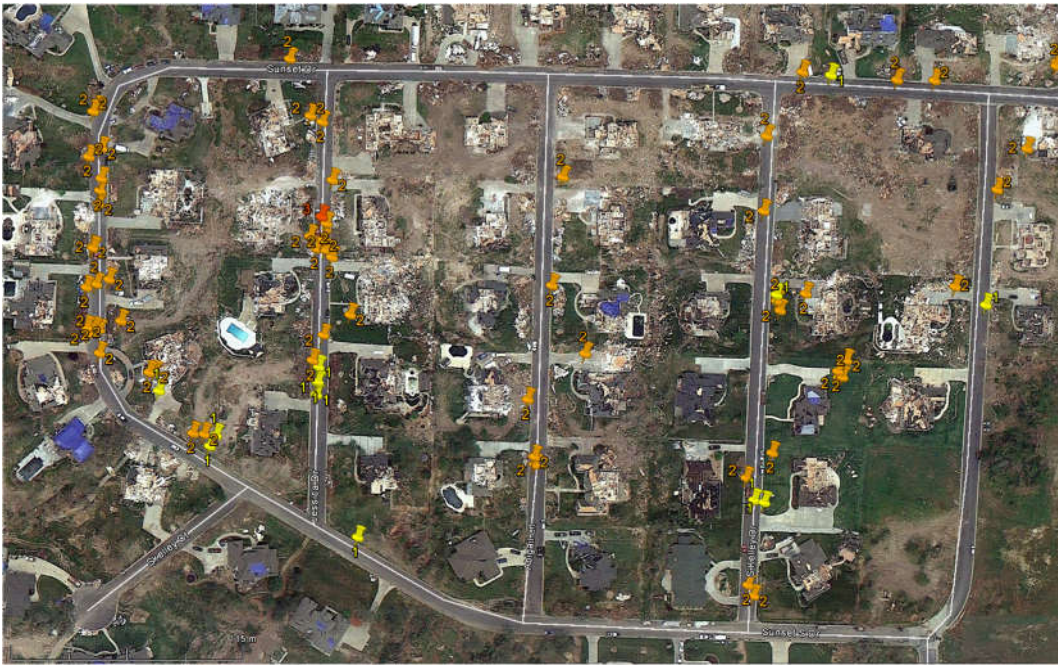
Figure 1-6: Map of Region 1 neighborhood (Sunset Drive) with aerial photography showing the aftermath of the tornado in Joplin, MO (Image provided by Dr. David Prevatt)

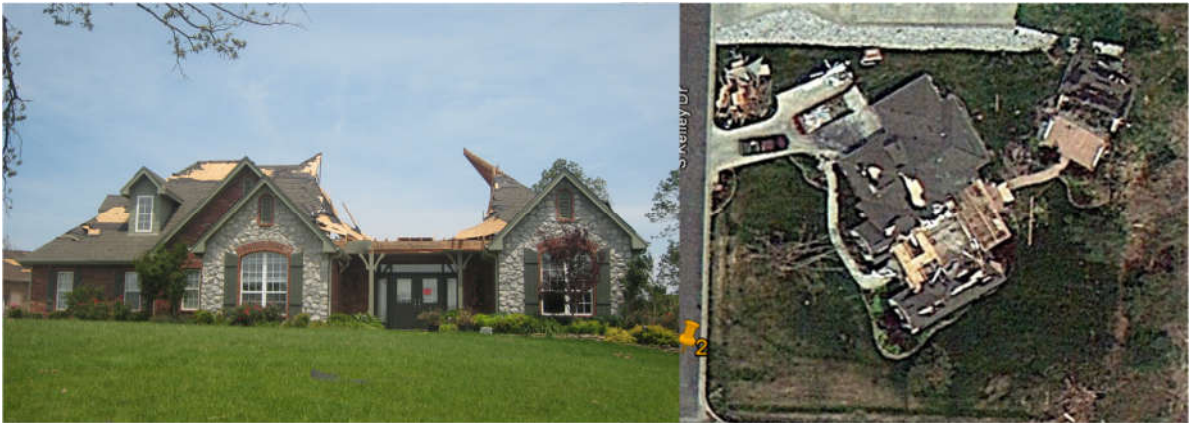
Figure 1-7: Example of typical hip roof configuration in Region 1, with an aerial photo showing the footprint of the partial failure on the right-hand side of the figure (Image provided by Dr. David Prevatt, Google Earth)

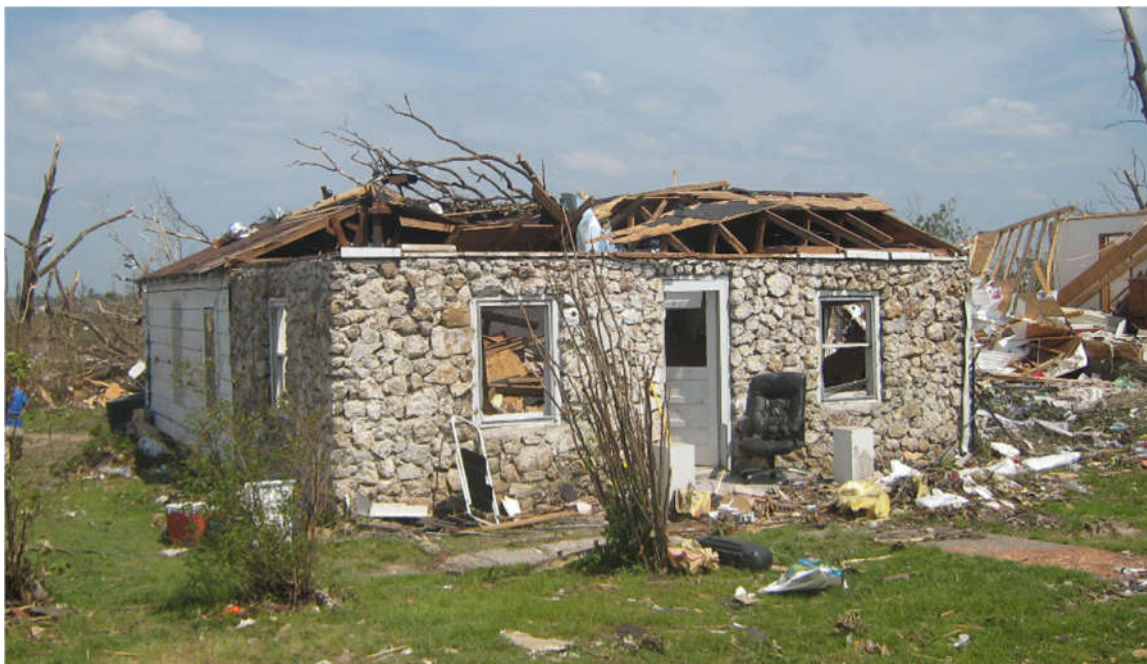
Figure 1-8: Partial hip roof failure in Region 2 (Image provided by Dr. David Prevatt).

The distribution of failure types in Region 2 is different from that of Region 1; 15% showed partial failures, while 2%, 22%, and 18% suffered RTWC failure, sheathing failure, and wall collapse, respectively. This shift could have occurred due to a number of factors; however, it was noted that many of the houses in Region 2 appeared to be of older construction than those in Region 1, and had lower-sloping roofs. While this observation may suggest that roof slope contributes to the occurrence of framing failures, it is not apparent what other factors may have had an additional impact. For example, the lack of lateral restraint in older houses may have led to increased numbers of wall collapses, and aging structures may also be less resistant to debris damage. In the example shown in Figure 1-8, partial roof failure occurred. However, this failure may have occurred due to the tree debris visible on top of the failed roof. Other instances of partial failure in Region 2 were similarly ambiguous, and because Region 2 was downwind of Region 1, debris likely played a larger role. In both regions, partial failures were found to occur at least as often as other modes of roof failure. More work is required to obtain a complete set of statistics on these failures and better define the regional conditions that may contribute to their occurrence.

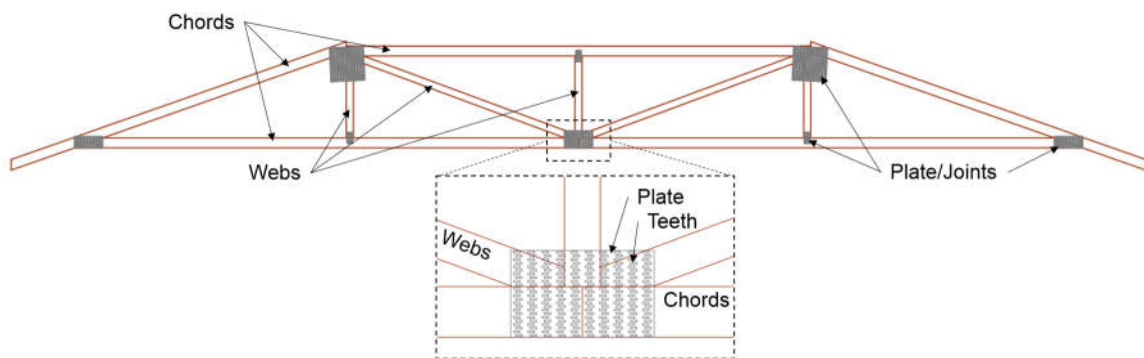
Figure 1-9: Illustration of MPC Truss with Components Labelled

Figure 1-9 illustrates the parts of a MPC truss and shows the nomenclature used in the present study. On site, trusses are placed on top of the wall top plate at equal spacing. Roof sheathing is fastened to the top of the top chords to enclose the roof, and ceiling drywall is typically fastened directly to the bottom faces of the bottom chord members. In gable roofs, all trusses in a roof may be identical in shape and configuration, while hip roofs require progressively taller trusses moving towards the centre of the roof, as well as short jack trusses placed perpendicular to the outermost full-length trusses to complete the roof slope at the eaves. For the reader's reference, Figure 2-4, later in this thesis shows a 3-dimensional model of an entire trussed hip roof, including full-length hip trusses and jack trusses.

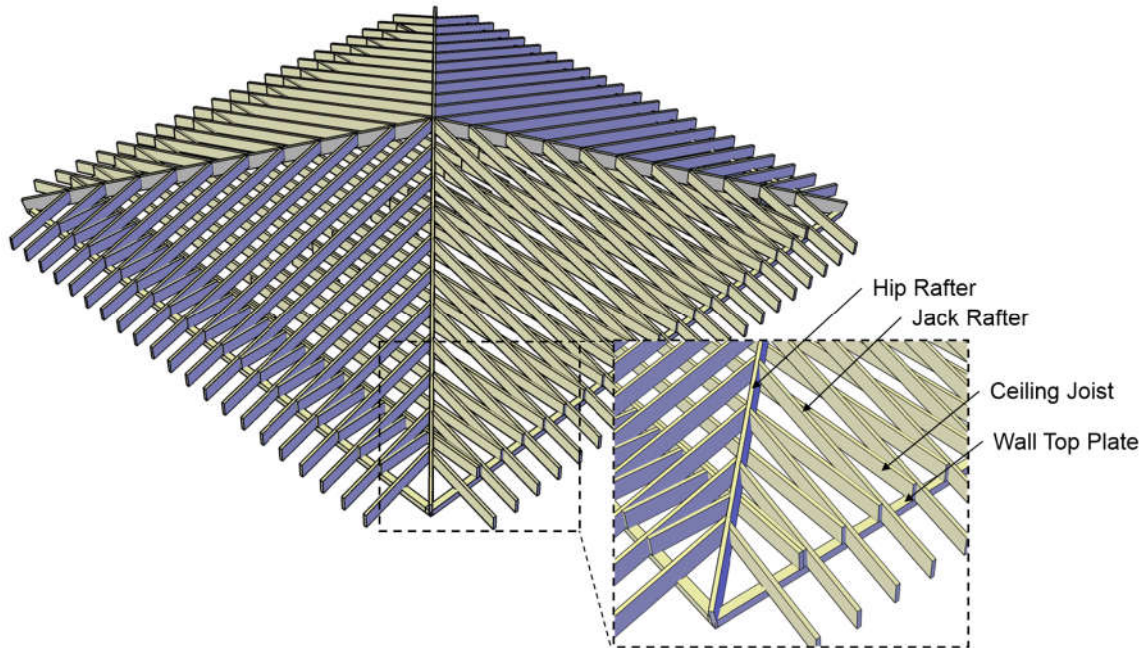
Figure 1-10: Illustration of Stick-Frame Hip Roof with Components Labelled

In stick-frame roofs such as that shown in Figure 1-10, the closely-spaced jack rafters are structural members, while the larger hip rafters simply provide a rigid, continuous member for the jack rafters to frame into. There is no requirement in the code to join the hip rafters together at the peak of the roof, and it is expected that the roof sheathing significantly contributes to load sharing throughout each face of the roof. The connections between the jack rafters and hip rafters along the ridge typically consist of nails going through the side of the hip rafter and into the end of the jack rafter, though they can alternatively be horizontal toe-nailed connections. It is well understood that both end-nailing and toe-nailing yield weak connections, and strength reduction factors must be applied to these values during capacity estimation (Canadian Wood Council/Canadian Standards Association, 2015). At the RTWC, the jack rafter is nailed to the ceiling joist using several nails perpendicular to the length of each member, and both the jack rafter and the ceiling joist are toe-nailed into the top plate.

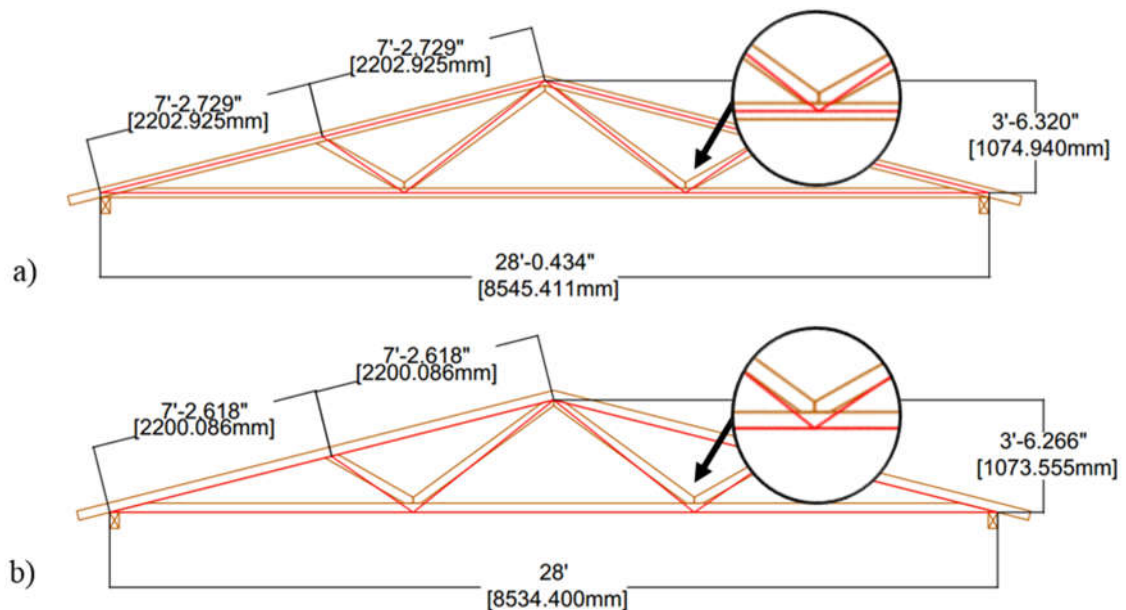
Figure 1-11: Geometric analogs applied to a 3:12 slope Fink truss, using different chord member insertion points: a) Chord Centerline, b) Chord Bottom-Line

Commonly, truss members are modeled along the centroid of their cross-section, as shown in Figure 1-11 (a). This assumption was used and validated with deflection data in many past studies (Li, 1996; Pfretzschner, 2012; Jacklin, 2013), and is the method most often used in conventional design and analysis. The Chord Centerline (CL) analog, as it will be referred to herein, assumes that the MPC truss behaves as an ideal truss, with member actions acting through concentric points at each connection. In reality, eccentricity occurs at most MPC joints due to member geometry and joint cut tolerances. Previous standards have recommended accounting for these eccentricities by using analog lines along the bottom edges of chord members (Limkatanyoo, 2003), as shown in Figure 1-11 (b).

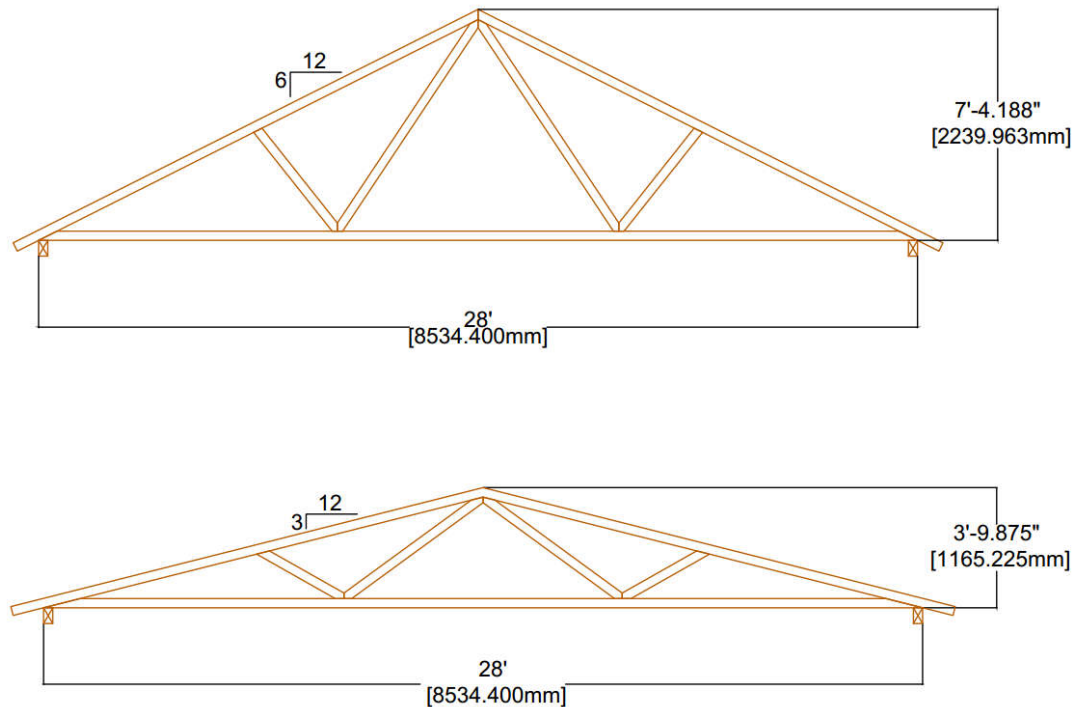
Figure 1-12: Illustration of Fink trusses used in 2-D model validation, based on the 6:12 slope and 3:12 slope truss configurations tested in FPL (1986, 1989, 1991, 1996)

The FPL studies included tests performed on geometrically-similar trusses with slight differences in the truss design or test setup, depending on the scope of each study. In all reports, 28-foot-long, 3:12 slope and 6:12 slope Fink trusses were initially designed according to conventional design procedures. All trusses consisted of No. 2 Southern Pine sawn lumber with nominal cross-sectional dimensions of 38 by 89 mm (Standard 2x4 lumber). Figure 1-12 provides an illustration of the Fink trusses tested in the FPL studies.

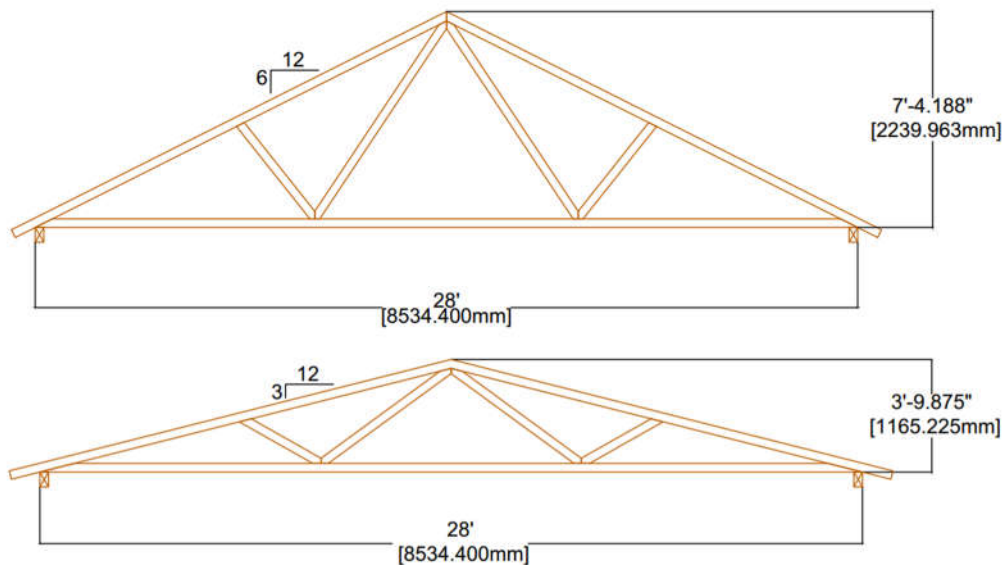
Figure 2-1: Overview of Fink Trusses used in 2-D Model Validation, based on the 6:12 (upper) and 3:12 (lower) Truss Configurations Tested in FPL-1986 and FPL-1991

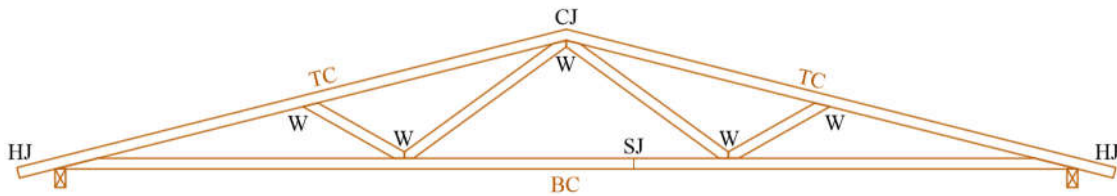
Figure 2-2: Truss 3H joint and member naming convention

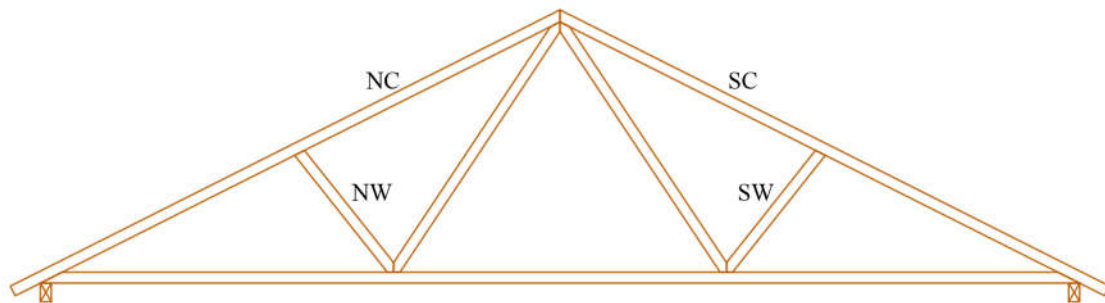
Figure 2-3: 6:12 slope trusses tested in FPL-1996, with members labeled and approximate locations of force data readings shown by location of member labels

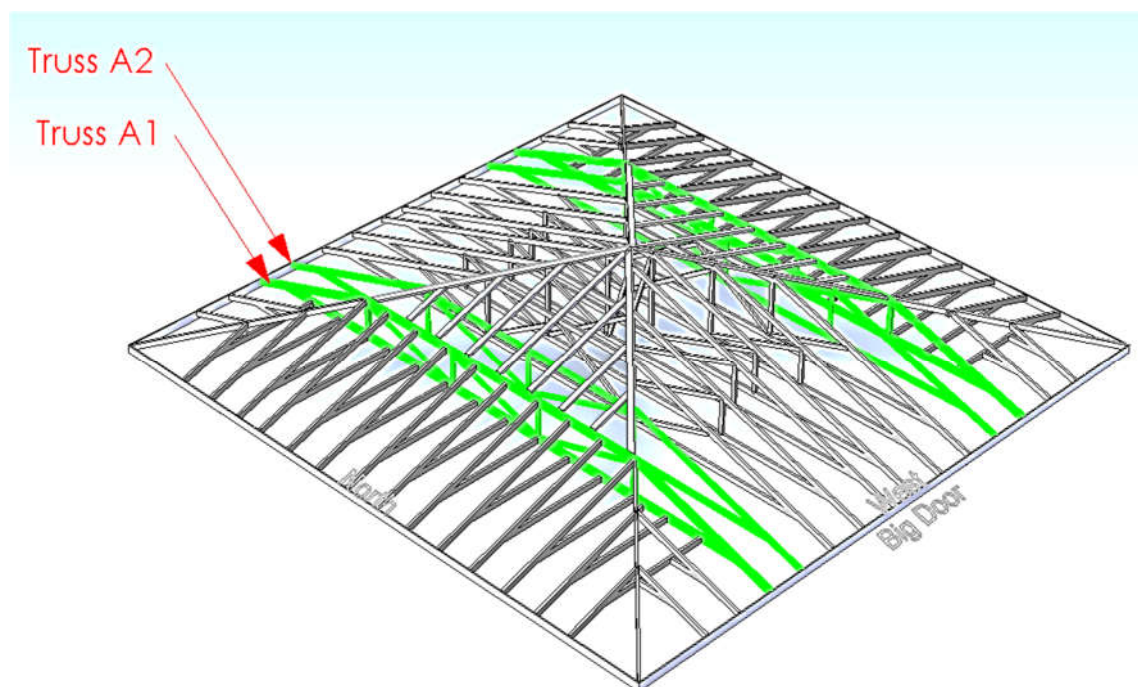
Figure 2-4: Model rendering of full-scale hip roof tested by Henderson et al. (2013)

One of the truss configurations constructed as part of the hip roof tested in Henderson et al. (2013) is selected from the truss drawing package and is used for the first D/C analysis. The envelope modeling method and force results for the selected truss are summarized using the figures in the present section. The second full-length truss in the roof is used for the present modeling. Figure 2-4 shows the configuration of the roof tested in Henderson et al. (2013), and the location of the selected truss, labeled “A2”. This truss is selected for the present analysis because it is the first full-length truss from the outer edge of the roof, aside from the two-ply “A1” truss, and its symmetry simplifies the determination of joint capacities.

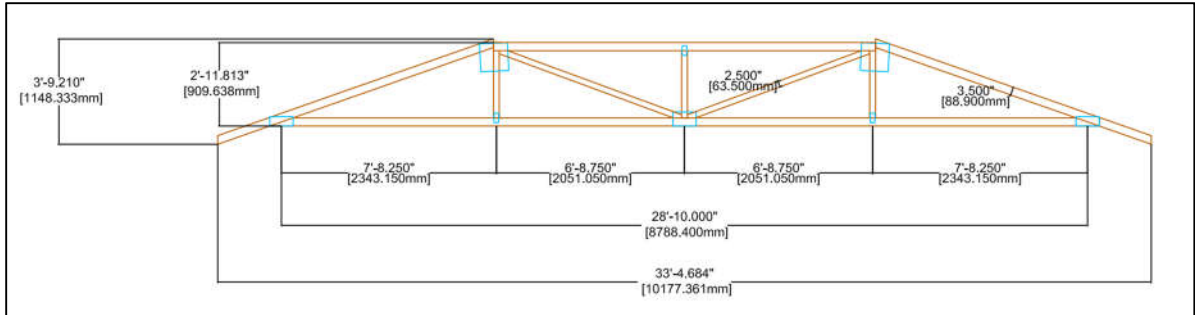
Figure 2-5: Dimensioned drawing of hip roof Truss A2 from the full-scale house tested at the Insurance Research Lab for Better Homes

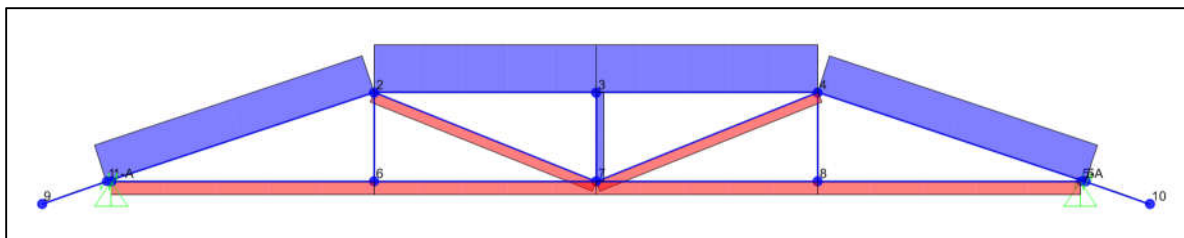
Figure 2-7: Sample of relative axial force results from the rigid SAP2000 model of Truss A2, under 1.22 N/mm uniform uplift. The blue positive results indicate tension and the red results indicate compression

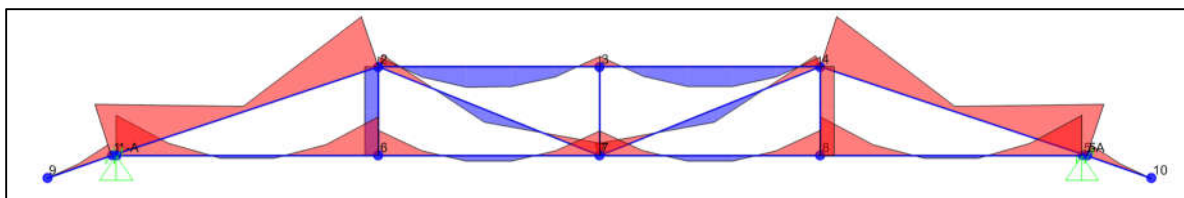
Figure 2-8: Sample of relative member moments from the rigid SAP2000 model of Truss A2, under 1.22 N/mm uniform uplift

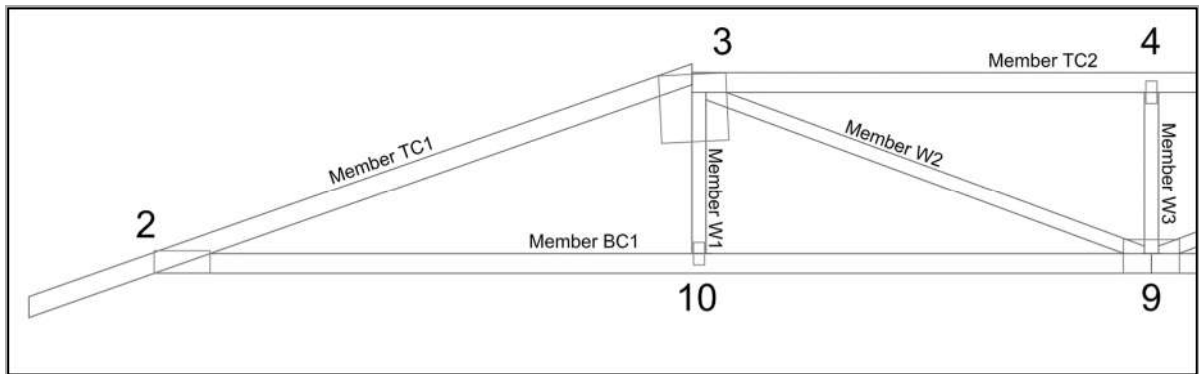
Figure 3-1: Half of modeled hip roof truss with MPC joints and members labeled according to truss manufacturer’s drawing package

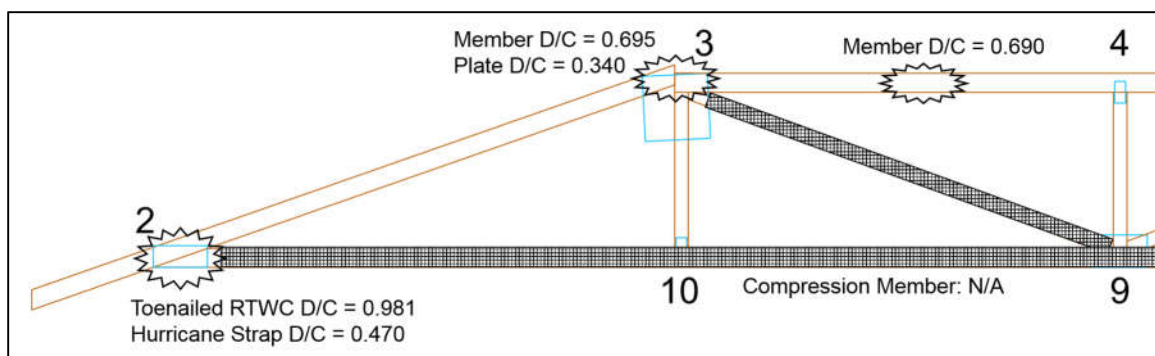
Figure 3-2: Schematic of failure locations in Truss A2 based on estimated D/C ratios from Table 3-2

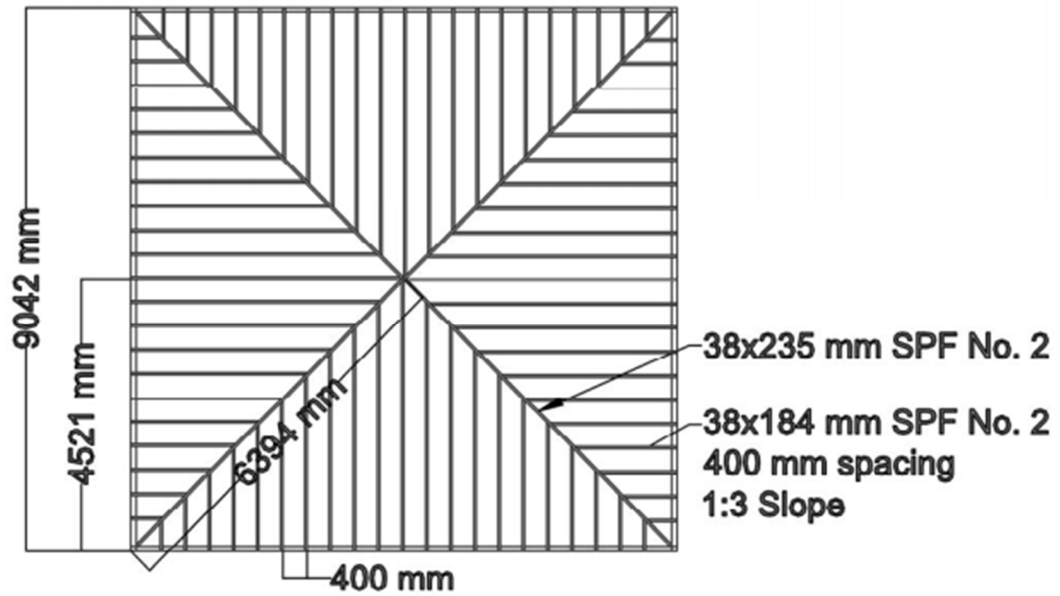
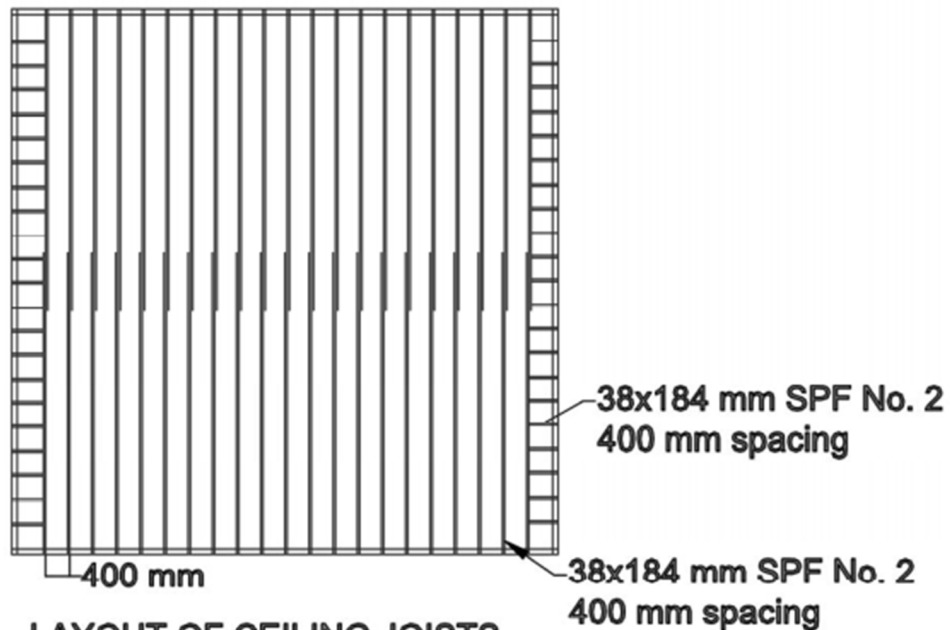
Figure 4-1: Plan-view, dimensioned stick-frame member layout drawings

LAYOUT OF JACK AND HIP RAFTERS

LAYOUT OF CEILING JOISTS

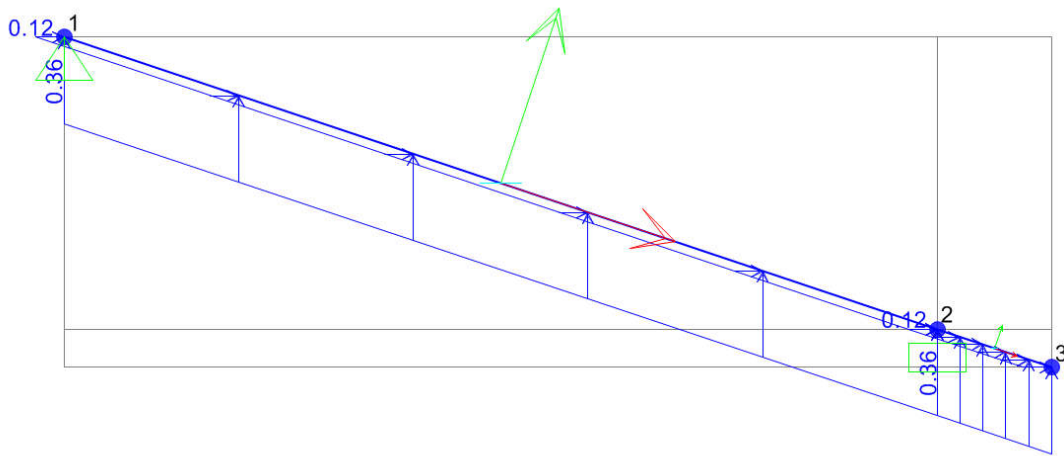
Figure 4-2: SAP2000 model of jack rafter under 0.38 N/mm uniform uplift

Analysis of a single rafter can easily be accomplished through hand calculations. For this study, however, SAP2000 is used so that the rafter can be modelled with Pinned and Rigid joint behaviour at the supports, and the maximum force results from both cases can be obtained. Figure 4-2 shows the modeled rafter with applied uplift loads. Like in the truss models, loads are applied as outward pressures, perpendicular to the member, rather than vertically upwards. The magnitude of the applied load is calculated using the same adjusted wind speed as presented in Section 3.2. The pressure corresponding to 115 km/h is multiplied by the tributary area supported by the rafter, resulting in a uniformly distributed load of 0.38 N/mm. From this model, maximum member forces and support reactions are obtained and shown in Table 4-1.

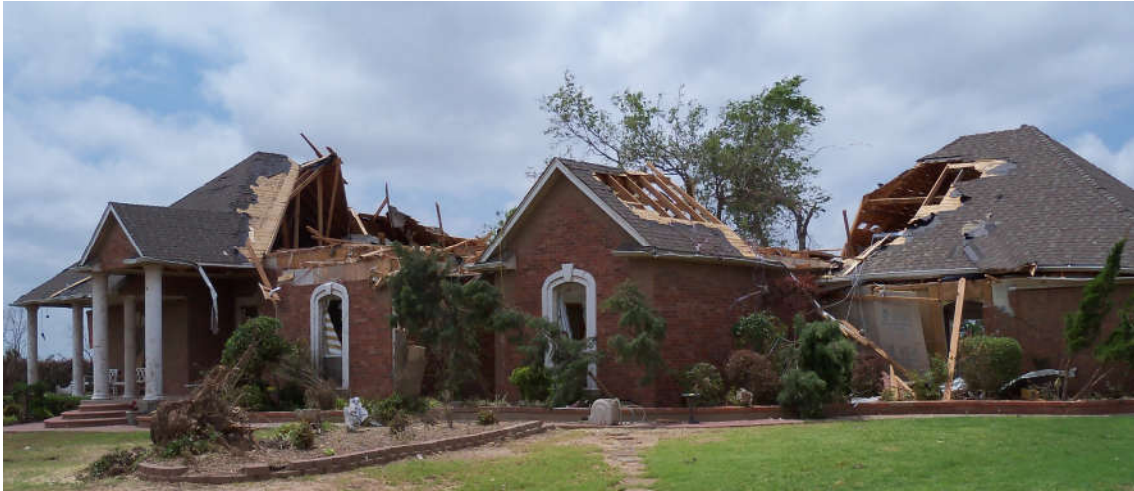
Figure 4-3: Failure of stick-frame roof with irregular roof shapes (Image provided by Dr. David Prevatt)

4-3 below. The results from the D/C analysis verify that loss of members or faces of a stick-frame hip roof may be likely under relatively low wind speeds, however the progression of failure of large sections of the roof is not well-defined. Other causes such as improper design or construction may have a significant impact as well.

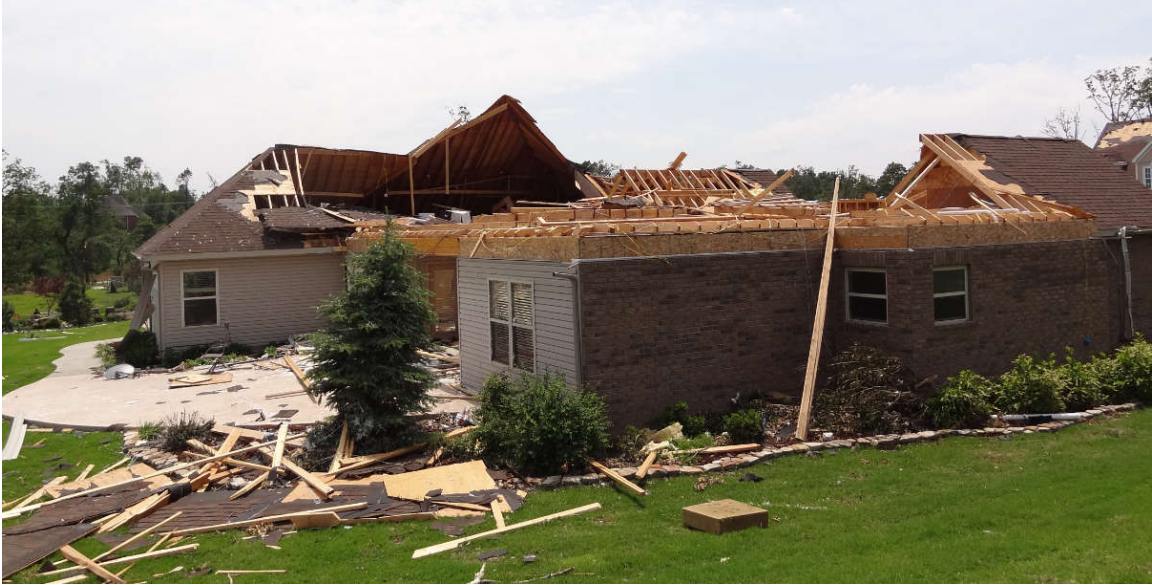
Figure 4-4: Partial stick-frame, hip roof failure with ceiling joists intact (Image provided by Dr. David Prevatt)

Upon revisiting the damage survey data and the report from the Moore, OK tornado (Graettinger, et al., 2014), an additional mode of failure related to the stick-frame case is noticed. This mode may point to improper construction of the outer roof frame, or to the potential impact of cascading failures caused by load sharing in stick-frame structures. In Figure 4-4, partial framing failure and removal of large sections of the roof appears to have occurred. Upon closer inspection, however, it becomes apparent that the ceiling joists, and the ceiling beneath them, are intact. Only the jack and hip rafters have been removed or damaged. Based on the results of the D/C analysis for the stick-frame case, this type of failure is unlikely, due to the relatively robust connection between the rafter and the ceiling joist. The RTWC and the connection along the ridge of the roof appears to be much more vulnerable. The pictured failure may have occurred due to improper or missing fasteners between the rafter and the joist at the wall top plate or initiated as failure of the upper rafter joint. Additionally, system effects may have led to progressive, cascading failure of adjacent joints, resulting in removal of entire faces of the roof following initiation at a single point.

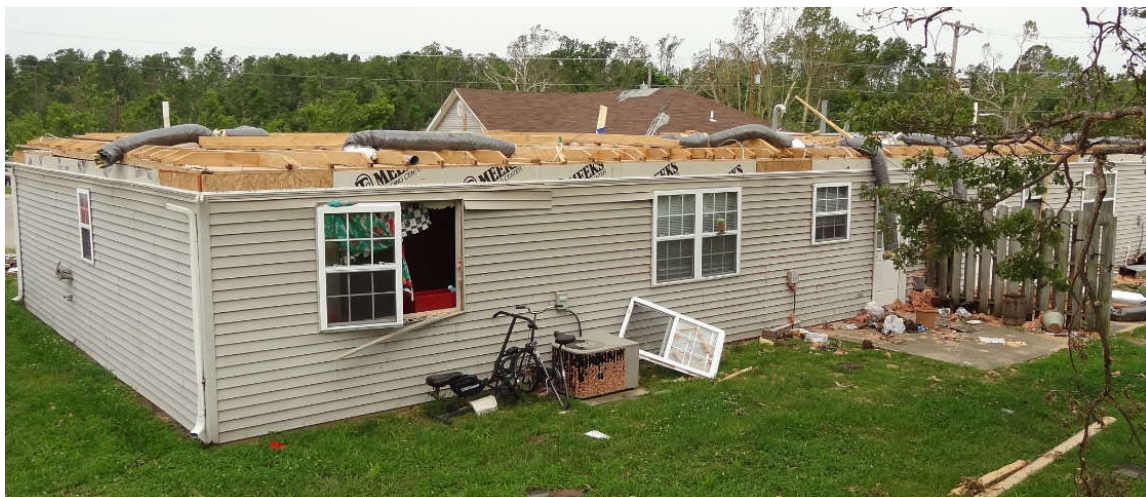
Figure 4-5: Loss of the entire surface of a stick-frame hip roof with intact ceiling joists (Image provided by Dr. David Prevatt)

Figure 4-5 shows another example of a major roof failure which has left the ceiling framing and drywall intact. This failure, and many others like it, would be objectively classified within DOD-6 for residential roofs, however this may be an inaccurate assumption. As mentioned in the previous example, the D/C analysis for the stick frame case did not predict that the rafter-to-wall connection would be vulnerable due to its relatively robust connection to the ceiling joist. Closer inspection of Figure 4-5 suggests that there were some connections at the ends of the intact joists, however from the faces of the members it does not appear that there were more than a few nails. Keeping in mind that these houses were not designed in Canada, exploration of the prescriptive design requirements in the US is required to determine whether these connections are meant to include more nails.

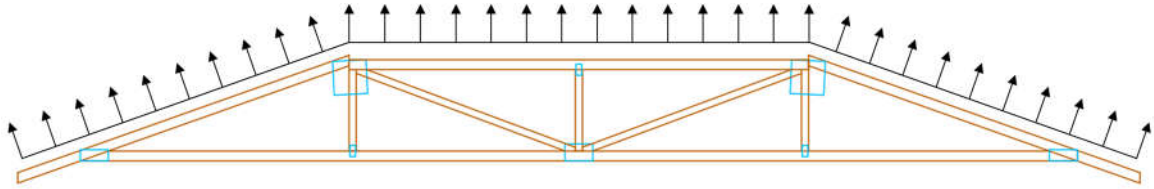
Figure A-1: Diagram of Truss A2 under uplift pressure

Tributary width of truss = 24" = 609.6 mm

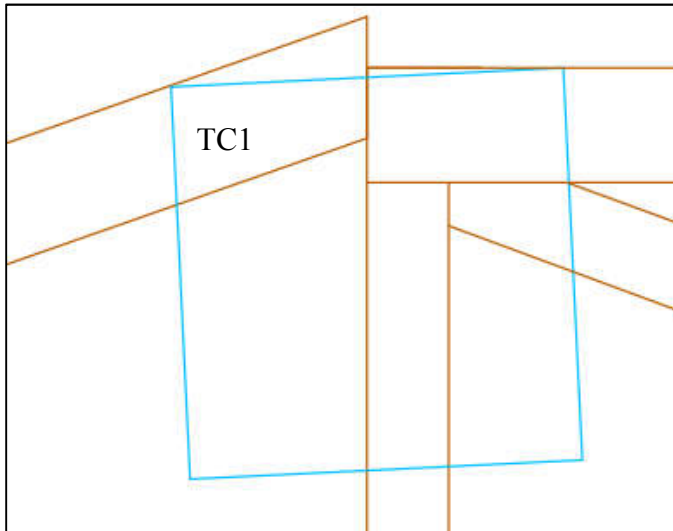
Figure A-2: Truss A2 Joint 3 diagram with member TC1 contact area shown

The following sample calculations are based on the Member TC1 capacities from Joint 3. The TC1 contact area is shown in the following diagram.

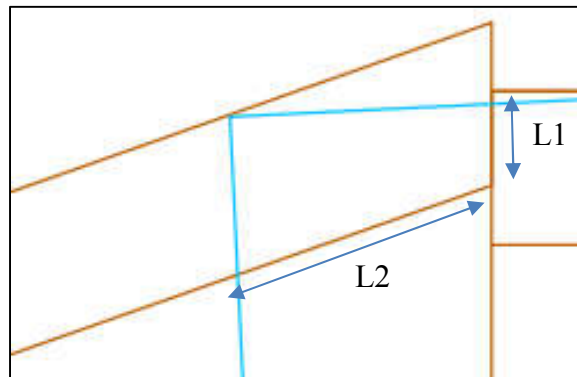
Figure A-3: Joint 3 with shear and tension lengths labeled
