**Confirmed Tornado
Rice Lake, Ontario
May 31, 1985**

THE MAY THIRTY-FIRST TORNADO OUTBREAK IN SOUTHERN ONTARIO

Rice Lake May 31/85

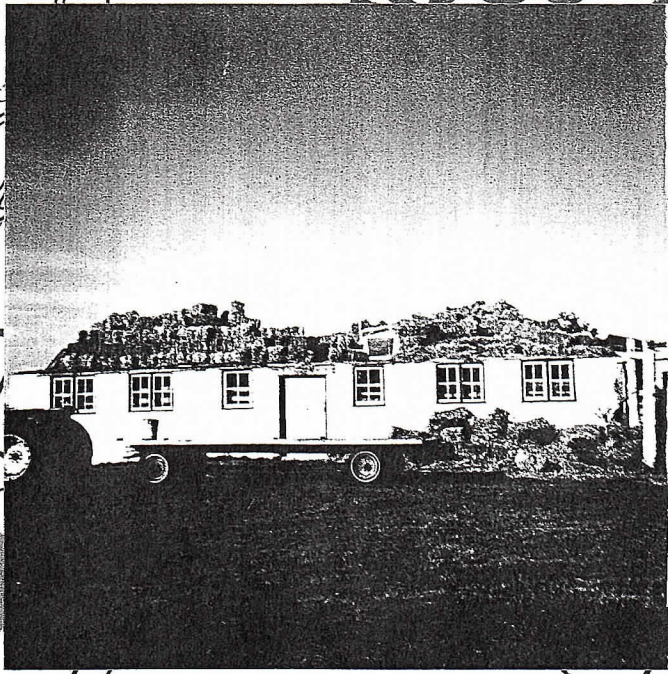
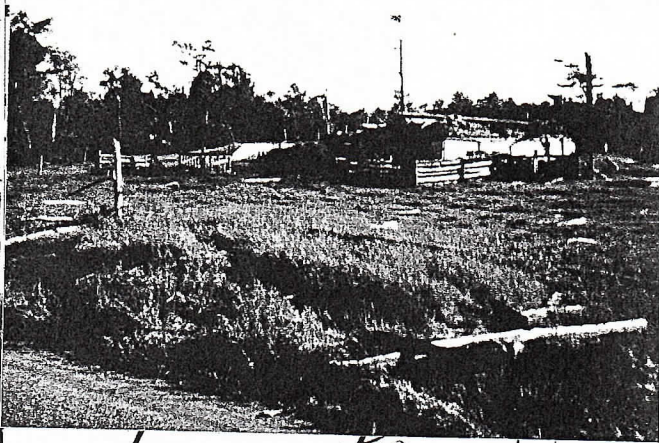
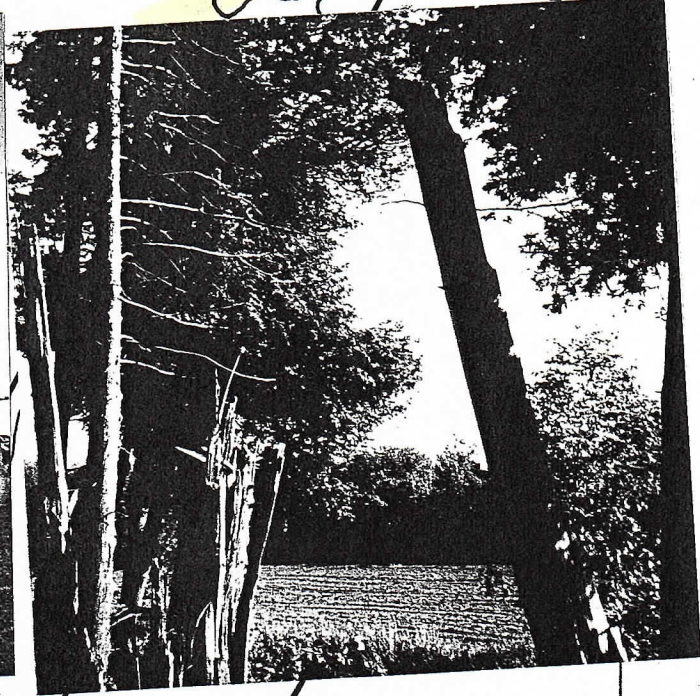
Rice 1-1

This was the most heavily damaged area of the three storm regions that we checked out.

2 - 3 Million
Several old barns
Numerous trailers
Damage estimate does not include extensive damage to hundreds of trees and the shade they provided.

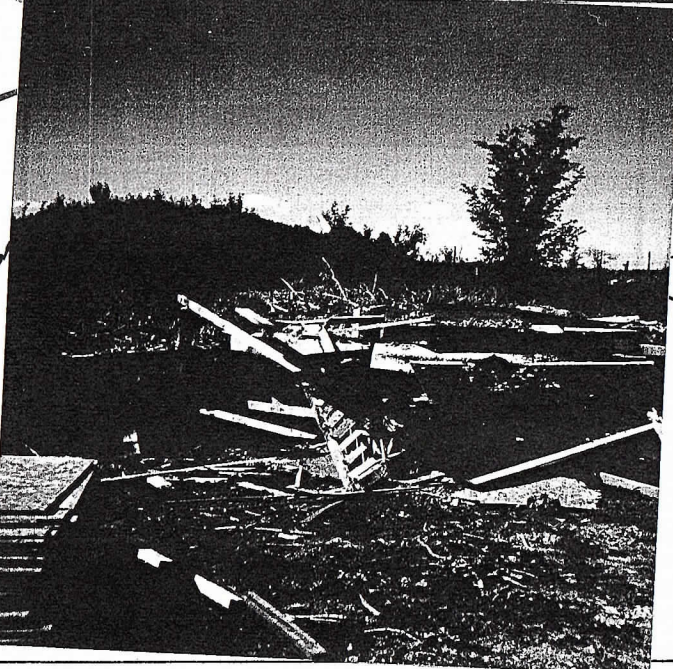
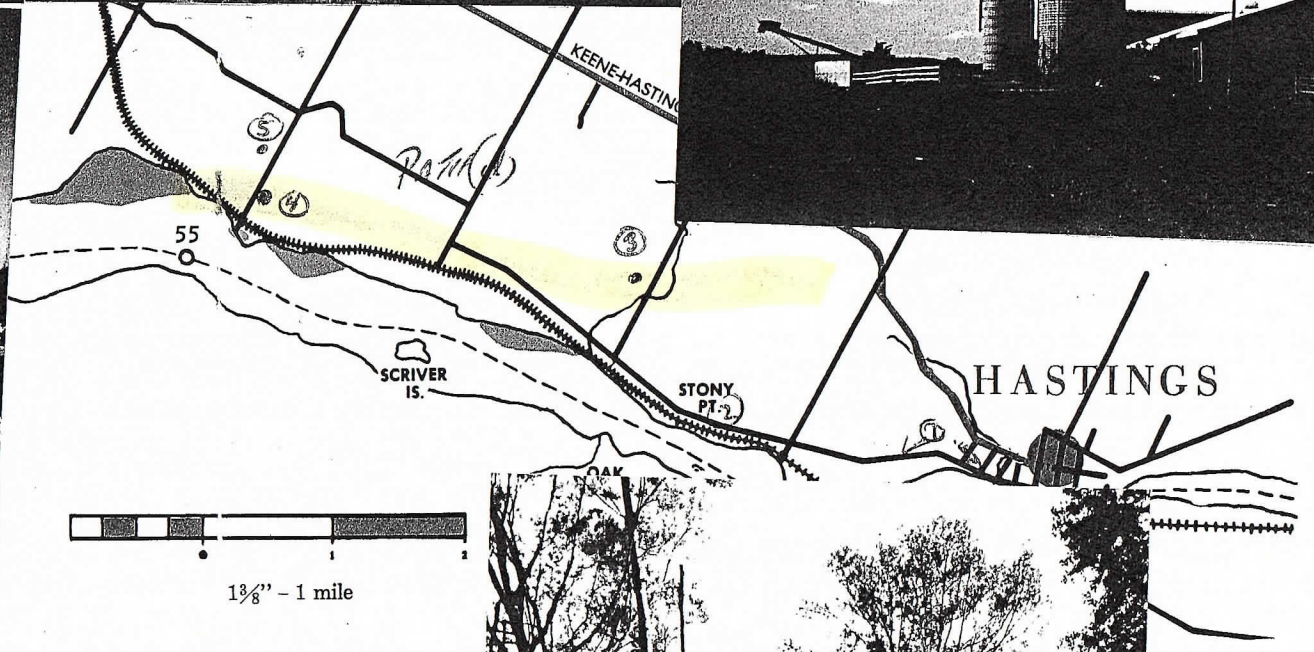
#4
Cabin Flattened

~ 6:30 pm
11 km track.
