**Confirmed Tornado
Franktown, Ontario
May 16, 2000**

Tornado F-Scale Assessment

Explanation of Assessment: Old barn of questionable construction blown down.
Siding and steel roofing blown around.

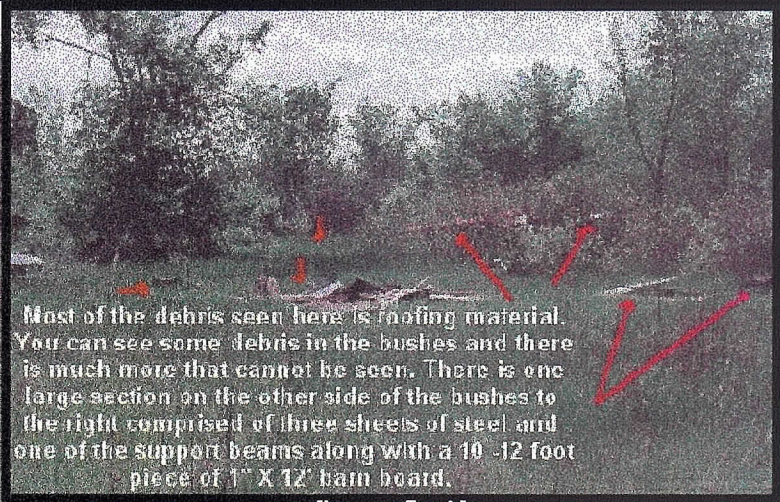
figure2.gif

As you can see here, some of the steel roofing was bent around the bushes. From this vantage point, directly behind this bush approx. 30' is more of the roofing material as stated in figure2.
