**Confirmed Tornado  
Elmvale, Ontario  
June 2, 1998**

## **Tornado F-Scale Re-Assessment**

## Rough Summary of Damage in the Elmvale Area

# F2 Tornado in Elmvale, Ontario on June 2<sup>nd</sup>, 1998

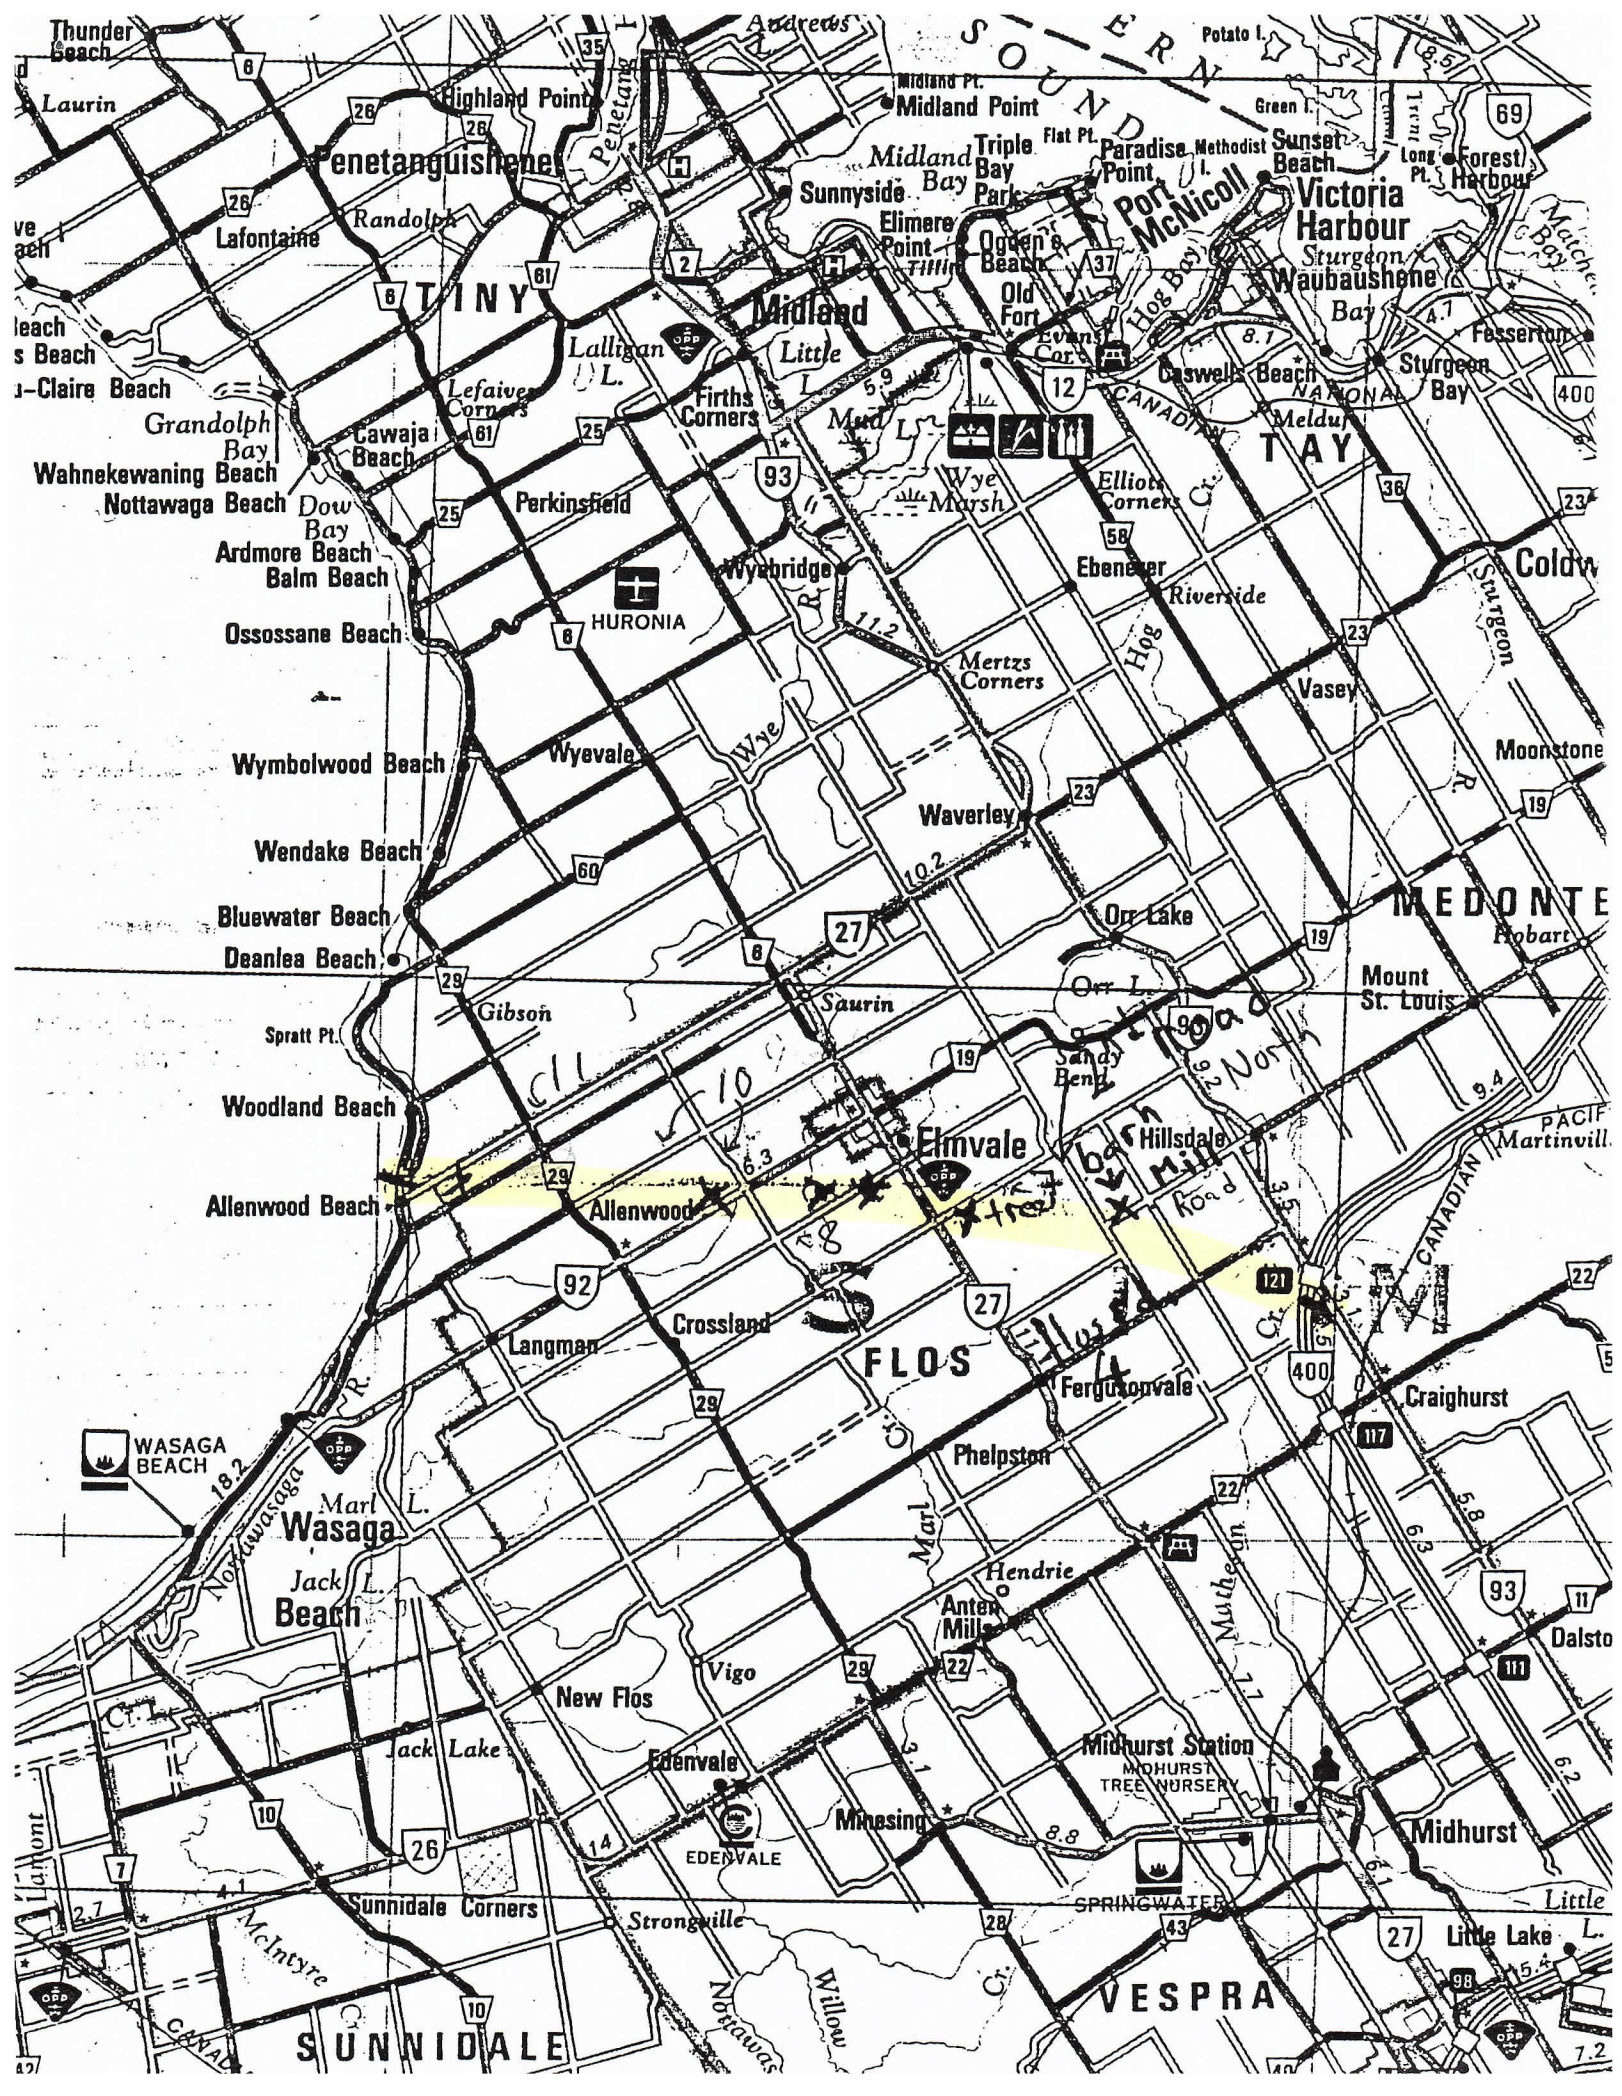
- (FO-FI) • The most major damage was to the "leg" of the silo which is some sort of loading/unloading mechanism. The steel structure was about 40-50 ft tall and was knocked to the ground and bent in the middle. It was a new structure being added only 3 months prior to the storm. The 3/4" stainless steel bolts that attached the leg to the silo were sheared right off.

- Just across from the silo (40-50 ft away) that was damaged an older silo and loading mechanism were left untouched.
- A fully loaded 15x30 ft chemical storage building was moved 10-12" off its concrete slab.

- F1  
(F3?)  
Dave... • Two 5 ton manure spreaders were tossed 200-300m into a wheat field with one of them sustaining substantial damage.
- FC • One the other side of the CO-OP building the guide wire from the hydro poles snapped although the poles were left standing. The hydro lines had grass hanging in them and there was lots of debris from trees that were at the other side of the field to the west.

- FO • In the front yard of home there were a group of trees that were down.
- FO • The largest of the trees had a 3ft diameter trunk and the tree was literally shredded although the inside of the tree was rotted.
- There was debris from the damaged trees lodged in the branches of those trees that were left untouched. The largest of these was a 5" limb that was found in a tree about

- We found more trees uprooted and some insulation caught in the wire fencing that maybe blew from the CO-OP when the roof was damaged.

- P0* • We found more trees down in this area.
- P1* • Two large trees with 10-12" trunks were snapped right off 15-20 feet above the ground
