**Confirmed Tornado  
Gads Hill, Ontario  
May 22, 2004**

## **Tornado F-Scale Assessment**

# Storm Damage Survey - 22 May 2004

## - Gads Hill/Seabringville Area -

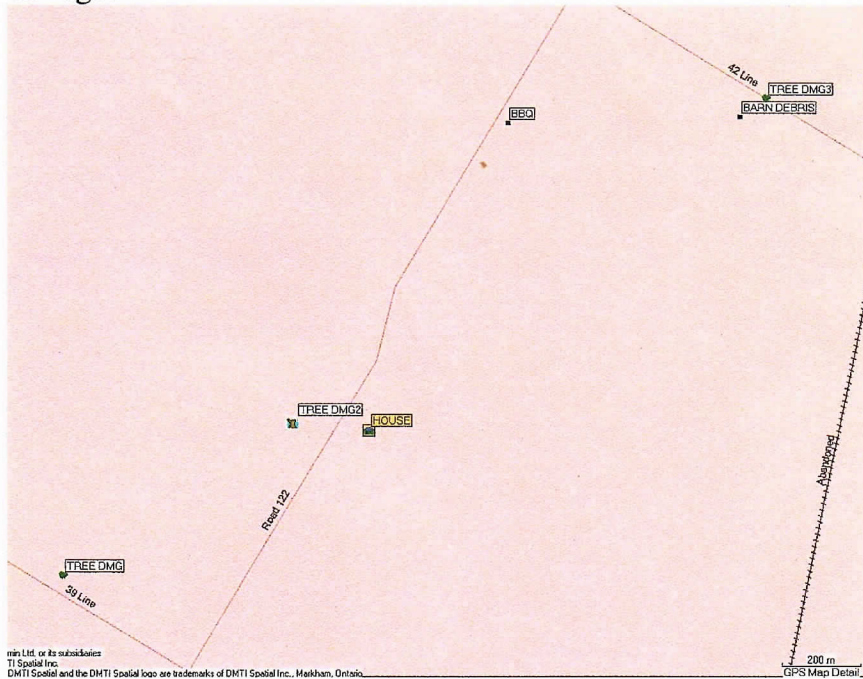
When we arrived on scene the next day, it was obvious that the property had been severely damaged the previous night by a tornado. The 2-story house was mostly 2 bricks thick and in some places had walls that were 3 bricks thick. The back room which was completely gone had only been 1 brick thick. Many of the trees that lined the driveways were either snapped off or stripped of leaves and bark. The barn walls and roof were completely gone with only pieces found strewn across properties that lay to the NE. The only part of the barn still there was the thick cement foundation. In front of the barn had stood two identical silos. Both silos had their tops removed which were never identified in all the crumbled debris and one silo was significantly shorter (by about 3-5m) than the other. To the SE of the barn was a farm shed which had numerous punctures in it as a result of projectiles. The drive shed located directly behind the house was no longer there. A BBQ that had been in the shed was picked up and carried almost 1km away and dropped back down in a neighbour's field in near perfect condition. Also in front of the shed had been a 1/2 tonne truck which was picked up and moved 10-15m away. The truck had large dents in it and had the driver's window smashed in with debris now lying inside the truck. The house itself had significant damage done to the back. Many of the windows on the house were broken and the roof was ripped off. At the back, one of the rooms was gone on the ground floor (1-brick thick walls only). On the NE side of the

house, a large hole was made in the 2nd story wall. Here, the walls were at least 2 bricks thick and in some places 3 bricks thick. The damage was mainly concentrated on this property. The remainder of the damage was done to trees in the country-side between Gads Hill and Seabringville as there were no other houses or barns in the tornado path. The following is a map of the general area where the tornado went through. Clicking on certain areas will take you to a more detailed section including photos and text regarding damage.

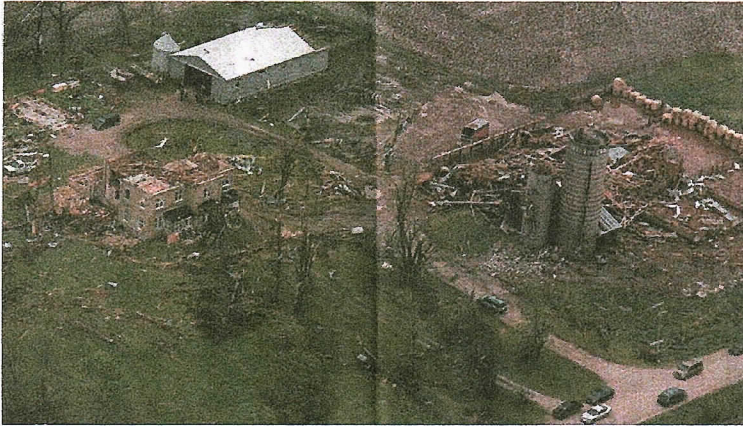
### **Damage to the Property along County Road 122 between 39 Line and 42 Line**

The following is an aerial shot of the damaged property. This section can be navigated by scrolling through the images or by clicking on specific locations on this image will take you to a close up of photos taken on the ground along with descriptions.

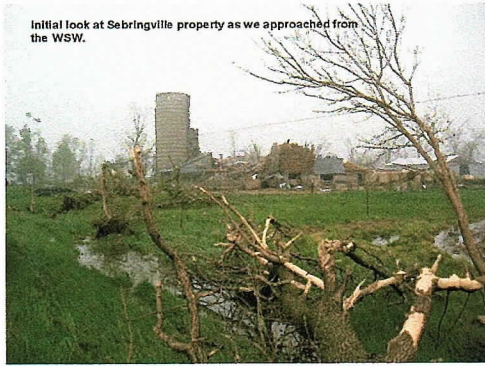
Looking E at uprooted tree, powerlines toppled, destroyed barn, partially destroyed shed roof.

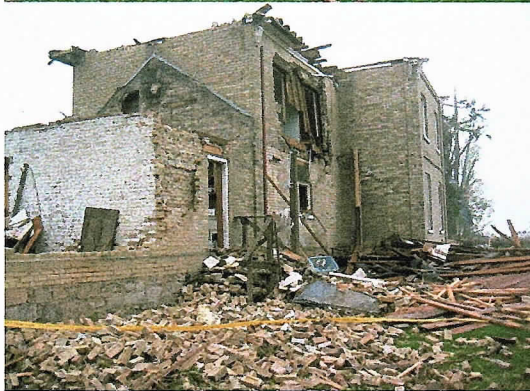
The rear (Northeast side) of the house received the worst damage. The windows are blown out. Large portions of brick wall have been torn away. One room at the back of the house has been completely destroyed. This was an addition and was single brick.

Looking W at the rear of the house where a portion of the 2nd floor triple bricked wall has been destroyed. The back of the house which was completely destroyed was old single brick. Large tree also uprooted.
