Probable Tornado Echo Bay / Laird Township, Ontario June 6, 2008

Tornado F-Scale Assessment

OSPC Storm Damage Survey Report

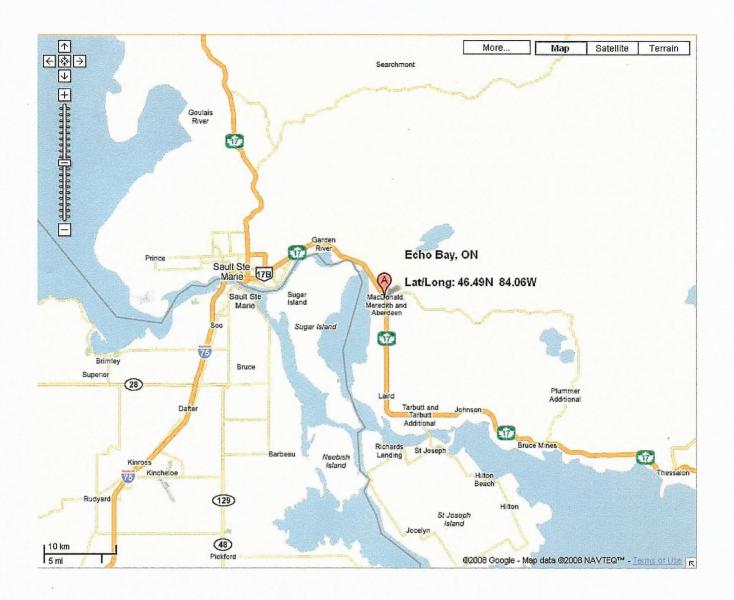
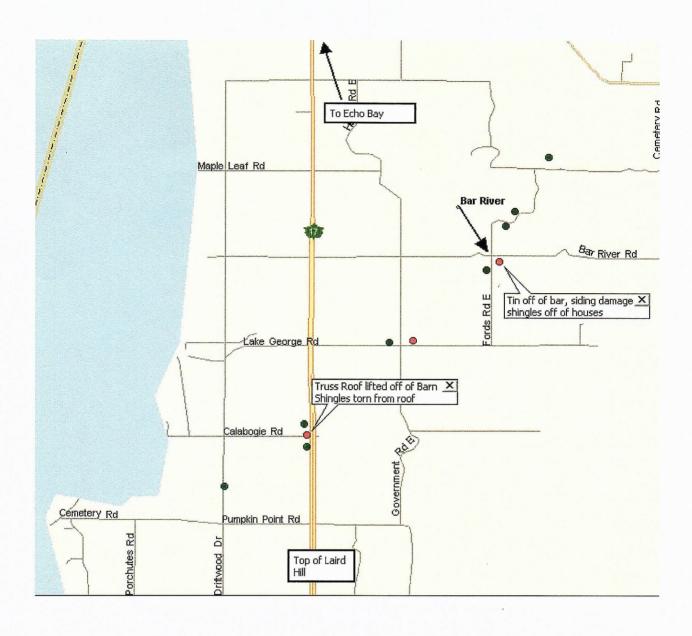
Important notes from this isolated storm:

- Hail size reported to be ~ 2.5 inches in diameter, both reported by Vic Fremlin and the Sault newspaper.
 - (http://www.saultstar.com/ArticleDisplay.aspx?e=1064372&auth=Corina+Milic or http://www.sootoday.com/content/news/full_story.asp?StoryNumber=32576)
- Tom Fremlin (Vic's brother) took picture(s), but I could not get a hold of him. Vic can be reached at 705-256-0496 and Tom can be reached at 705-255-0885
- Evidence of F0 damage from photos; however, since a roof was torn off it is possible that this was F1 damage.
- Trees were down on the property of Vic Fremlin, plus damage to equipment and the building.
