**Confirmed Tornado  
Leamington, Ontario  
June 25, 2009**

## **Tornado F-Scale Assessment**

# OSPC Storm Damage Survey Report

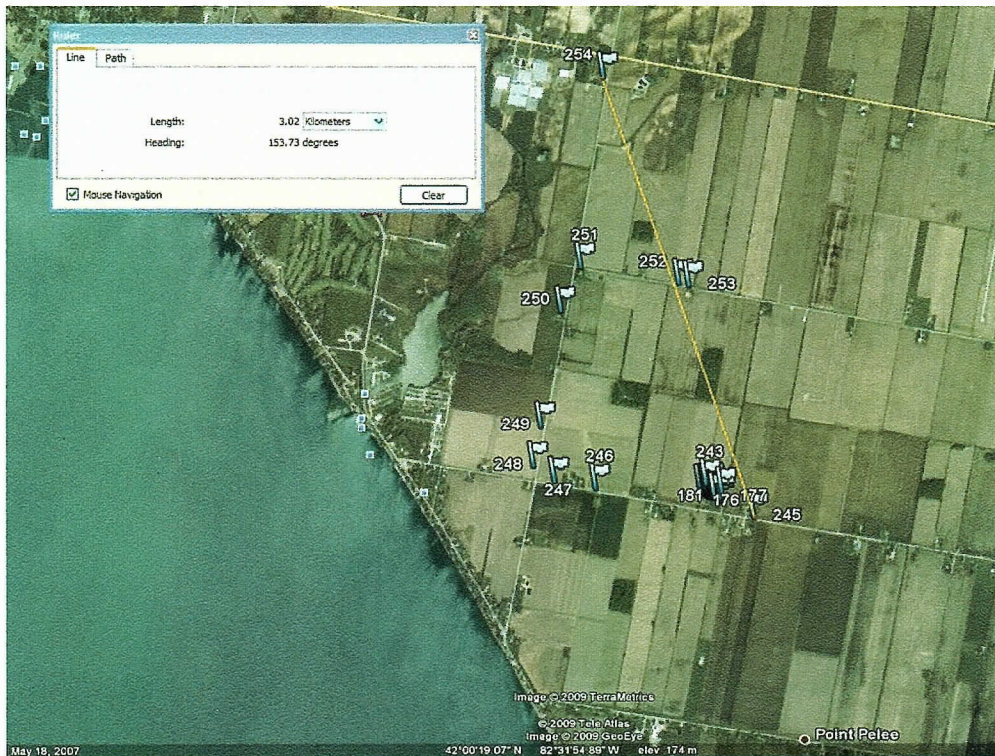
Locations of Damage found in Leamington area, June 26, 2009

Distance from NW-most to SE-most damage is 3.02km according to Google Earth
