## Full-Scale Tests of a Wood-Frame Structure under Extreme Wind Loads

# Full-Scale Tests of a Wood-Frame Structure under Extreme Wind Loads

## **Abstract**

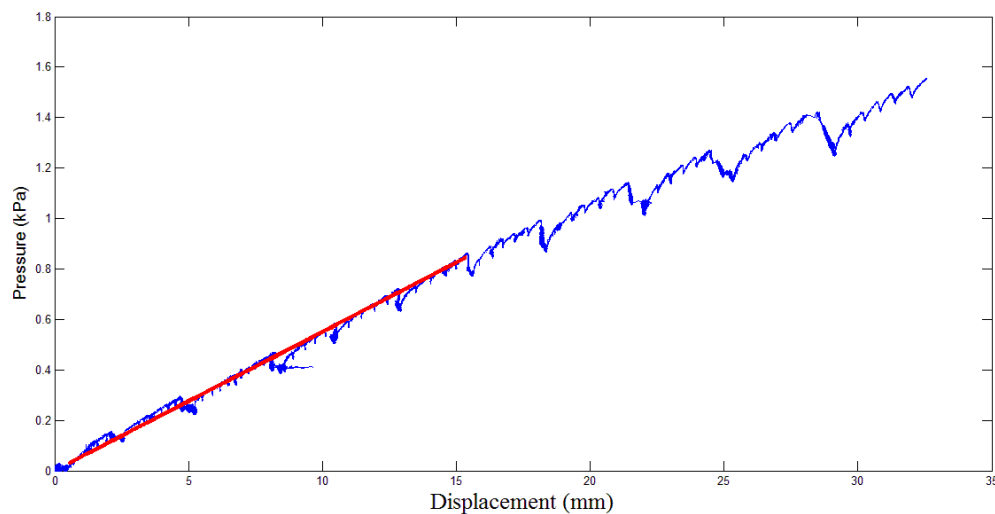
The load-displacement curve for this wall is relatively linear up to an applied pressure of about 0.8kPa. This is shown in Figure 4.5, which shows the pressure-displacement curve for an LVDT located at the top of the wall, about 160mm from the corner located at A1 towards B1. It is noted that this failure load is the same as was observed for the first failure of the full house with the brick attached (along wall A10 – J10, as discussed in the previous section). However, when wall A1-D1 failed, there was negligible damage at the current location, indicating that the brick veneer has a substantial effect and that the first failure would have occurred at a much

**Figure 4.5 - Load Displacement curve for the wall A1-D1.**

lower load had the house been without brick veneer for the first full house test. It is also emphasized that the two walls have different factors which affect the performance including the unsupported lengths, number and location of openings, and number of interior walls connecting to the external wall. Dolan and Heine (1997a, 1997b) and Doudak et al. (2006) found that these differences significantly affect wall strength.

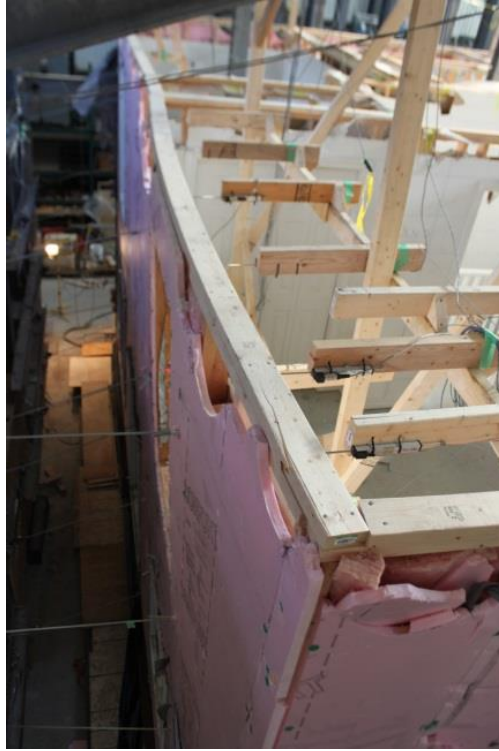
The wall below would have influenced the rotational behaviour, but a full 3-dimensional analysis was outside the scope of this thesis. Rotation of the lower member of the top plate relative to the upper member of the top plate is easily visible in Figure 6.7, just to the left of the point where the interior wall enters from the top of the image. In the background (D1) of Figure 6.7, it can be seen how the rotation of the top plate is effecting the overall displacement of the wall, by allowing a much higher maximum displacement. The difference in deflection which could be affected by more rotational resistance depends on how much fixity is added. If one end of a wall span is built to resist rotation, the maximum deflection under the same load will be

**Figure 6.7 – Exterior wall looking from A1 – foreground and D1 – background.**

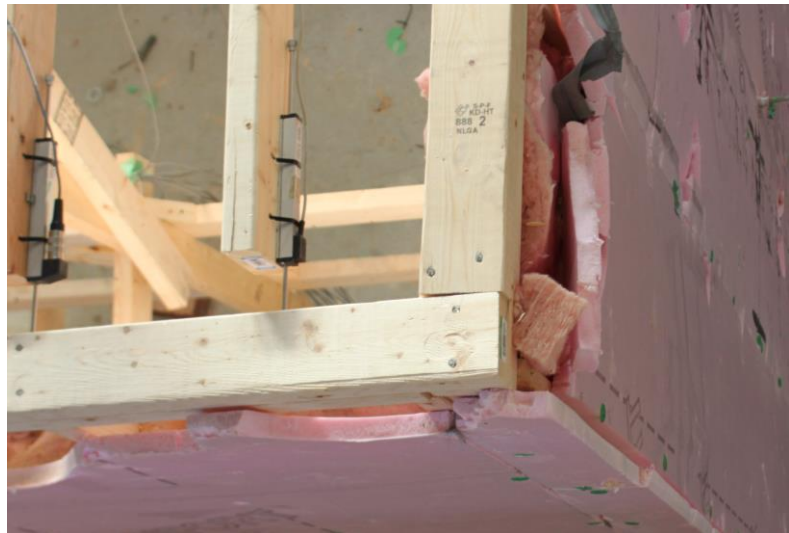
In the tests without brick veneer, the corner was visibly opening (shown in Figure 7.1), which was not observed in the full house tests with brick veneer. Figure 7.2 shows a sketch of how the opening angle was obtained from the wall displacement data. The applied torque on opening angle were calculated using equations 7.1 and 7.2 The total opening angle at the corner was calculated for the test with no brick veneer, as shown in Figure 7.3.

Figure 7.1a - The corner located at A1 with no brick before loading.
