Damage in Non-Crimp Fabric carbon fiber reinforced epoxy composites under various mechanical loading conditions

A thesis submitted in partial fulfillment of the requirements for the Doctor of Philosophy degree in Mechanical and Materials Engineering

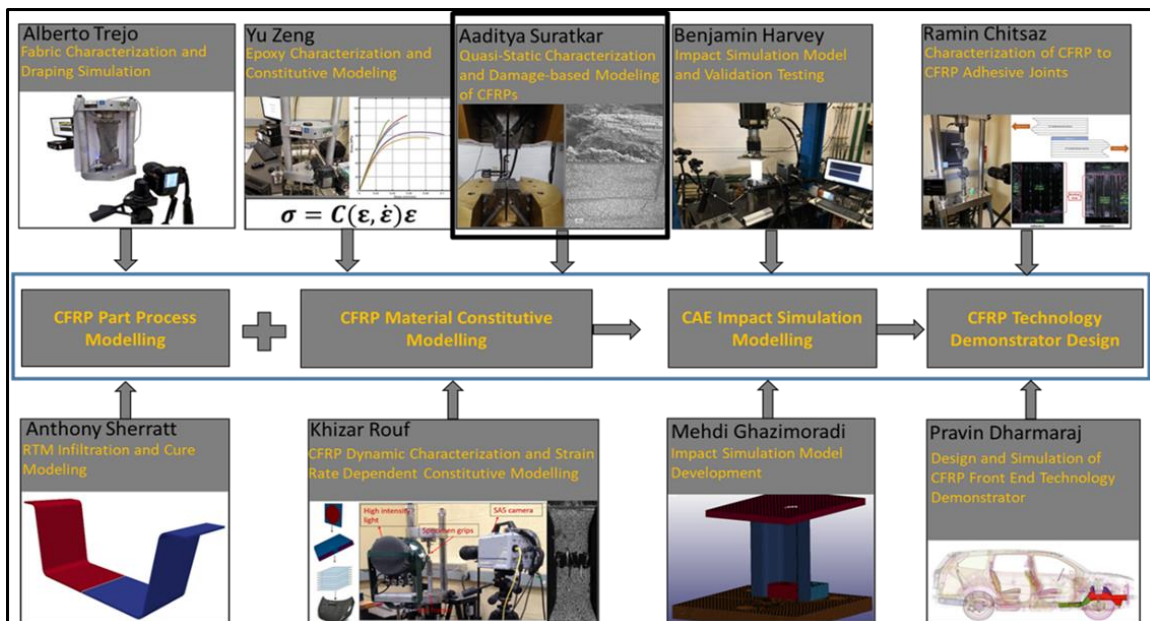
Figure 1: Project task-flow

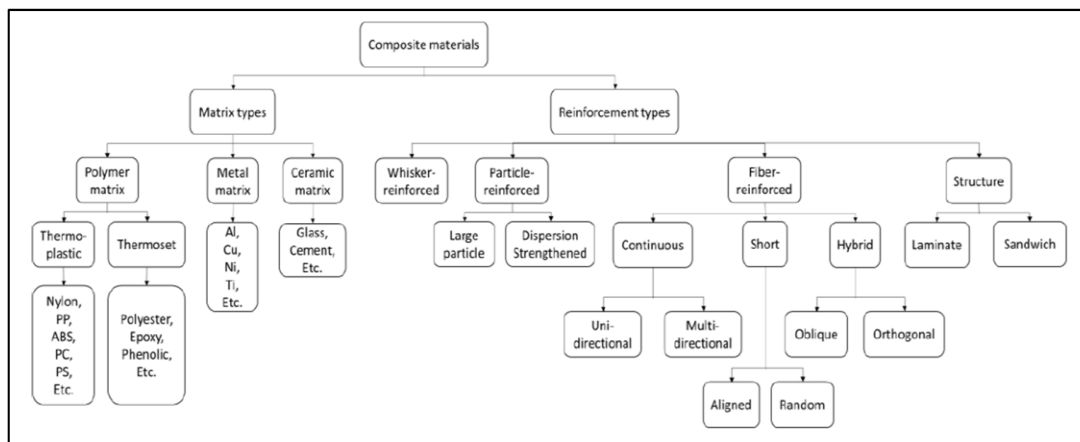
Figure 2: Classification of composites (Yang, 2019)

Composite materials can broadly be classified as shown in Figure 2 based on the type of matrix and reinforcement materials (Yang, 2019). The materials can be classified by the chemical nature of matrix material, i.e. by if the matrix is either a polymer, metal or a ceramic. The composites are broadly classified further depending on the geometry (if the reinforcing phase is primarily fibers, particles, etc.), size (length of the fibers, diameter of particles, etc.) and arrangement (if the fibers are randomly dispersed, if the reinforcing phase is present as a stack of aligned continuous fibers, etc.) of the reinforcing phase. Although the broad classification in Figure 2 encompasses a wide range of materials, the discussion in this study would be focused on “continuous fiber reinforced polymer composites”.

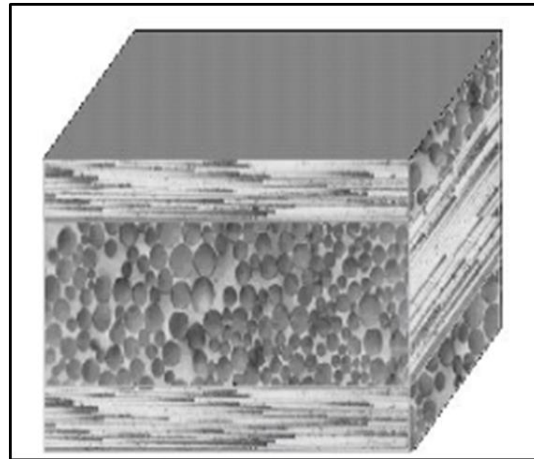
Figure 3: Structure of a unidirectional prepreg composite (Mattson, 2005)

Unidirectional (UD) prepreg composites are multiple layers of thin sheets, comprising of fibers aligned in a single direction, stacked in desired orientations (Figure 3). The thin sheets, the prepregs, are made of fibers pre-impregnated into partially cured resin material. A prepreg sheet is formed by passing uniformly spaced fibers through a resin melt of a controlled viscosity, which is then partially cured by applying heat. The sheets may then be stored for a certain length of time, varying from days to months, depending on the curing characteristics of the resins and storing conditions. Some polymer materials may continue to cure at room temperature, which severely shortens their shelf lives. The shelf lives of prepreg sheets may be increased by storing them at low temperatures, which increases the overall cost of materials. Composite parts are formed from the prepreg sheets by stacking the sheets in desired orientations. The stack is subjected to vacuum to remove air bubbles and then placed in an autoclave to complete the curing process (Vallons, 2009).

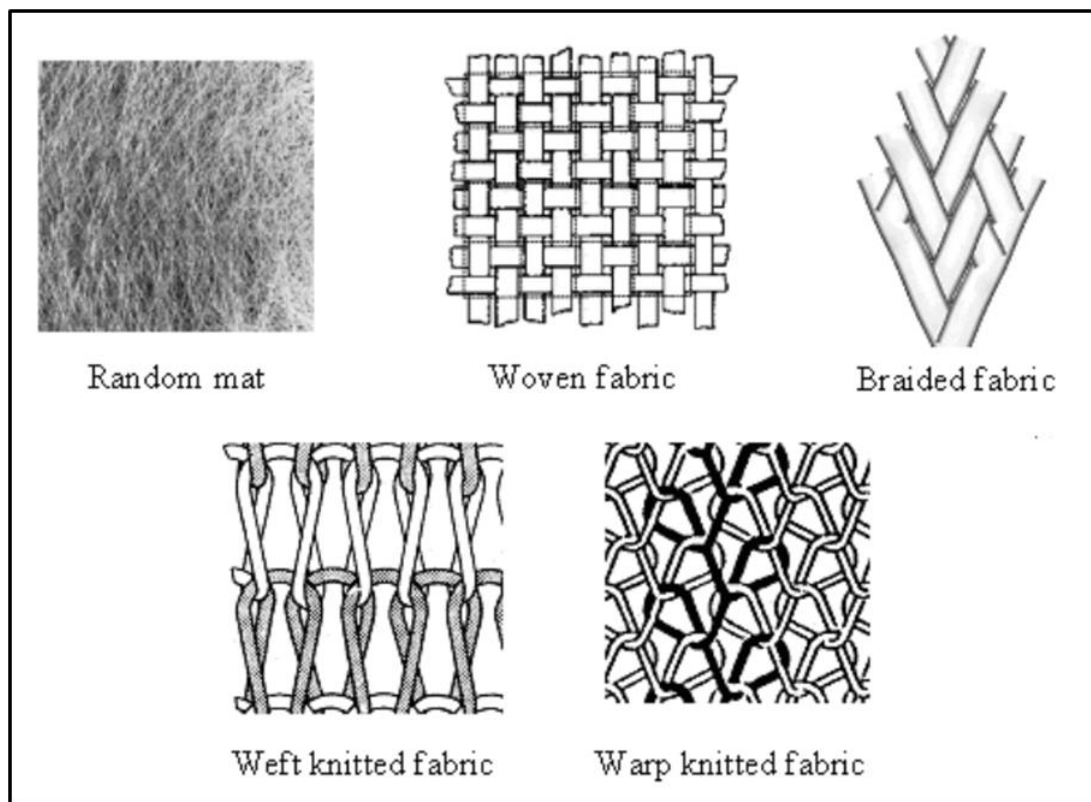
Figure 4: Examples of textile reinforcement architectures (Vallons, 2009)

The disadvantages associated with unidirectional prepreg composites such as constraints with prepreg shelf life, higher handling cost, etc. could be overcome to a certain degree by the use of textile blankets. The woven textiles are blankets of interlocked fiber bundles or yarns. Some examples of woven reinforcement architectures are shown in Figure 4. The interlocked fibers may be randomly oriented in the plane of fabric, perpendicular to each other or at other angles. As the textile blankets are dry almost till the point of being placed in the mold, they do not have shelf-life limitations, are cheaper to store and are easier to handle than unidirectional prepreg sheets. Furthermore, they offer better draping abilities and higher damage tolerance.

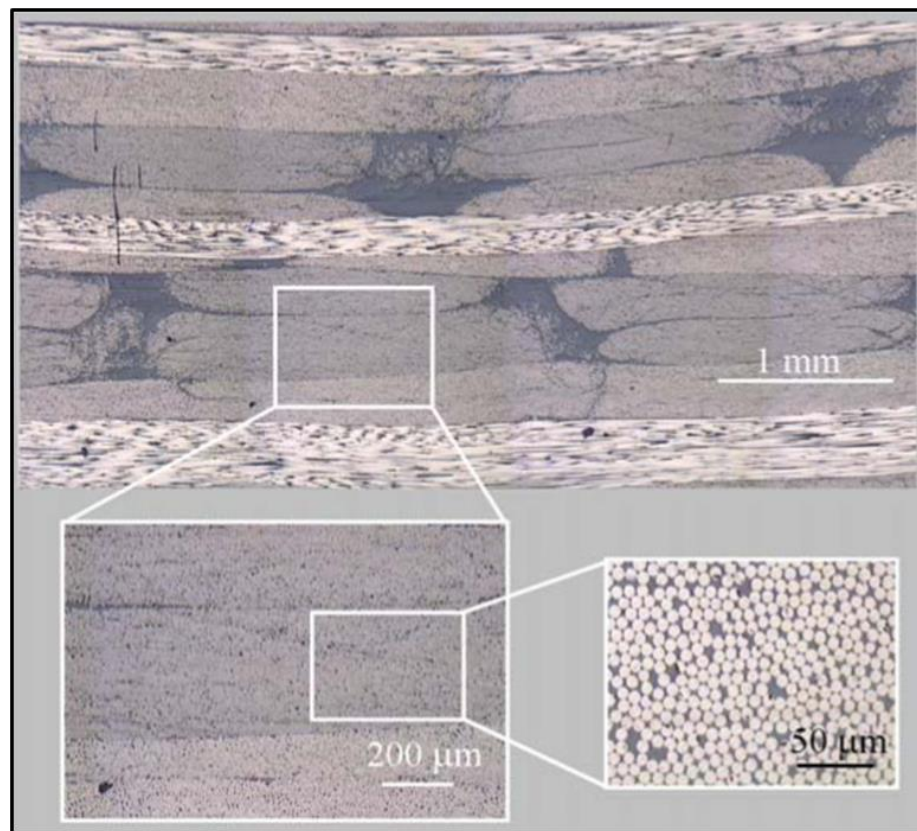
Figure 5: Macro-, meso- and micro-structure of NCF composites (Mattson, 2005)

NCF composites are inherently multi-scale materials (Figure 5). At the microscale, NCF composites may be described as unidirectional materials with a certain fiber volume fraction. The distinguishing characteristics of NCF composites are, however, the properties of bundles at mesoscale such as the fiber volume content in the bundle and the localized waviness of bundles. The waviness in the bundles may be introduced by either manufacturing parameters or the stitching threads used to knit the fiber bundles into fabric. The stitching threads push the bundles (and the adjacent fabrics) apart creating resin-rich areas in the materials, creating local weak spots.

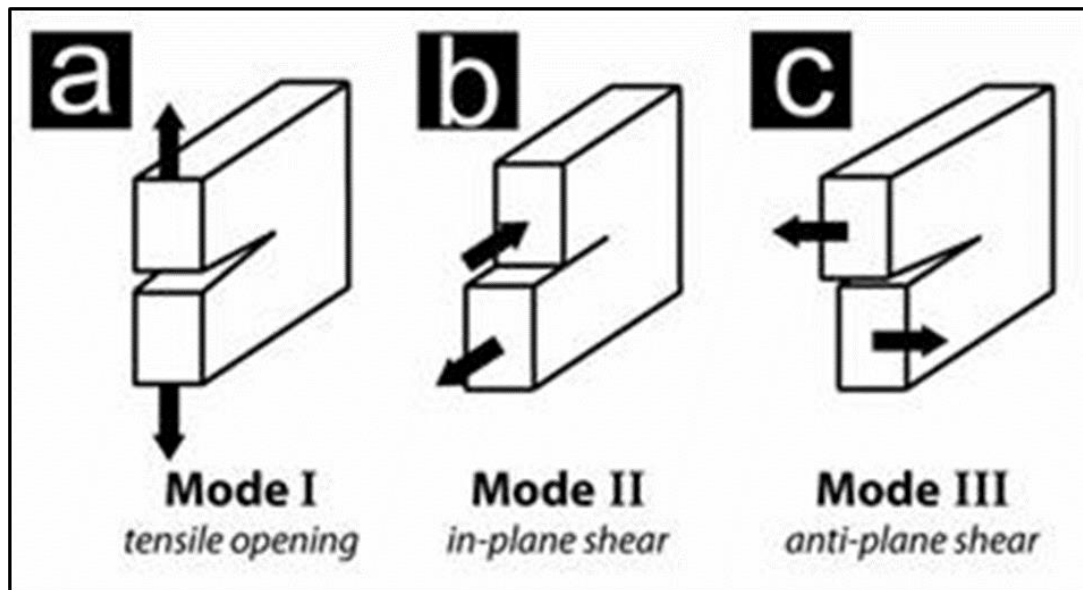
Figure 6: Primary loading modes (Zimmermann, Launey, & Ritchie, 2022)

Damage initiates and propagates in materials under three primary loading modes (Figure 6). Depending on the orientation of the crack relative to the loading direction, the crack or flaw may either be subjected to a tensile stress opening up the cracks ('Mode-I') or a shear stress caused by sliding of the cracks parallel to primary crack orientation ('Mode-II'). The crack may also slide perpendicular to their orientation ('Mode-III'). Being loaded in either of the above modes (or mixtures thereof) leads to stress concentrations around defects in the materials, such as voids. The pioneering researchers in the field developed mathematical expressions to explain this stress concentration and its effect on the propagation of flaw. This approach towards description of damage is called as a 'stress intensity' approach. Although the stress intensity approach is useful in engineering practices, an alternative 'energy based' approach was developed by another group of researchers, which was based on energy-balance arguments. Both the approaches are discussed in detail in subsequent sections.

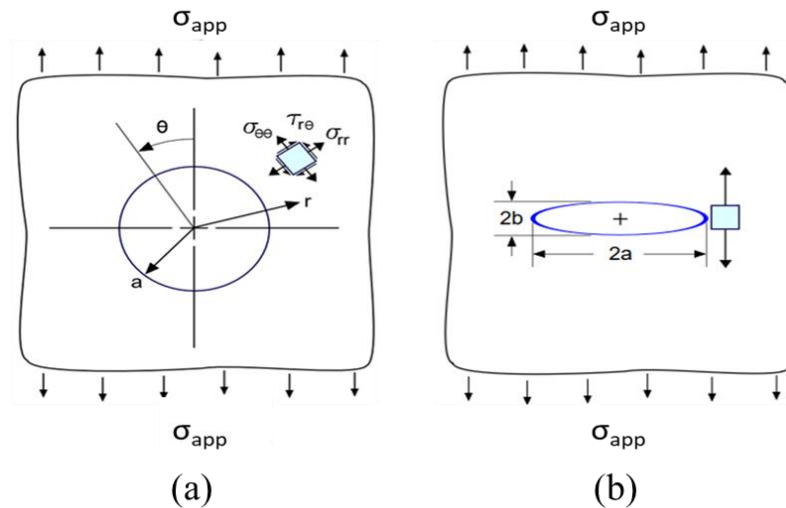
Figure 7: (a) Kirsch's solution (Stress Concentrations at Holes, 2022) (b) Inglis's solution (Stresses At Elliptical Holes, 2022)

The stress concentrations were first mathematically expressed by the scientist named Ernst Kirsch (Stress Concentrations at Holes, 2022). Kirsch considered a circular hole in an infinite plate (Figure 7.a.), subjected to uniaxial tension, in his analysis. He developed equations describing the stress state around the hole as a function of applied stress (σ_{app}), radius of hole (a) and distance from hole (r) in polar co-ordinate system. The equations (Equation 1.1-1.3) derived by Kirsch are mentioned in Appendix 1. According to Kirsch's equations, the stress at the edge of hole (i.e., when $r = a$) was three times higher than the applied stress for isotropic materials. The factor of three, though, was independent of the radius of the hole. This was a counter-intuitive result, as in physical realm, it would mean that a small hole would cause as much stress concentration as a large hole. This presented inherent limitations while extending the result to elliptical cracks which had a larger width but smaller height.

The major step, overcoming the limitation in Kirsch's solution, was taken by Inglis (Inglis, 1913). Inglis' approach considered the flaw to be of an elliptical shape in an infinite plate. Hence, by varying the aspect ratio of ellipse, multiple scenarios could be considered. Inglis's mathematical description (Equation 1.4) can be found in Appendix 1. If the major axis dimension is set equal to minor axis dimension, Inglis's solution decomposes to Kirsch's solution. However, by the mathematical equation, if the minor axis ($2b$, as marked in Figure 7.b.) approached zero, the stress at the crack tip would be infinite. This was qualitatively invalid, as it would mean that the structure would fail at the slightest of the applied loads.

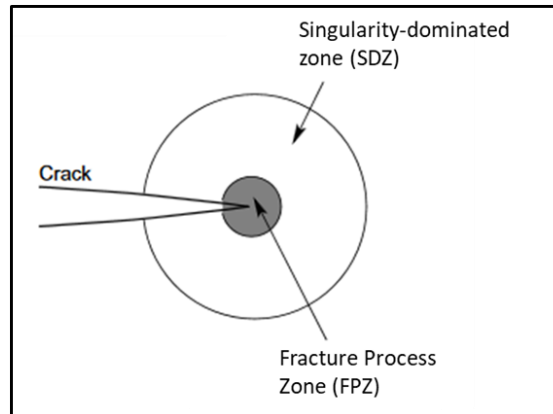
Figure 8: Fracture Process Zone and Singularity Dominated Zone near crack tip
(The Elastic Stress Field around a Crack Tip, 2022)

As was discussed in Section 2.2.2.1, Irwin represented the stress intensity parameter by inverse square root singular stresses at the crack tip. Irwin expressed his criterion as: $K_{@failure} = K_c$ (Sanford, 2003, The Elastic Stress Field around a Crack Tip). In words, a material body will fail in a brittle fashion when the stress state in the immediate vicinity of the crack tip exceeds a critical value. Irwin defined a singularity stress dominated zone (SDZ) around the crack tip and the area in the immediate vicinity as fracture process zone (FPZ), and FPZ is completely enclosed by SDZ (Figure 8). The $K_{@failure}$ is the applied K, depending on the applied stress and flaw length. The K_c is called 'critical stress intensity factor' and is a material property (measured under plane strain conditions). As will be discussed later in Section 2.2.2.3, non-linear material behavior occur in FPZ, which the criterion ignores. For the criterion to be valid, the FPZ must be sufficiently small (The Elastic Stress Field around a Crack Tip, 2022).

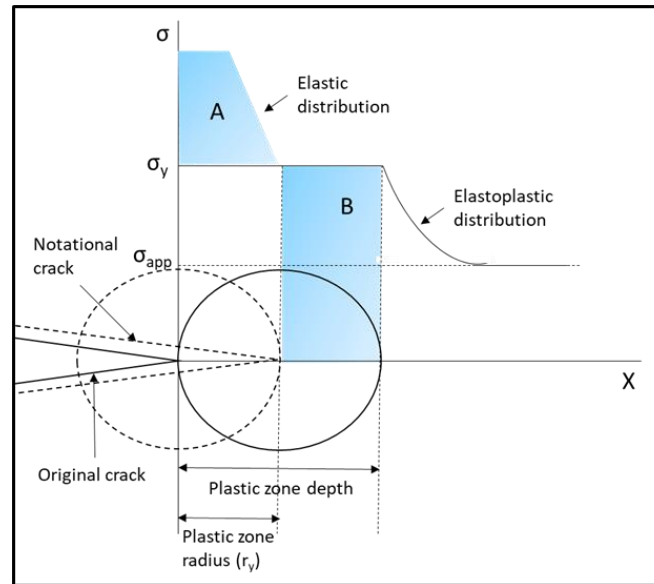
Figure 9: Elasto-plastic distribution for Mode-I loading

The key results suggest that the stress cannot exceed the yield stress near crack tip. Hence as the stress exceeds the yield stress, the stress gets redistributed in front of the crack tip as local plastic deformation. With reference to Figure 9, the physical manifestation of this localized plastic deformation is that the stress distribution (shaded region, labelled as A) gets distributed by an equal amount as the plastic zone (r_y) to the left to give the depth of plastic zone (shaded region, labelled as B), hence restoring equilibrium. Assuming that

the FPZ is completely enclosed within SDZ, the crack length (a), is replaced by an effective notational crack length ($a+r_y$). The stress distribution and elasto-plastic characteristics are still governed by stress intensity factor (Sanford, 2003, Roylance, 2001).

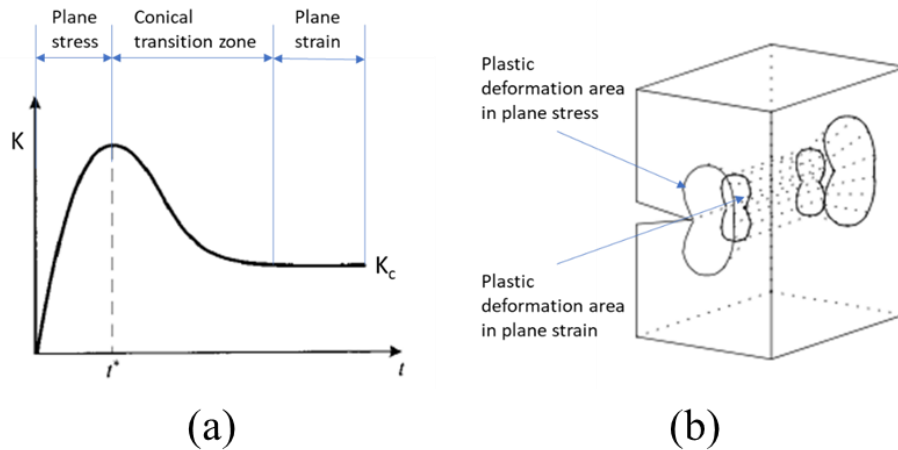
Figure 10: (a) Influence of thickness on critical stress intensity factor (Roylance, 2001) (b) Conical transition from plane stress to plane strain (Schreurs, 2012)

due to the constraint imposed by adjacent material, setting up a high tri-axial constraint (The surfaces would still be free to contract and hence be in plane stress). The transition, resembling a cone, is shown in Figure 10.b. This constraint reduces the drive towards plastic flow, making energy available for a brittle fracture. For K_c to be a material property, it is important to maintain the material in a state of plane strain, as it does not change with increase or decrease in thickness.

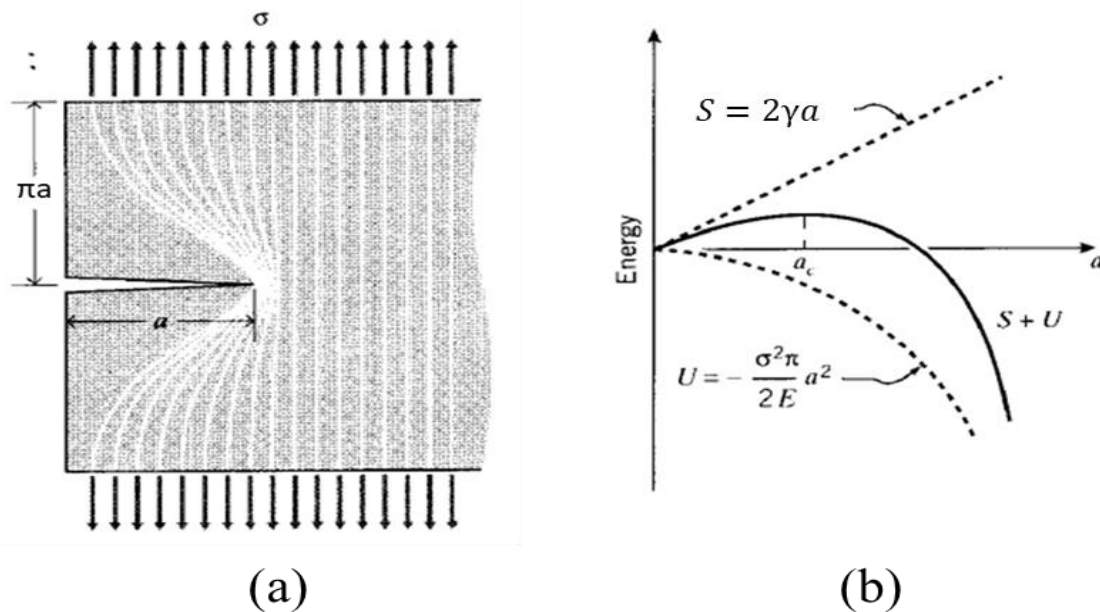
Figure 11: (a) Released strain energy adjacent to the crack (Roylance, 2001) (b) Energy balance (Roylance, 2001)

Following from the above assumptions, Griffith employed an energy balance approach (Roylance, 2001, Sanford, 2003). When a crack grows by distance 'a', the strain energy of the material adjacent to the crack is released. The now-unloaded material was idealized as triangular flanks (Figure 11.a). This released strain energy (U) was calculated as a product of strain energy per unit volume (assuming linear behavior) and volume of unloaded material (V), as in Equation 2. However, for the crack to propagate, the material must cleave. This implies that the liberated energy must be absorbed by the material to break the bonds and create new surfaces (Equation 3), where γ is the surface energy (J/m^2) and a factor of 2 is needed since two surfaces are formed. The energy balance is expressed in Equation 4. As long as the liberated energy exceeds surface energy, the crack will continue propagating ahead.

As can be seen in equation 3 and Figure 11.b., over a certain threshold value of crack length (a_c), the strain energy liberated will be much higher than the absorbed surface energy. A fast fracture will then ensue. The stress at which the fast fracture (σ_f) will occur can be determined by setting the first differential of equation 3 to zero (Equation 5). Equation 5 is valid for a plane stress state. Plane strain requires consideration to the resistance to the contraction, and hence inclusion of the $(1-\nu^2)$ term, as in equation 6. Further, it is important to note that increase in crack length is an absolute term and independent of the body it is contained in. The strain energy released is proportional to the increment in crack length. It is also the reason why smaller bodies tend to be stronger, they are too small to contain the critical crack length.

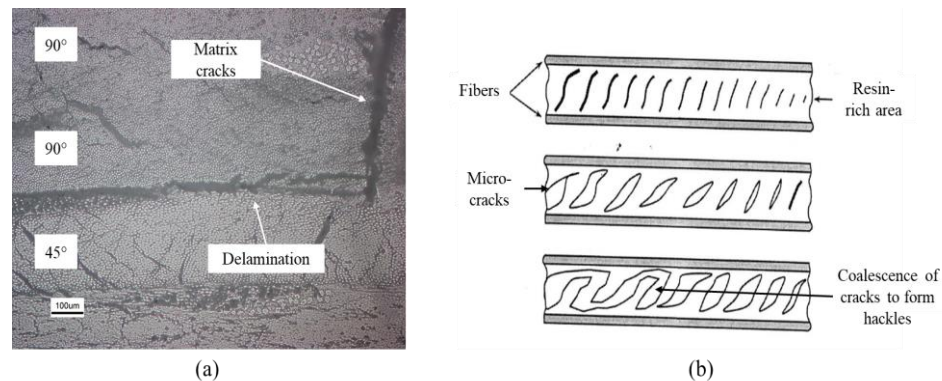
Figure 12: (a) Matrix cracks and delamination in continuous fiber reinforced carbon fiber epoxy composites (b) Process of hackle formation in composites (Bruce, 2011)

Damage in the matrix is often observed at even low levels of loading in composites. The matrix material may either crack or plastically deform depending on the chemical nature of the matrix material and loading condition. Matrix cracks in off-axis plies (Figure 12.a.) are often the first forms of primary damage observed in continuous fiber reinforced composites (including NCF composites) under tensile loads, as the matrix is more compliant than the reinforcing fibers. The resin rich regions caused by the presence of stitching sites have been observed to have an effect on the location of cracks in NCF composites (Mikhaluk, Truong, Borovkov, Lomov, & Verpoest, 2008; Truong, Vettori, Lomov, & Verpoest, 2005). A crack in thermoset matrix with a rigid structure typically span the entire width and thickness of the plies with limited plastic deformation. Depending on the geometric parameters of a composite test coupon, energy is absorbed in creation of multiple cracks in the coupon with a thermoset matrix. Thermoplastics, on the other hand, may exhibit higher degree of energy dissipation in plastic deformation. As the materials fail by yielding of the matrix under compressive loads (explained in greater detail later), energy is dissipated in matrix deformation in composites loaded in compression. The extent of plastic deformation in the matrix depends on both, the chemical nature of the matrix (if it is a thermoset or thermoplastic) and also the reinforcement phase. The presence of stiff reinforcing fibers inhibits the free plastic flow of the matrix, constraining the degree of plastic deformation (Hull & Clyne, 1996).

Another critical damage mode responsible for extensive stiffness losses in composites is delamination. A mismatch between the elastic moduli and Poisson's ratios between different layers in a laminate may lead to out-of-plane interlaminar stresses, which lead to delamination cracks (Figure 12.a.), which assume a critical place in the energy absorption characteristics and design of laminates. Delamination may also be formed when the matrix cracks join, causing reductions in strength. The formation of delamination cracks is strongly influenced by geometric effects, defects and phase constitution (Wisnom M.

R., 2012; Kahla, 2019). The contribution of the delamination crack to overall work of fracture depends strongly on the matrix type and loading mode (Bruce, 2011; Greenhalgh E. S., 2009). The failure surface of a brittle thermoset resin is characterized by a smooth surface under Mode-I loads. A Mode-II failure surface of a thermoset, on the other hand, is characterized by ‘hackles’ and multiple secondary cracks through the resin. Hackles are also the primary energy absorbing mechanisms in thermoplastic matrices with suitable constraints on the plastic flow in the matrix. A surface with hackles has a rough, saw-like appearance. Hackles are formed due to coalescence of multiple inclined microcracks ahead of the crack tip (Figure 12.b.). This increases the effective length of delamination and hence, an increased contribution to the work of fracture.

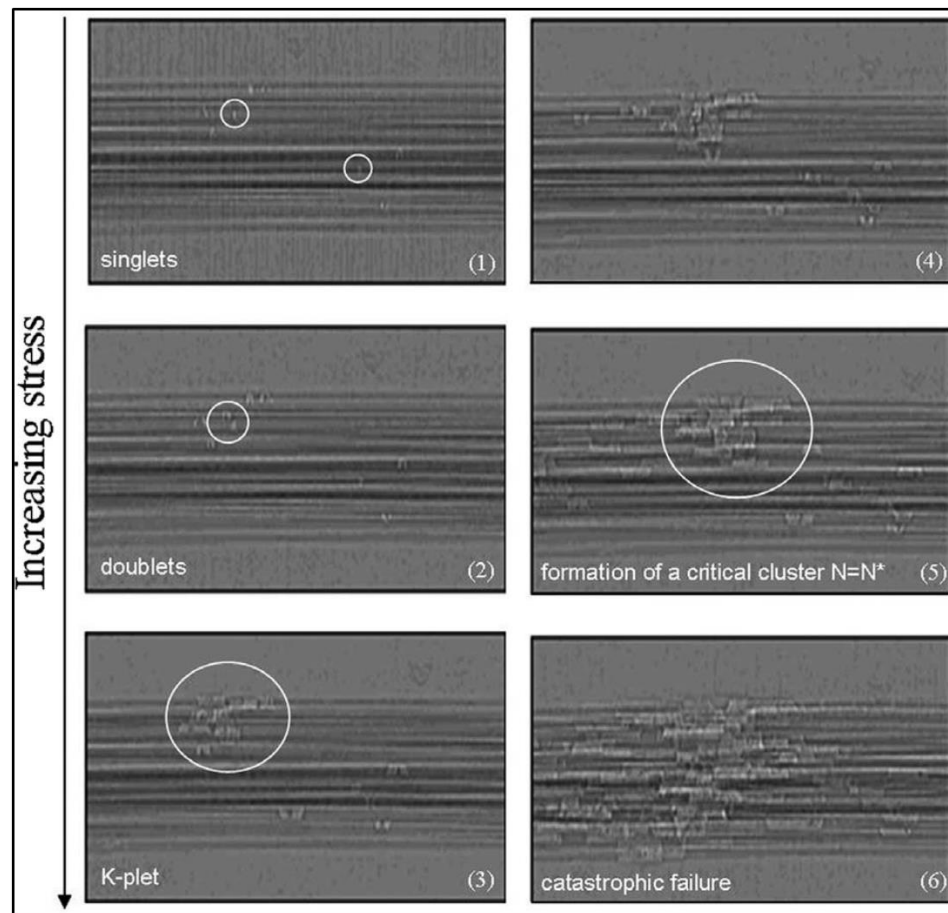
Figure 14: Sequence of events leading to failure in unidirectional composites under axial tensile loads: (1) Single fiber breaks (2-4) Breaks in neighboring fibers (5) Critical cluster of broken fibers (6) Catastrophic failure (Raz-Ben Aroush, et al., 2006)

Failure of the unidirectional composites under axial tension has been the focus of the scientific community for several years owing to the significance of this failure mode on the final catastrophic failure. Observation techniques such as scanning electron microscopy, fractography and high-resolution computed tomography reveal a failure process of localized nature in fiber clusters. Single fiber breaks have been reported at low loads, followed by breakage of neighboring fibers as load increases till the cluster of broken fibers reaches a certain threshold (N^*) close to failure. The formation and unstable growth of this “critical fracture plane” leads to the failure of the composite. The sequence of events is shown in Figure 14.

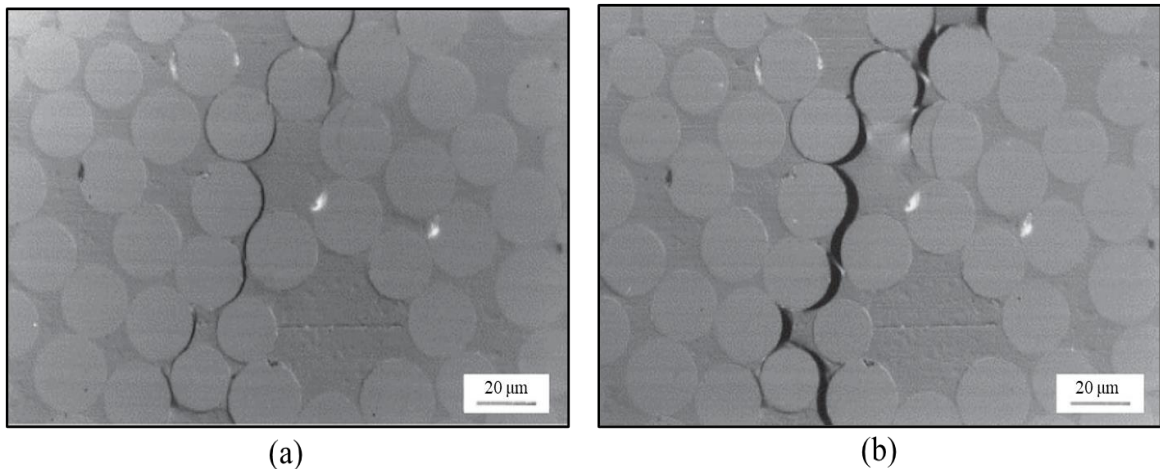
Figure 15: (a) Damage initiation in the form of interface debonds (b) Coalescence of debonds into transverse cracks (adapted from Gamstedt & Sjögren, 1999)

The micro-mechanisms leading to failure in a transverse ply were studied experimentally by Gamstedt et al (Gamstedt & Sjögren, 1999). In-situ microscopy images (Figure 15) revealed damage initiation in the form of fiber-matrix debonding. As the material was further loaded, the debonds coalesced to form a transverse crack.

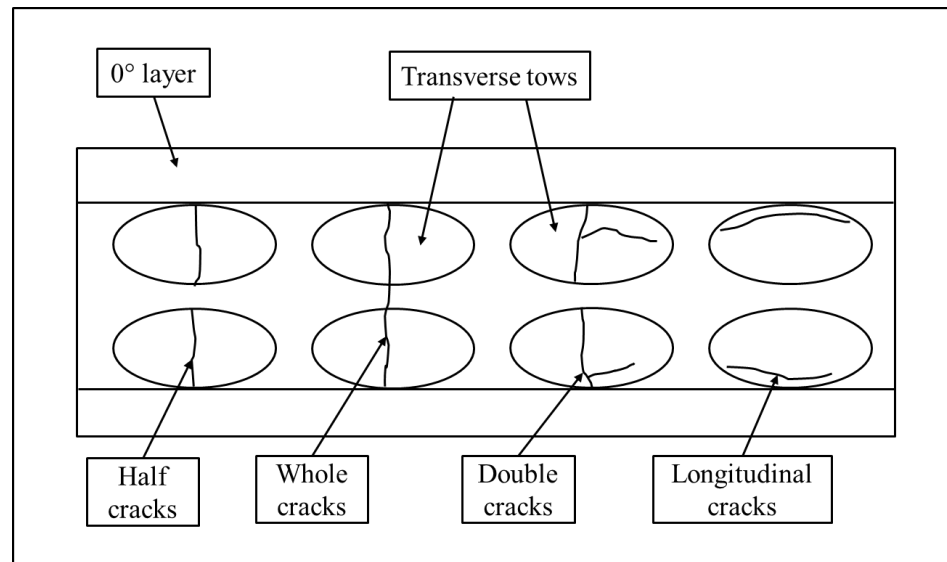
Figure 16: Types of transverse cracks observed in NCF composites under tensile loads (adapted from Edgren, Mattsson, Asp, & Varna, 2004)

Four types of transverse cracks were found to occur in NCF cross-ply laminated composites by Edgren et al (Edgren, Mattsson, Asp, & Varna, 2004), the distinguishing features of which are shown in Figure 16. The “half cracks” were found to occur first. They initiated at strains of about 0.4%, whereas the other types of cracks initiated at strains higher than 0.5%. The cracks extending in the loading direction along the tow boundaries, namely the “longitudinal cracks” and the branches of “double cracks”, are very specific to NCF composites. Finite element studies revealed that the longitudinal cracks occur due to stress concentrations caused by the straightening of the fibers in the adjacent 0° layers.

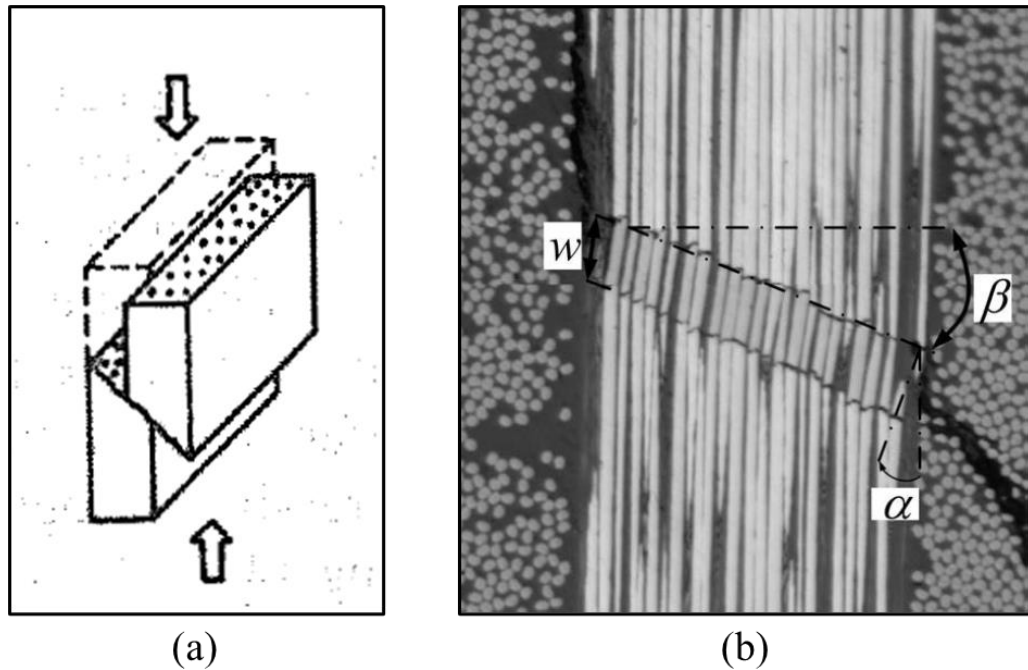
Figure 17: Axial compression failure modes (a) Fiber shear failure (Agarwal, Broutman, & Chandrashekhara, 2015) (b) Typical kink-band geometry (Gutkin, Pinho, Robinson, & Curtis, 2010)

At very low fiber misalignment angles (i.e., less than 2°), the composites fail by failure of the reinforcing fibers in shear mode at an angle of 45° to the loading axis, which is referred to as fiber shear failure mode (Figure 17.a.) or fiber crushing (Gutkin, Pinho, Robinson, & Curtis, 2010; Gutkin, Pinho, Robinson, & Curtis, 2010; Agarwal, Broutman, & Chandrashekhara, 2015). The lateral support provided by the fibers is very high in case of low misalignment angles, and the composite approaches the theoretical compressive strength. In-situ microscopic observations on notched specimens confirmed minimal effect of shear stresses in the matrix in the composite failure. Significant debris and abrasion has been reported on the surfaces of the shear driven compressive failure surfaces of carbon fiber reinforced epoxy composites (Ewins & Potter, 1980). This is due to the friction arising from the sliding of the failure surfaces over one another post-failure. In an alternate scenario, the fiber shear mode may also be observed in the composites with a large fiber volume fraction where the interfiber distances are small (Agarwal, Broutman, & Chandrashekhara, 2015) or in composites with large fiber diameters (Wilhelmsson, 2019).

The most commonly observed failure mechanism in a wide range of materials under axial compression, however, is “fiber kinking” (Rosen, 1964; Argon, 1972; Budiansky, Fleck, & Amazigo, 1998). A typical fiber kinking geometry, along with its distinguishing characteristics (width of the kink-band (w), kink-band propagation angle (β) and fiber rotation angle (α)), is shown in Figure 17.b.

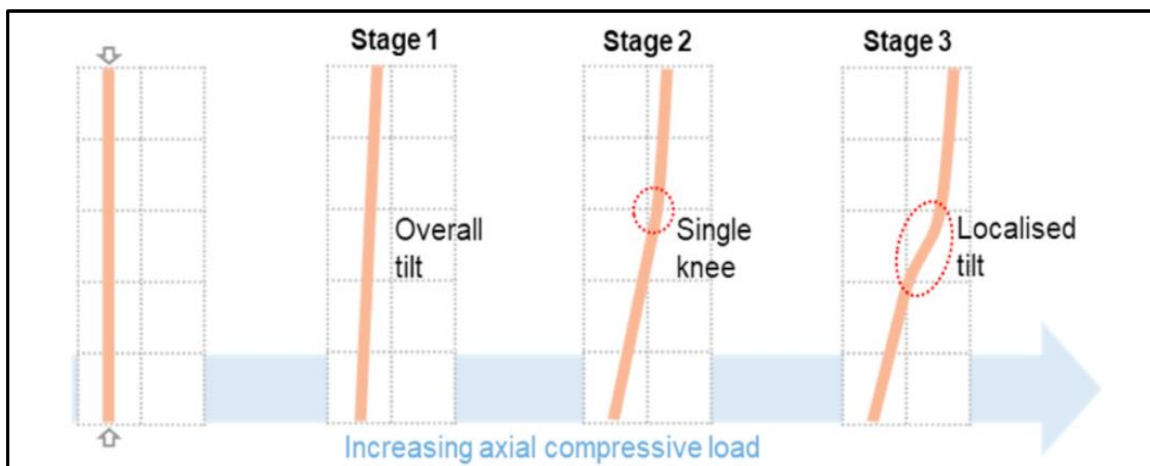
Figure 18: Stages of fiber displacement in kink-band formation (Wang, et al., 2021)

Recent real-time X-Ray CT observations of kink-band formation revealed three distinct stages (Figure 18) in fiber displacement leading up to kink-band formation. The observations showed that the fiber displacement starts with an overall tilt of fibers, followed by formation of a knee and eventually a micro-buckle (Wang, et al., 2021).

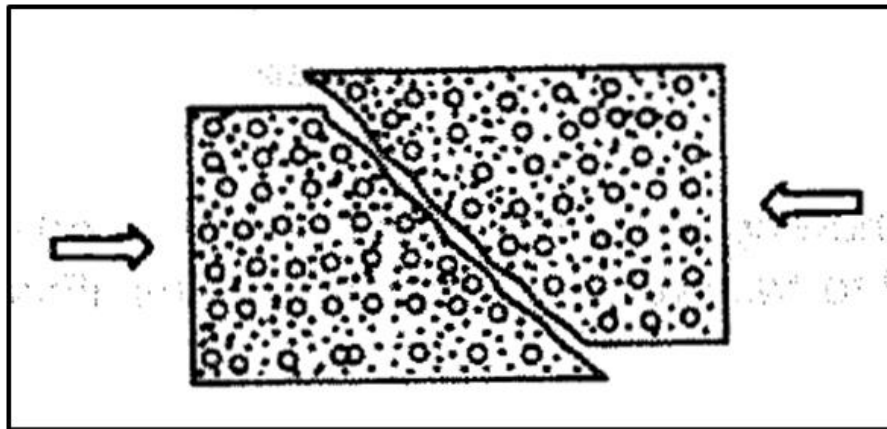
Figure 19: Failure under transverse compressive load (Agarwal, Broutman, & Chandrashekhara, 2015)

The unidirectional lamina have been found to fail parallel to fibers, inclined at a plane with respect to the loading direction under transverse compression (Figure 19). The failure is a combination of yielding in the matrix due to in-plane shear, friction between the two failure surfaces and fiber-matrix debonding (Agarwal, Broutman, & Chandrashekhara, 2015; Talreja, 2016; Lowe, 1996). A fracture plane angle of $53^\circ (\pm 3^\circ)$ has been reported for carbon fiber epoxy systems (Totry, González, & Llorca, 2009; Rouf, et al., 2021; Tsampas, Greenhalgh, Ankersen, & Curtis, 2012). Several studies (Hu, Kar, & Nutt, 2015; Totry, González, & Llorca, 2009; González & Llorca, 2007; Gutkin, 2013) have been conducted over the last decades to study and predict the influence of various factors affecting the angle of fracture plane in various composite material systems.

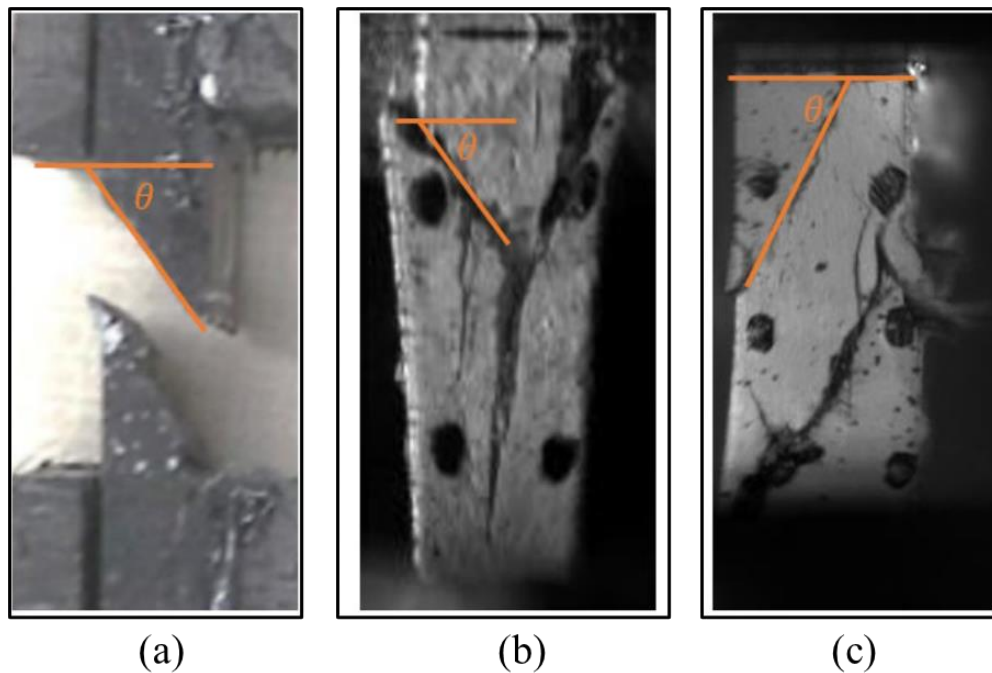
Figure 20: Coupons failed under transverse compression at (a) quasi-static (b) intermediate (c) high strain rates (Rouf, et al., 2021)

A prominent effect of strain rate on the transverse compression behavior of NCF carbon fiber/epoxy composites was recently observed by Rouf et al (Rouf, et al., 2021). The fracture plane angle was found to increase from 53° to 60° when the strain rate was increased from a quasi-static rate to high rate. Also, while the failure at quasi-static rate was characterized by a single crack, multiple cracks were observed at higher rates (Figure 20).

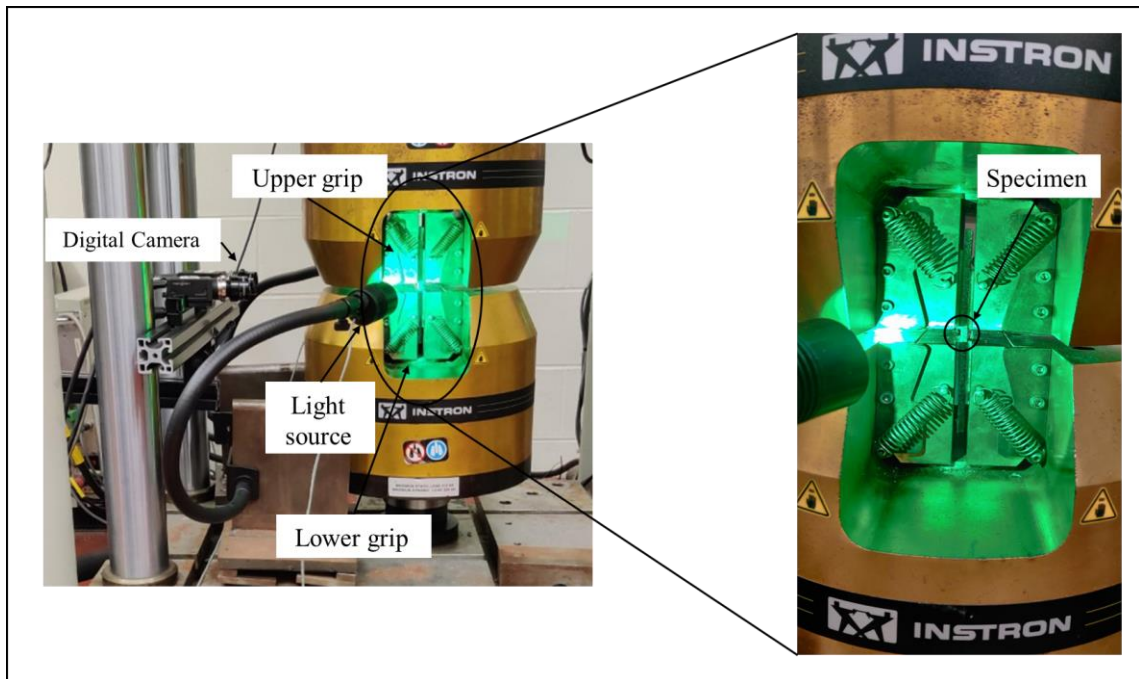
Figure 22: INSTRON 8804 servo-hydraulic test frame

The quasi-static characterization tests were carried out on a servo-hydraulic test frame (INSTRON 8804, Norwood, MA, USA; Figure 22) equipped with hydraulic wedge grips using either of 5 kN or 250 kN load cells. Two GRAS-505SM-C (Point Grey) digital cameras with 2448 X 2048 pixel resolution, with a pixel size of 3.45 μm , were used to capture the specimen images during the tests. The specimen surfaces to be imaged were speckled with a random white-on-black pattern to facilitate the strain measurement by DIC technique using the Vic3D software. The images were taken at a rate of 3.33 frames per second, unless otherwise specified. A region of (40 mm X 20 mm) 800 mm^2 was generally selected for strain acquisition.

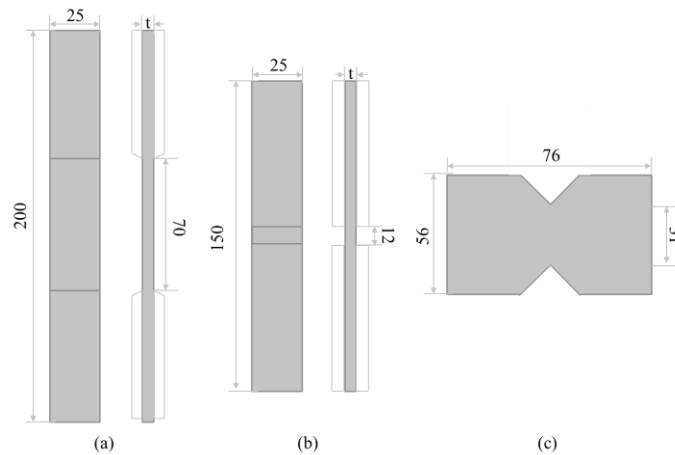
Figure 23: Representative test coupon geometry for (a) tensile test (b) compressive test (c) V-Notch in-plane shear test. ‘t’ stands for specimen thickness. All dimensions are in ‘mm’.

ASTM standard	Dimensions (mm)	Gauge length (mm)	Rate of testing (mm/min)
Tension	D3039	200*25*t	50	2
Compression	D3410	150*25*t	10	1
V-Notch shear	D7078	76*56*t	31	2

Test coupon geometry is represented in Figure 23. Carbon fiber/epoxy tabs were bonded on both the faces at the end of the specimens with Devcon 5 Minute[®] two-part epoxy glue to promote the failure in gauge lengths in tension and compression tests. The thickness of the tabs was in the range of 2.5-3.0 mm. The tabs used for tension tests had a low bevel angle of approximately 10° to allow for a smooth transition into the coupon gauge length. On the other hand, non-beveled tabs were used for compression tests, as they have been reported to produce acceptable failure modes in the ASTM D3410 standard. Spacers were used for specimen alignment in the V-Notch test while tightening the clamping bolts. A bolt torque of 94 Nm was required to clamp the specimens in the V-Notch test fixture.

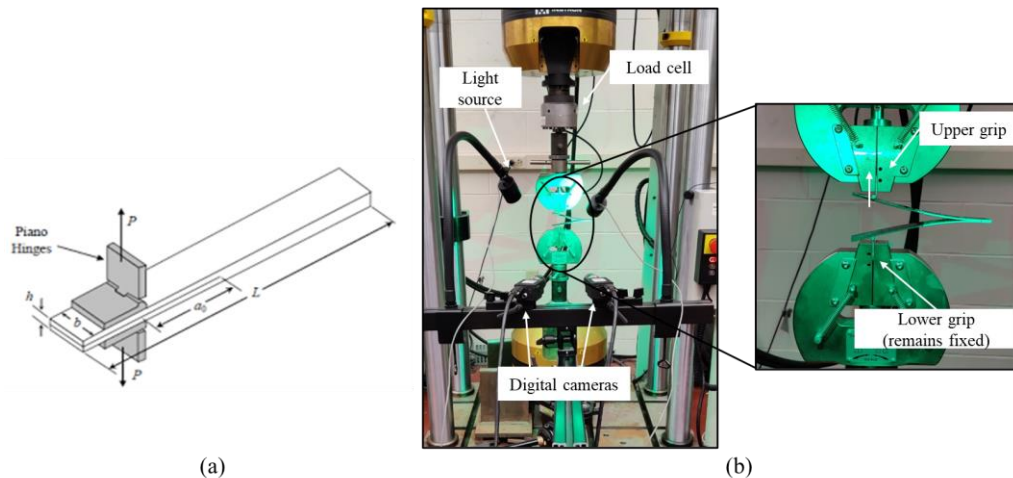
**Figure 24: (a) Schematic for typical Double Cantilever Beam (DCB) test specimen
(b) DCB test set-up**

The opening Mode-I interlaminar fracture toughness was determined using a DCB test. The test was conducted in accordance with the ASTM D5528 standard (ASTMD5528, 2013). Flat, rectangular, 25 mm wide test coupons were extracted from the manufactured plaques using a waterjet cutter. The specimens were approximately 130 mm long, including a Teflon insert on the mid-plane with a length of 65 mm (Schematic for a typical DCB specimen is shown in Figure 24.a.). The Teflon insert was placed on the midplane during the plaque manufacturing process. The Mode-I opening forces were applied to the specimens through Nickel plated aluminum piano hinges (Figure 24.b.) glued to the specimens using Loctite 495 adhesive. The piano hinges were glued to result in an initial delamination length (a_0), measured from the line of load introduction to the end of the insert, of 50 mm. The edge of the specimen was coated with a thin layer of a white correction fluid to aid in visual detection of the crack. The specimen was then loaded at a constant crosshead displacement rate of 5 mm/min. The crack propagation was observed at the edge of the specimen using two GRAS-505SM-C (Point Grey) digital cameras with 2448 X 2048 pixel resolution. The images of the edge were taken at 2 frames/second. The crack lengths were manually measured using ImageJ software.

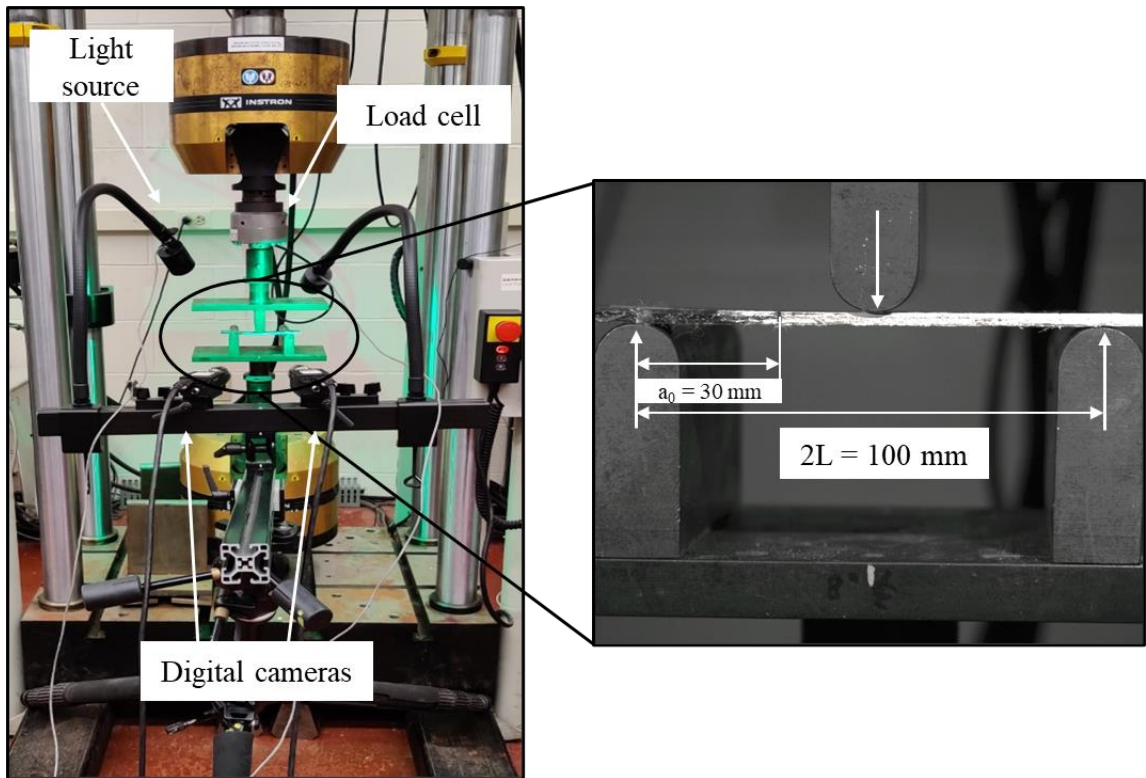
Figure 25: End Notch Flexure (ENF) test set-up

The test method used to determine Mode-II shear delamination fracture toughness by End Notch Flexure (ENF) test, ASTM D7905 (ASTMD7905, 2019) standard was referred to for sample preparation and test parameters. Similar to DCB test coupons, rectangular specimens were removed from the plaques using waterjet cutter. The specimens were 25 mm wide and 140 mm long, containing 50 mm of non-adhesive Teflon insert on the midplane. The tests were carried out on a 3-point testing fixture with a specimen span (2L) of 100 mm and a half span (L) of 50 mm (Figure 25). The radius of loading and support pins was 9 mm. The specimen was placed such as to have an initial delamination length of 30 mm. The initial delamination in an ENF test is measured from the center of the support pin to the end of Teflon insert. A thin coat of white correction fluid was applied on the edge, like in DCB test. The test was carried out at a crosshead displacement rate of 0.5 mm/min. The edges were observed using two GRAS-505SM-C (Point Grey) digital cameras at 1 frame per second and the crack lengths were measured manually using ImageJ software. Further, the specimens were not subjected to any additional pre-cracking in this case to avoid any external inaccuracies in the data. The Mode-II fracture toughness (G_{IIc}) was calculated by Carlson method (Carlsson & Pipes, 1987):

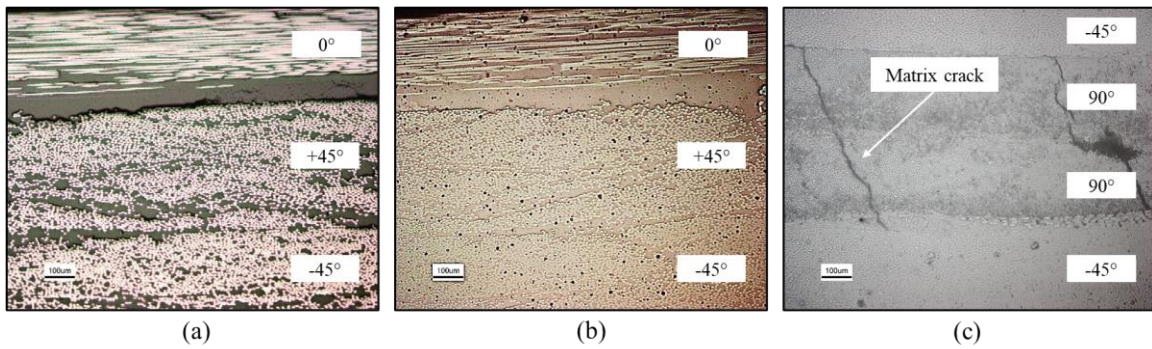
Figure 26: $[0/\pm 45/90]_s$ laminate microstructure on: (a) Actual edge (b) Replicating tape (c) Crack on replicating tape

The damage evolution was captured in-situ using an ER technique, which required polishing of the specimen edges to observe the microstructure. The specimen edges were first wet sanded with 240-grit, 400-grit and 600-grit silicon carbide sandpaper. Next, the specimen edges were polished with a 3-micron diamond paper and mineral oil on a low nap polishing pad for two hours in 20-minute runs, and finally with 0.25-micron diamond powder and mineral oil on a medium nap polishing pad for two to three hours in 20-minute runs. The tests were paused at pre-defined displacements, where a 125 μm thick cellulose acetate film wetted with acetone was compressed on the specimen edge using a rubber pad for two minutes to imprint the microstructure. The replicas were then observed under a Leitz Purapol 11 optical microscope (Figure 26). The displacement was then reduced manually to nearly 0 mm and the process repeated for subsequent values of displacement. Only one test per stacking sequence and loading condition was conducted.

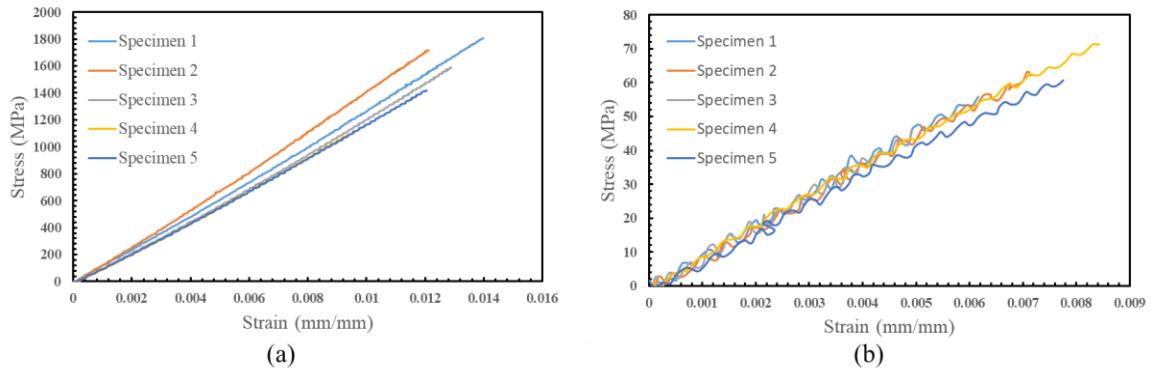
Figure 27: Stress-strain curves for unidirectional lamina under (a) axial tensile loads (b) transverse tensile loads

Five specimens each were tested under axial and transverse tensile loads. All the specimens exhibited a linear-elastic behavior until failure (Figure 27). All the tested specimens failed in the gauge section in a brittle fashion. While the failure of the axially loaded coupons was primarily in the middle of gauge section, the transversely loaded specimens failed closer to either of the grips but within the gauge length.

The axial tensile response is dominated by the fiber response. The test coupons failed explosively when the failure strain of carbon fibers was reached, at about 1.3%. Some of the specimens exhibited a slight increase in stiffness at higher strains. This phenomenon can be most clearly observed in the stress-strain curve of “specimen 2” in Figure 27.a. This could be attributed to unfolding of a limited crimp in the specimen and rotation of the fibers in the direction of loading. The response under transverse tensile loads, on the other hand, was governed by the matrix and fiber-matrix interface properties. Since the load-to-failure of these specimens was much lower than the capacity of the load cell, considerable noise was recorded in the data in the form of oscillations. The failure characteristics of the specimens are discussed in detail in the next chapter (Section 6.1).
