Damage in Non-Crimp Fabric carbon fiber reinforced epoxy composites under various mechanical loading conditions

A thesis submitted in partial fulfillment of the requirements for the Doctor of Philosophy degree in Mechanical and Materials Engineering

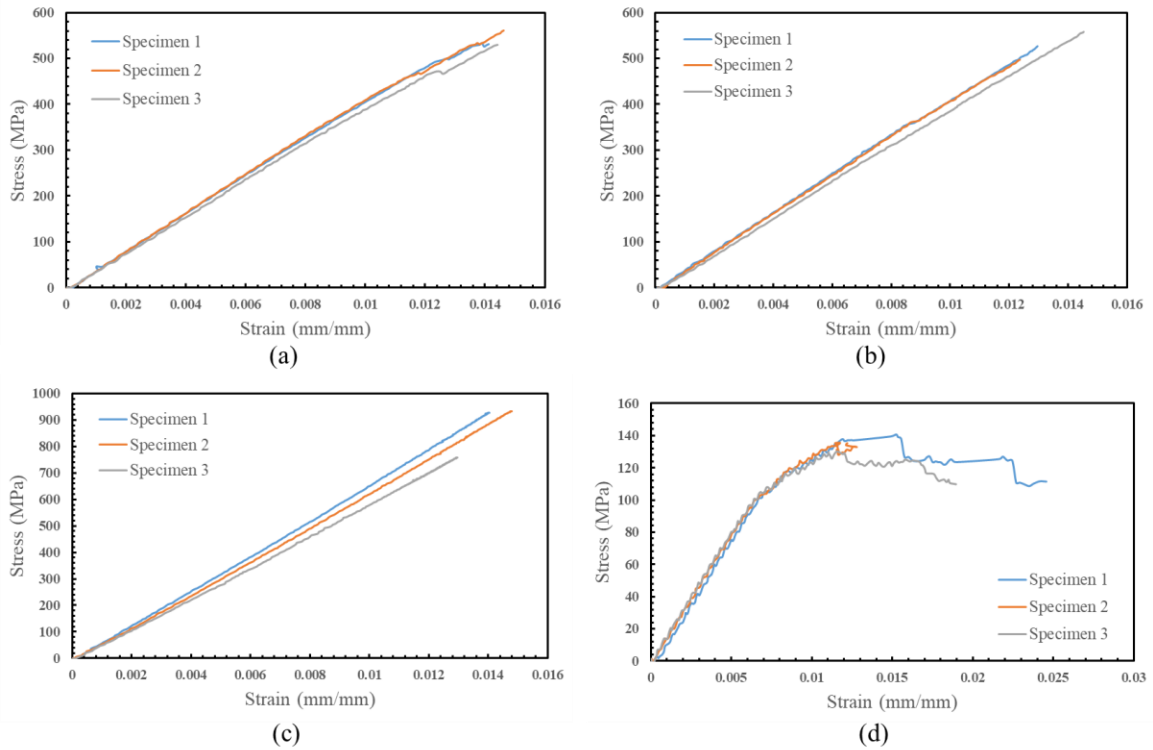
Figure 28: Tensile stress-strain curves for (a) $[0/\pm 45/90]_s$ laminate (b) $[90/\pm 45/0]_s$ laminate (c) $[\pm 45/0]_2$ laminate (d) $[\pm 45/90]_2$ laminate

The stress-strain responses of all the test coupons from the $[0/\pm 45/90]_s$ and $[90/\pm 45/0]_s$ laminates were repeatable (Figure 28.a. and Figure 28.b.) with very minimal scatter. The failure of all the test coupons was governed by the failure of the load bearing plies. All the tested laminates failed in the gauge section when the failure strain of the load-bearing fibers was reached (1.3% strain). As can be seen in Appendix 6, the measured engineering elastic moduli, tensile strength and strain-to-failure are almost identical for both the laminates. The elastic moduli, tensile strengths and failure strains were measured to be 42 GPa, 546 MPa, 1.4% and 42 GPa, 532 MPa, 1.3% for $[0/\pm 45/90]_s$ and $[90/\pm 45/0]_s$ laminates respectively. This implies that the stacking sequence of the laminate does not affect the measured engineering properties. Minor differences were, however, observed in the stress-strain responses. Load drops were observed close to failure, at about 1.2% strain, in the test coupons in the $[0/\pm 45/90]_s$ laminate. These drops supposedly correspond to the breakage of carbon fiber bundles and occur around the same strain. Such load drops were also observed in the $[90/\pm 45/0]_s$ laminates at a lower strain of 0.9%. In this case, however, the drops correspond to cracking in off-axis plies. This is an indication that although the stacking sequence of the laminates has negligible influence on the measured engineering properties under tension, the initiation and growth of damage must be different depending on the relative position of the plies in the laminate. The same is investigated further in Section 6.2.2.1.

The response of the stiffer 0° plies was reflected in the stress-strain response and measured properties of $[\pm 45/0]_2$ laminate (Figure 28.c.). The stiffness and the tensile strengths of the laminate in the axial direction were measured as 62 GPa and 934 MPa. The tested coupons failed in a brittle manner in the center of the gauge length once the failure strain of 0° plies was reached (1.4% strain). On the other hand, in the $[\pm 45/90]_2$ laminate, all the plies are oriented off-axis with respect to the loading direction. Therefore, the laminate was significantly more compliant as compared to the $[\pm 45/0]_2$ laminate. The elastic modulus and tensile strength were measured to be 18 GPa and 135 MPa respectively for the $[\pm 45/90]_2$ laminate.

Very clear change in slope and load drops could be observed in the stress-strain curves of the $[\pm 45/90_2]_s$ laminate (Figure 28.d). The change in slope at around 0.75% strain suggests an onset of damage. The growth of damage makes the material further compliant, as can be most clearly seen in the stress-strain response of “specimen 1” in Figure 28.d. The two sharp load drops, as characterized by vertical lines, likely correspond to cleavage of the 45° plies. The laminate fails eventually at about 1.8%. The damage evolution process is further discussed in Section 6.2.2.2. A large amount of scatter can be observed in the strain-to-failure recordings of the $[\pm 45/90_2]_s$ laminate. This may be attributed to the individual plies all failing along the same plane in that particular test coupon, which is a stochastic phenomenon.

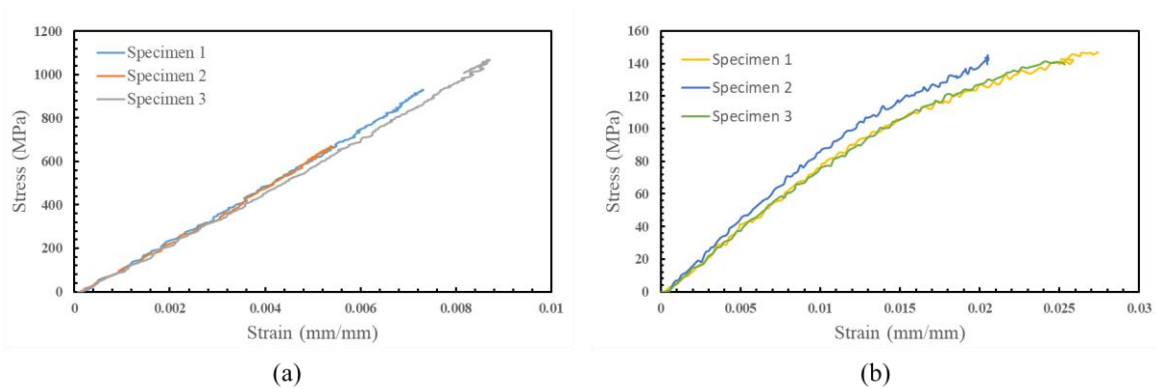
Figure 29: Stress-strain curves for unidirectional lamina under (a) axial compressive loads (b) transverse compressive loads

The unidirectional lamina exhibited a linear-elastic response to failure under axial loads (Figure 29.a.), reflecting the expected response from 0° plies. The failure in all the axially loaded specimens was by formation of out-of-plane kink bands in the gauge section at a failure strain of 0.8%. The compressive stiffness of the materials was measured to be 122 GPa, which was equal to the tensile stiffness (121 GPa). The compression strength (1000 MPa) was, however, about 60% of the tensile strength (1637 MPa). The results in this study are slightly different from the literature reports which generally suggest tensile stiffness to be 10% higher than the compressive stiffness, and the compression strength to be about 50% of the tensile strength. Furthermore, the axial compression strength measurements contain a large amount of scatter. As has been reported in the literature, the axial compression strengths are highly sensitive to even small misalignments. Therefore, the scatter may be attributed to a bundle of fibers with large local misalignment or a slight specimen misalignment. On the other hand, the unidirectional lamina failed under transverse compression as a result of matrix yielding and fiber/matrix debonding at 2.42% strain. The change of slope of the stress-strain curves (Figure 29.b.) is indicative of the shear response of the matrix. The failure of all the tested specimens was characterized by the formation of a failure plane inclined at an angle of about 53° to the loading direction in the gauge section, which is discussed in detail in Section 7.1.2.

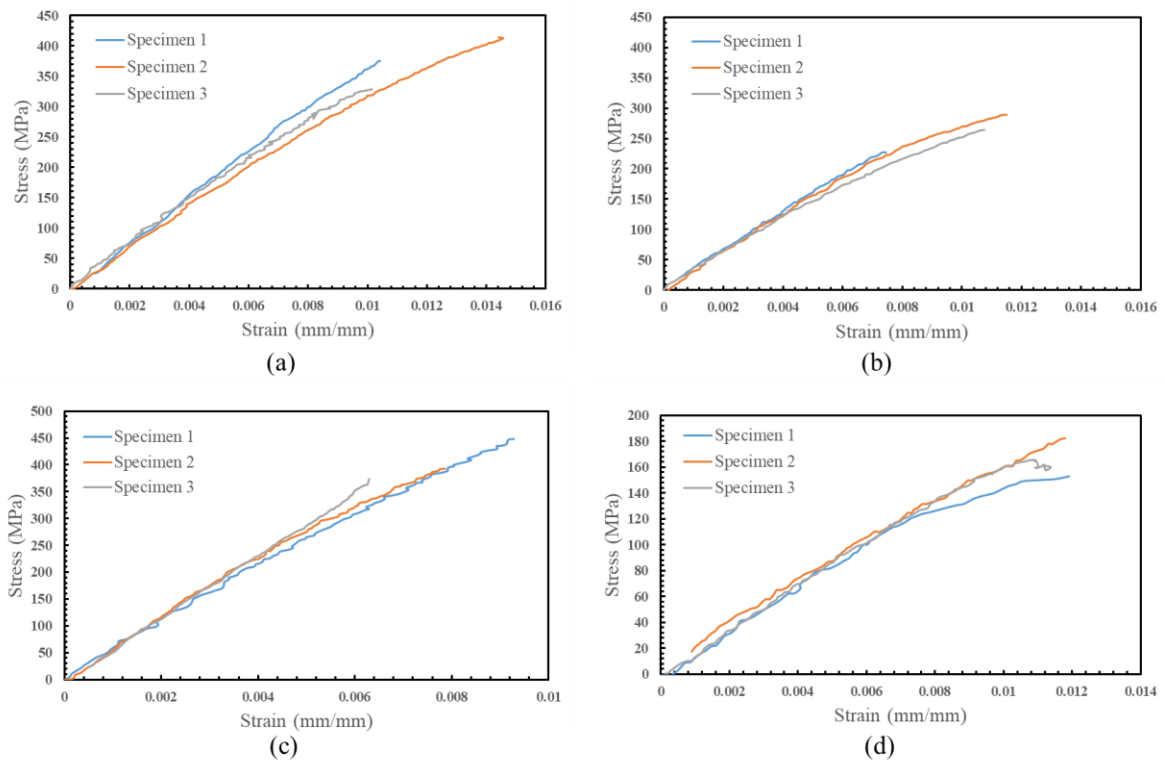
Figure 30: Compressive stress-strain curves for (a) $[0/\pm 45/90]_s$ laminate (b) $[90/\pm 45/0]_s$ laminate (c) $[\pm 45/0]_s$ laminate (d) $[\pm 45/90]_s$ laminate

The effect of stacking sequence can be clearly observed on the compressive responses of $[0/\pm 45/90]_s$ and $[90/\pm 45/0]_s$ laminates (Figure 30.a. and Figure 30.b.). The $[0/\pm 45/90]_s$ laminate, wherein the compliant off axis plies are sandwiched between the 0° plies, is stiffer and significantly stronger. The strains-to-failure for the $[0/\pm 45/90]_s$ laminate are slightly higher than the $[90/\pm 45/0]_s$ laminate. The compression moduli, compression strengths, strains-to-failure were measured to be 37 GPa, 384 MPa, 1.1% and 31 GPa, 265 MPa and 1% for the $[0/\pm 45/90]_s$ and $[90/\pm 45/0]_s$ laminates respectively. The presence of 0° plies on the outside constrains the damage in the compliant off-axis plies, delaying the catastrophic failure. The failure in $[90/\pm 45/0]_s$ laminate, on the other hand, is very strongly dependent on the stability of the central load-bearing plies. The material fails catastrophically as soon as the load-bearing plies fail.

The compressive stiffness and strengths of the $[\pm 45/0_2]_s$ laminate (Figure 30.c.; measured to be 59 GPa and 399 MPa respectively) is significantly higher than the $[\pm 45/90_2]_s$ laminate (Figure 30.d.; measured to be 18 GPa and 179 MPa), as was expected due to higher concentration of the stiffer 0° plies. There was, however, high amount of scatter in the compression data for $[\pm 45/0_2]_s$ laminate. The response of this laminate is very strongly dependent on the stability of the central block of 0° plies, which is highly sensitive to even the slightest of fiber misalignments, which may cause scatter in the data. The data for $[\pm 45/90_2]_s$ laminate was, however, consistent.

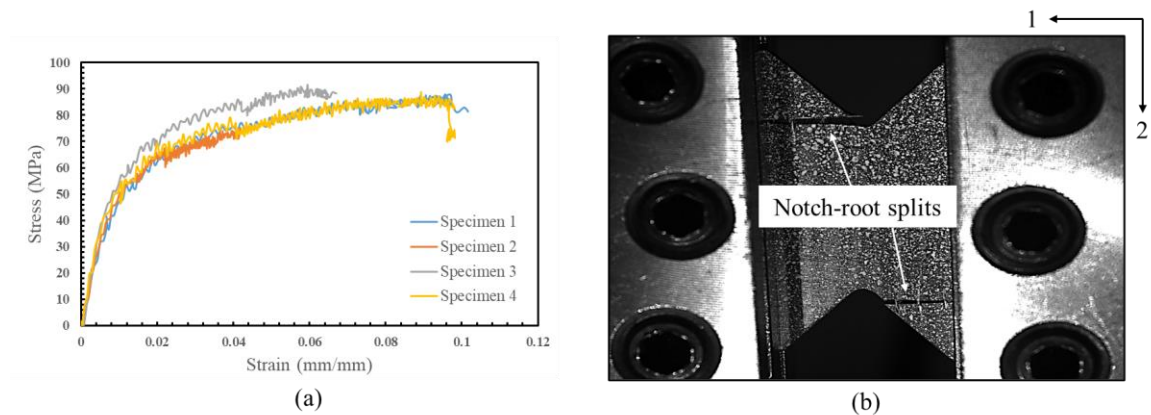
Figure 31: (a) Stress-strain curves for unidirectional lamina under in-plane shear loads (b) Notch-root splits observed during the V-Notch rail shear test

stress-strain curves recorded from the test are shown in Figure 31.a. The shear modulus of the lamina was measured as 3.55 GPa. The stress-strain curves are characterized by the load drops associated with splitting between fiber and matrix at the roots of the notches followed by failure in the gauge length. Although the overall shapes of the stress-strain curves are identical for the specimens, the strain at which the notch-root splits occurred was found to vary. The load drops associated with the splits are observed between 2% and 4% engineering shear strain. The failure stress (about 89 MPa) was, however, close to the stress at which the notch-root splits (Figure 31.b.) were observed (about 75 MPa). The specimen shear strain-to-failure was recorded as 8.88%.

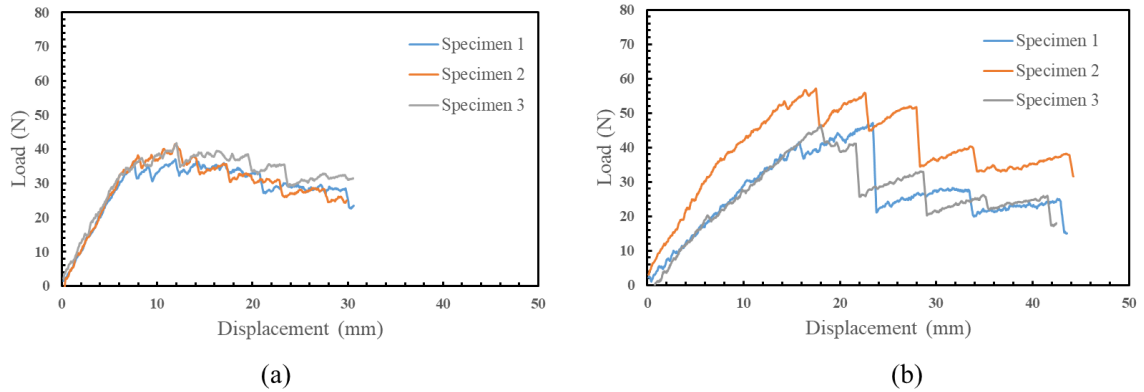
Figure 32: Filtered Mode-I load-displacement curves for (a) unidirectional lamina (b) cross-ply laminate

Three DCB tests were conducted for unidirectional and cross-ply laminates each under the testing conditions as described in Section 4.3.1.2. A symmetric opening of arms was observed in all the tests. Since the peak loads were around 50 N in all the tests (Figure

32), which is significantly lower than the capacity of the load cell (5 kN), the load signal data contained large amount of noise. A moving average filter was hence used to eliminate the noise. The data was averaged over 8-10 points for the tested specimens. Unprocessed load-displacement curves can be found in Appendix 7.

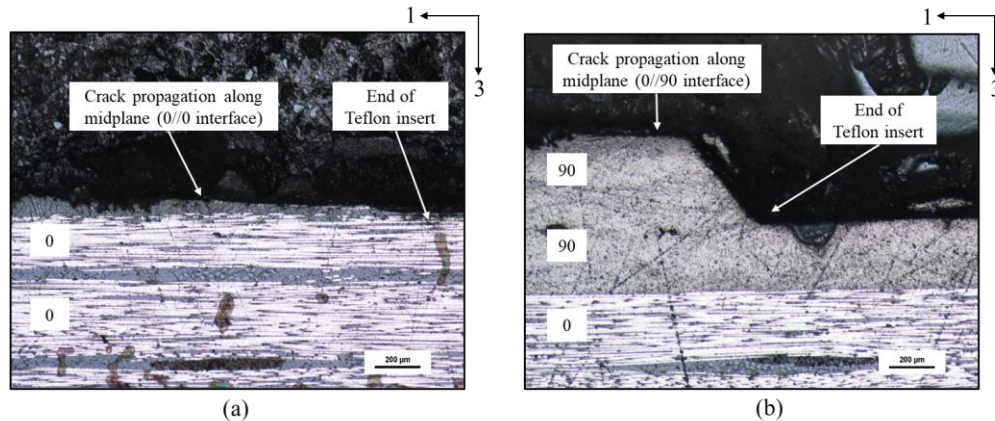
Figure 33: Mode-I interlaminar crack propagation in (a) unidirectional lamina (b) cross-ply laminate (through-thickness views)

The crack propagated along the midplane in the interlaminar region in all the three tested specimens for unidirectional lamina (Figure 33.a.). However, the crack instantly migrated to the 0//90 interface upon initiation from the pre-crack in cross-ply laminates (Figure 33.b.). The crack then propagated along the 0//90 interface.

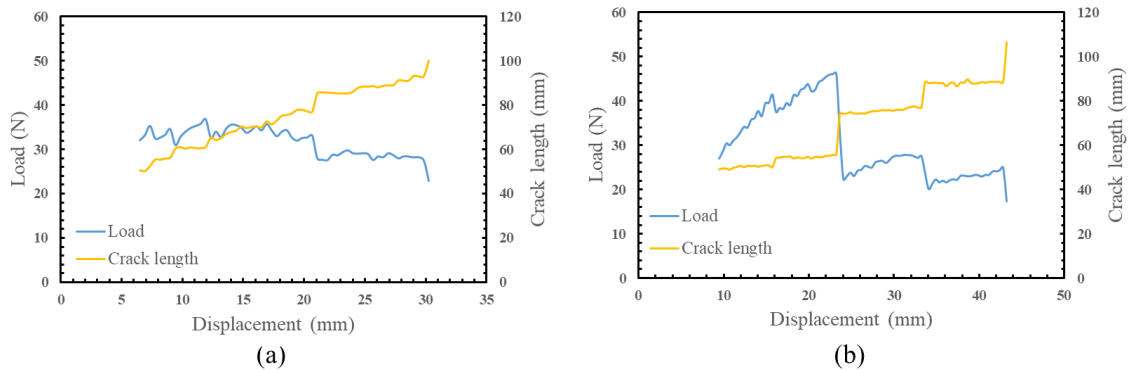
Figure 34: Representative Mode-I interlaminar crack propagation characteristics in (a) unidirectional lamina (b) cross-ply laminate

A “stick-slip” type of crack propagation behavior was observed in both unidirectional laminae and cross-ply laminates. This tendency is characterized by alternating periods of unstable crack growth and crack arrest. The periods of unstable crack growth are characterized by sudden load drops and large jumps in crack length (Representative curves are shown in Figure 34, more curves in Appendix 8 and Appendix 9). The crack may either exhibit a slow growth, as is observed in the case of unidirectional lamina, or may remain relatively stationary, as in cross-ply laminates.

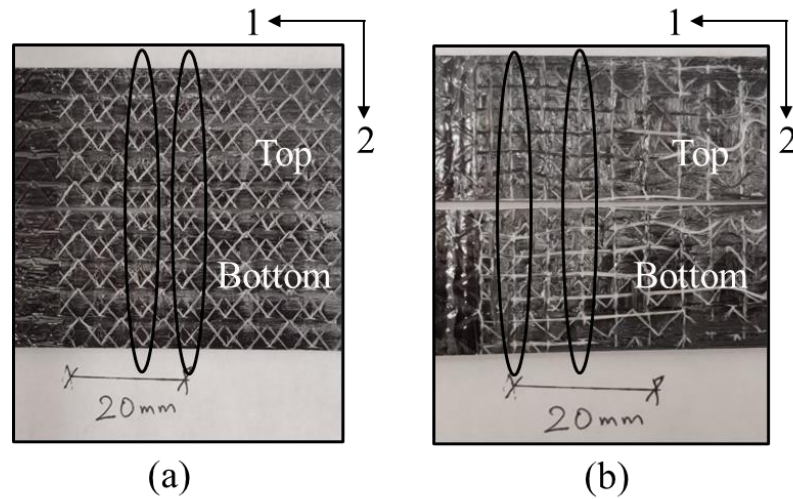
Figure 35: Top views of tested (a) unidirectional (b) cross-ply test coupons

The stick-slip behavior of the crack was correlated with top views of the tested coupons. The crack arrest in unidirectional lamina was found to coincide with the presence of stitching sites (encircled in Figure 35.a.). On the other hand, the major resistance to crack propagation in cross-ply laminates was offered by the transverse tows on the crack path (encircled in Figure 35.b.). The presence of tows pinned the crack in a stationary position until sufficient energy was available for the crack to move around the tows.

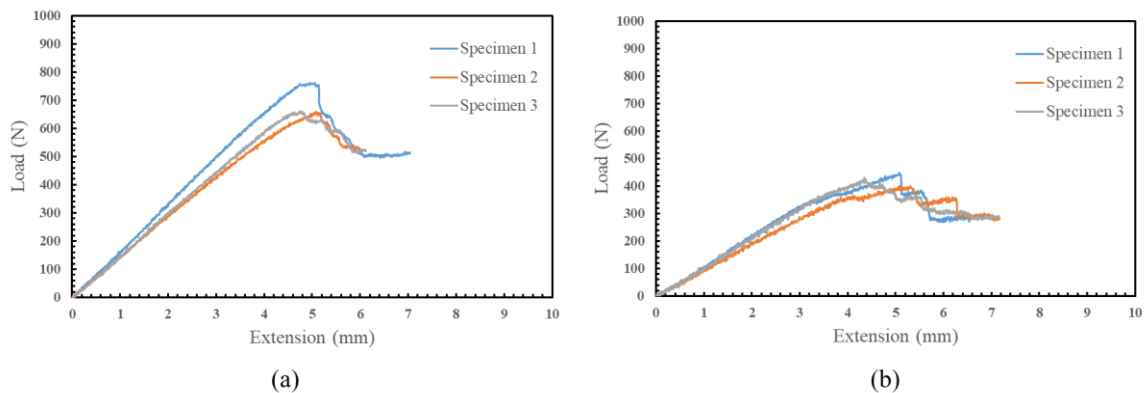
Figure 36: Mode-II load-displacement curves for (a) unidirectional lamina (b) cross-ply laminate

Three ENF tests each were performed for unidirectional lamina and cross-ply laminates to understand crack propagation under Mode-II shear loading conditions. High consistency was observed in the load-displacement data for both stacking sequences (Figure 36). As also was observed during DCB tests, the crack primarily propagated on the mid-plane in unidirectional lamina and instantaneously deviated from the mid-plane to and propagated along 0//90 interface in cross-ply laminates.

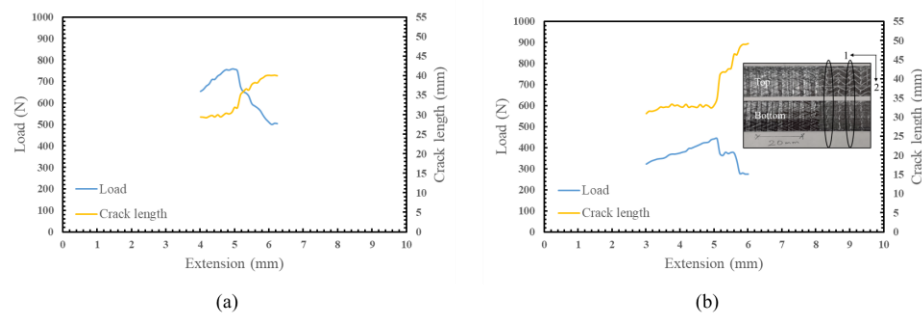
Figure 37: Representative Mode-II interlaminar crack propagation characteristics in (a) unidirectional lamina (b) cross-ply laminate

Representative crack propagation curves can be found in Figure 37 and the crack propagation results from other tests may be found in Appendix 10 and Appendix 11. A stable crack propagation was achieved under Mode-II loading in unidirectional laminae. However, similar to the crack propagation tendency under Mode-I loads, the crack exhibited a stick-slip behavior in cross-ply laminates. The transverse fiber tows resisted the propagation of the crack (inset in Figure 37.b.), resulting in periods of crack staying stationary, followed by the crack progressing in an unstable fashion till the next fiber tow arrests the crack.

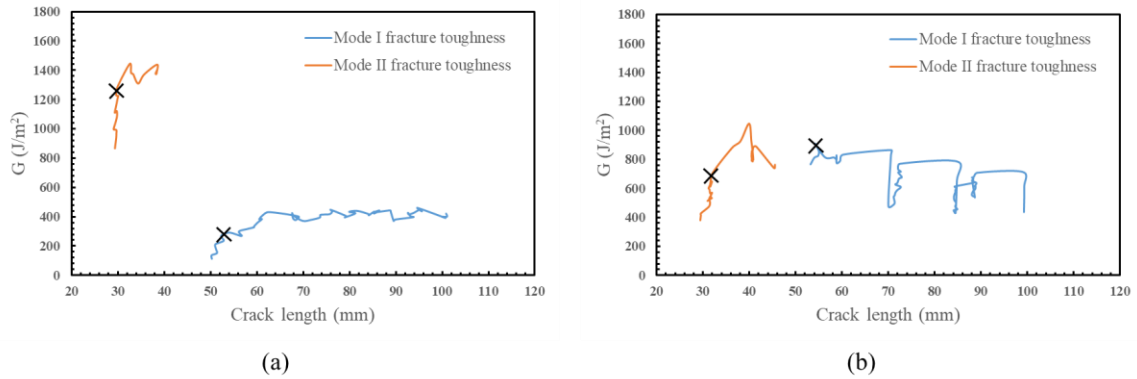
Figure 38: Representative R-curves for (a) unidirectional lamina (b) cross-ply laminates

Representative resistance curves (R-curves), in which the interlaminar fracture toughness is plotted versus crack length, under Mode-I and Mode-II loads are shown in Figure 38. R-curves for all specimens may be found in Appendix 12 and Appendix 13. Although a stick-slip behavior was observed in all tested specimens, the fracture toughness value at which the crack first extends from the Teflon insert has been reported as the initiation value (marked as “x” in Figure 38 and reported in Table 2). A linear fit was used after initiation to determine the propagation values, which correspond to the plateau region in R-curves. Except in the cross-ply laminate under Mode-I loading, an increase in the propagation values after initiation can be seen. Resin-rich pockets at the front of Teflon insert and on the path to migration of crack from midplane to 0//90 interface may have caused the additional toughening for initiation in cross-ply laminates under Mode-I loading.

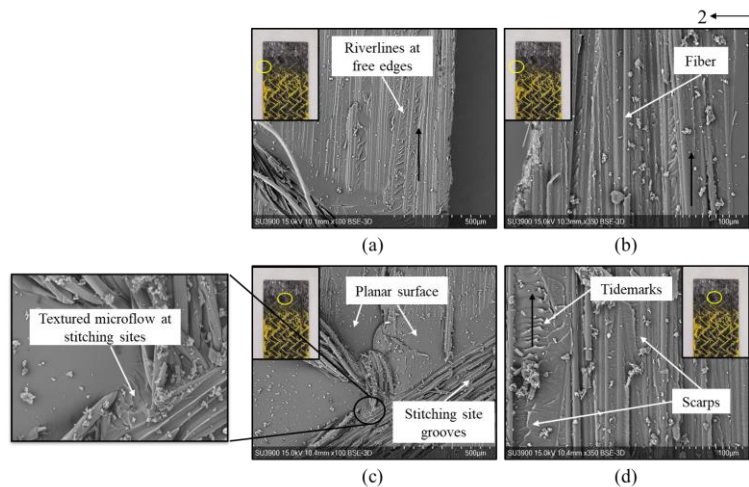
Figure 39: SEM characterization of the fracture surfaces of unidirectional composites under Mode-I loads

SEM investigations of the unidirectional fracture surfaces in this study show an overall rougher appearance (Figure 39, the crack propagates from bottom to top along 1-direction, as indicated by black arrows). The crack propagation occurred very close to the fiber matrix interface in unidirectional composites, as evidenced by presence of matrix on the fibers. Distinct features were observed on the free edges of the specimen versus at the center. As the material present at the free surfaces was unconstrained at one end, it was free to deform, leading to formation of riverlines at the free edges (Figure 39.a.). However, towards the center of the specimen, the material was effectively in a state of plane strain, leading to a planar cleavage (Figure 39.b.) type of fracture surface in resin rich regions.

‘Tidemarks’ (Figure 39.d.) can also be clearly seen on the fracture surface. These discrete bands are usually associated with changes in the crack speed (stick-slip behavior, as was explained in previous section). Areas with higher plastic deformation correspond to areas of crack arrest or slow growth and relatively feature free areas correspond to areas of rapid crack growth. The tidemarks are believed to be a result of blunting at the tip of a sharp crack and are aligned normal to the direction of crack propagation (Greenhalgh E. , 2009).

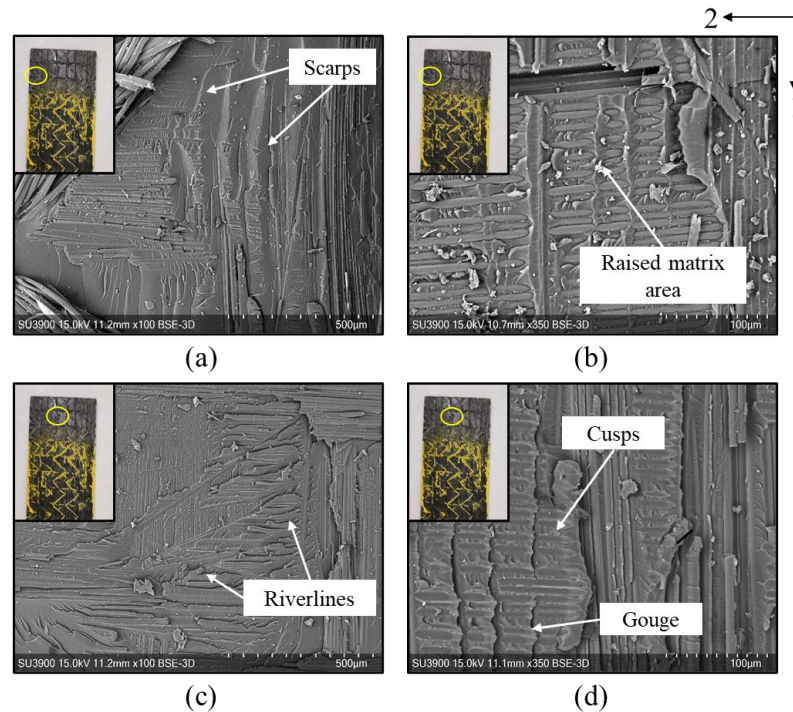
Figure 40: SEM characterization of the fracture surfaces of cross-ply laminates under Mode-I loads

The fracture surfaces of the tested cross-ply specimens are shown in Figure 40, in which the direction of crack propagation is along 1-direction from bottom to top. Unlike in unidirectional composites, no major distinction was found between the feature on the free edges and at the center of the specimen. Riverlines and scarps, diagnostic of local plastic deformations, could be observed on both, free edges and center.

Unlike in unidirectional composites, cusps and gouges can be seen on the failure surfaces of the cross-ply laminates. Cusps, also referred to as ‘hackles’, ‘flakes’, ‘lacerations’ or ‘serrations’ (Greenhalgh E. , 2009), appear as inclined platelet-like structures on the surface and may be formed as a result of local sliding of surfaces (discussed in detail in subsequent section). Deep ‘gouges’ (Greenhalgh E. , 2009), extending underneath the surface, may be seen accompanying the cusps. The gouges occur at the base of the cusps, where several cusps are aligned along a line. The spacing between the gouges however seems to vary.

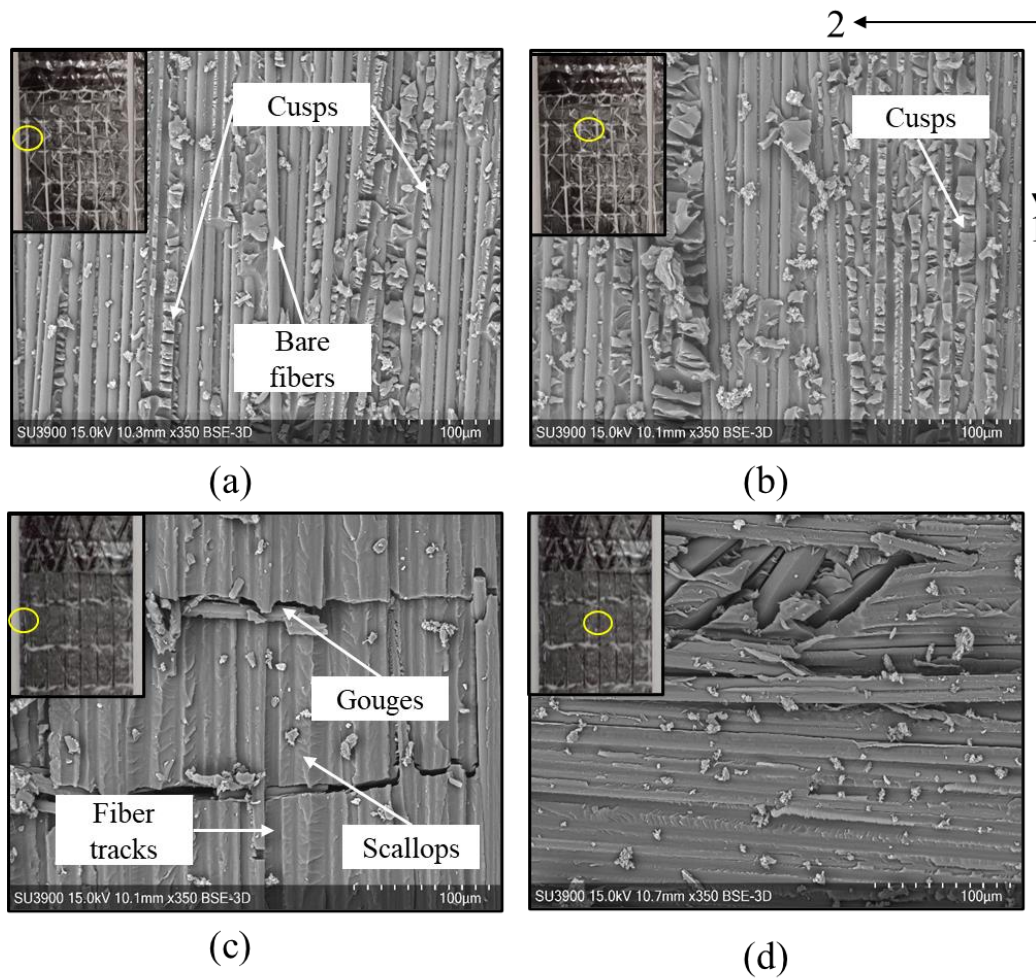
Figure 41: (a-b) SEM characterization of the fracture surfaces of unidirectional composites under Mode-II loads (c-d) SEM characterization of the fracture surfaces of cross-ply laminates under Mode-II loads

Fractographic observations reveal that the crack primarily propagates along fiber/matrix interface under Mode-II loads in both, unidirectional and cross-ply laminates. This is supported by the presence of bare fibers and clean fiber tracks left behind by pulled out fibers on the failure surfaces. Unlike in under unidirectional laminae subjected to Mode-I opening loads, no discernable distinction could be made between features on free edges versus at the center.

The dominant feature in both the investigated laminates was the presence of cusps. The cusps are formed owing to a relative shearing of two surfaces. The mechanism of formation of cusps may be understood by considering the stress state in front of the crack tip, which consists of a tensile traction angled at 45° . As the loads increase, the cracks grow along the tensile traction vertically in the interlaminar resin rich region and then rotate locally at the interface boundary. This leads to the formation of cusps, which detach from the surface, leaving behind the inclined platelet-like features. Generally, the cusps coalesce with the adjacent cusps, leading to one surface retaining cusps and the matching surface being left with the cusp marks. These are labelled as “scallops” in Figure 41. These features may be influenced by numerous factors such as fiber spacing and matrix toughness. In addition to cusps and scallops, gouges were also observed in cross-ply laminates.

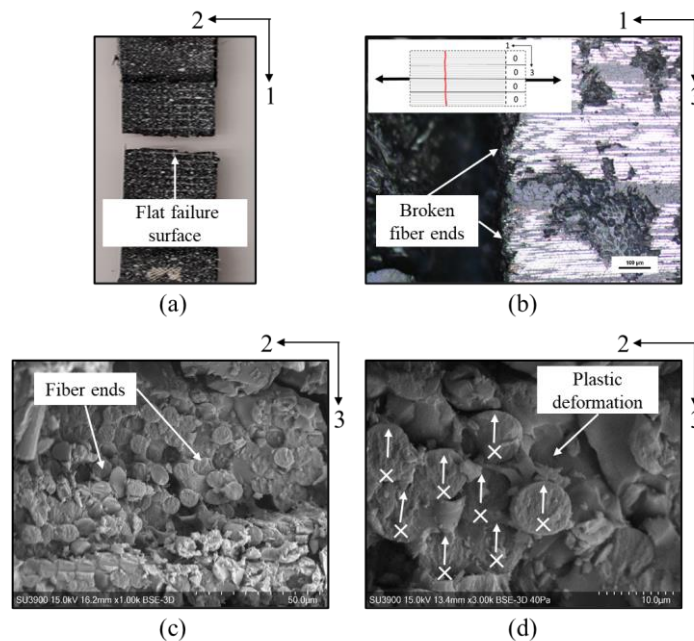
Figure 42: (a) Specimen failed under axial tension (b) Image of the edge of failed specimen taken using optical microscope (c, d) Images of the failed surface taken using SEM

The post-failure images of the specimens are shown in Figure 42, where the specimens were loaded along 1-direction. The composite specimens failed such that the resulting fracture plane was almost flat and oriented perpendicular to the direction of fiber alignment and by extension, also the direction of loading. No significant fiber breaks were observed in the specimen away from the fracture plane (Figure 42.b.). This indicates that all the fibers that failed were present on the same plane.

A closer inspection of the failure surface using SEM (Figure 42.c. and Figure 42.d.) revealed presence of lines radiating from a local point of origin, marked as 'x' in Figure 42.d. The sites marked as 'x' act as local crack initiation sites leading to the failure of the fibers. The presence of radial lines originating from these local sources of damage on the fiber ends may be used to infer the local growth directions. A failed fiber effectively induces failure in the neighboring fibers, providing a convenient means to be able to determine direction of crack growth within a local bundle or cluster of fibers. Plastic

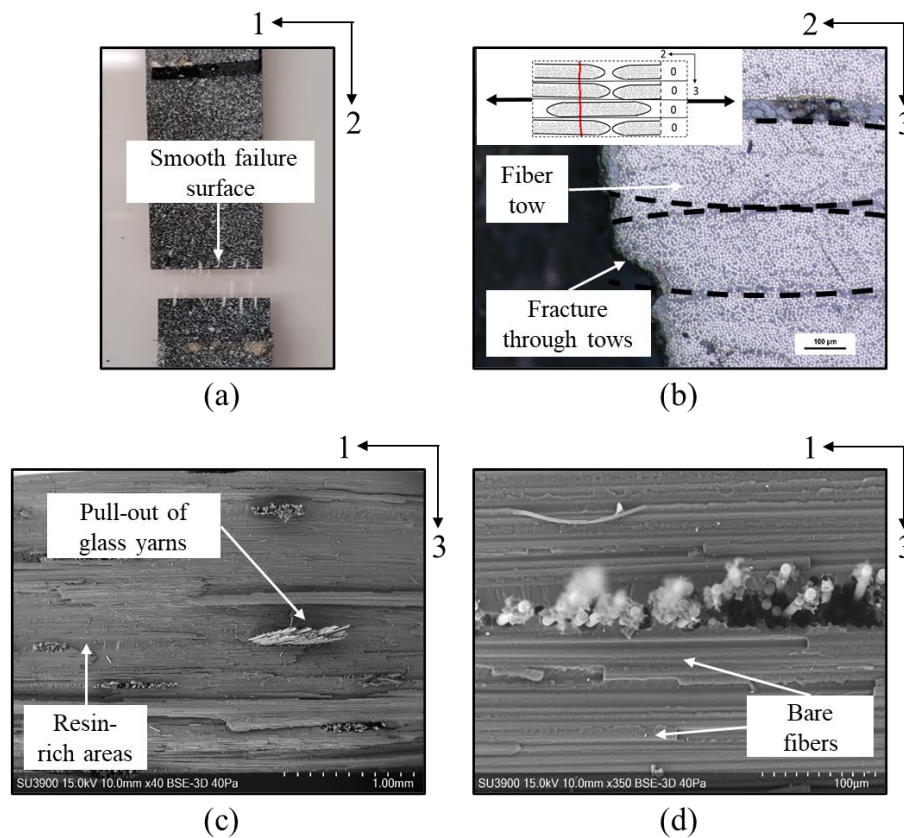
Figure 43: (a) Specimen failed under transverse tension (b) Image of the edge of failed specimen taken using optical microscope (c, d) Images of the failed surface taken using SEM

The unidirectional composites in transverse tension exhibit a brittle, cleavage type of fracture with a smooth fracture plane (Figure 43.a.; The fibers are aligned along 1-direction and the specimen is loaded along 2-direction). The fracture plane is perpendicular to the direction of loading, i.e. along the direction of carbon fiber tows. Optical microscopic observations of the edge of the specimen revealed that the fracture plane propagated through the tows (Figure 43.b.). High magnification images using SEM of the fracture surface showed the presence of pull-out of the supporting glass yarns, resin-rich areas in the vicinity of the supporting yarns and mostly bare fibers. These features are indicative of failure of the material along the fiber-matrix interface by debonding.

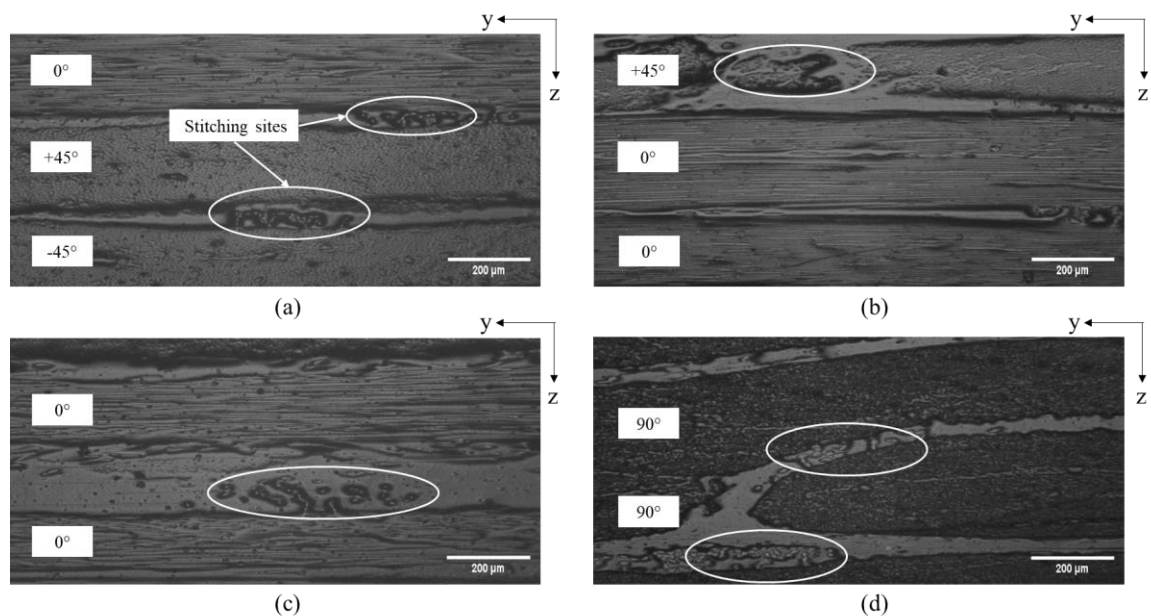
Figure 44: Edge replicas of virgin (a) $[0/\pm 45/90]_s$ laminate (b) $[90/\pm 45/0]_s$ laminate (c) $[\pm 45/0]_2$ laminate (d) $[\pm 45/90]_2$ laminate

Images of replicas taken from the edges of untested specimens revealed that there was no damage prior to loading (Figure 44). For reference, the 0° plies were oriented along the laminate y-direction, while the laminate x-direction was normally aligned with loading direction.

The tows in a single NCF layer are stitched together with low density linear polyester fiber yarns. The stitching yarns tend to cause resin-rich pockets between carbon fiber tows, while transversely oriented supporting glass fiber yarns influence the localized resin layers between adjacent plies (encircled in Figure 44).

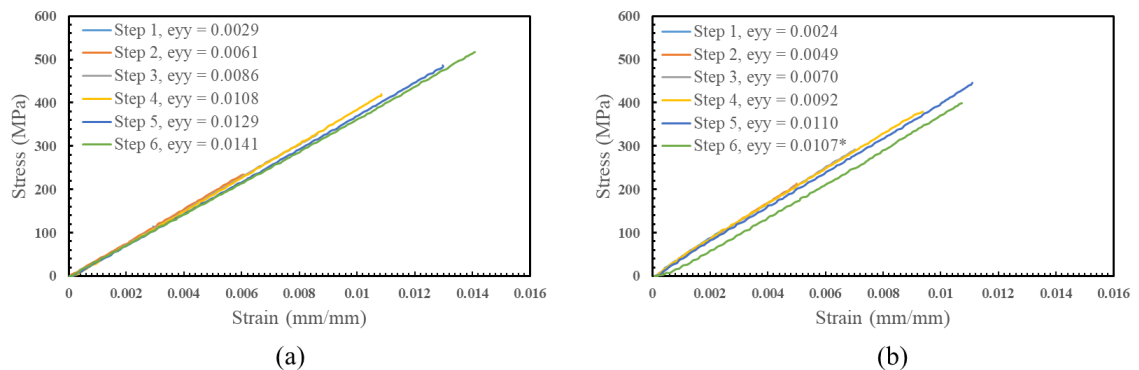
Figure 45: Stress-strain curves from interrupted tension tests for (a) $[0/\pm 45/90]_s$ laminate (b) $[90/\pm 45/0]_s$ laminate

The stress-strain curves of the tested specimens upon interruptions at pre-defined strain values, as per the process described in the previous section, are shown in Figure 45. Both laminates exhibited a linear-elastic response through all the loading steps. Therefore, it was not possible to define strain at damage onset based on the stress-strain curves alone. However, a reduction in the slope of the stress-strain curves with an increasing strain was observed, indicating the occurrence and development of damage within the materials.

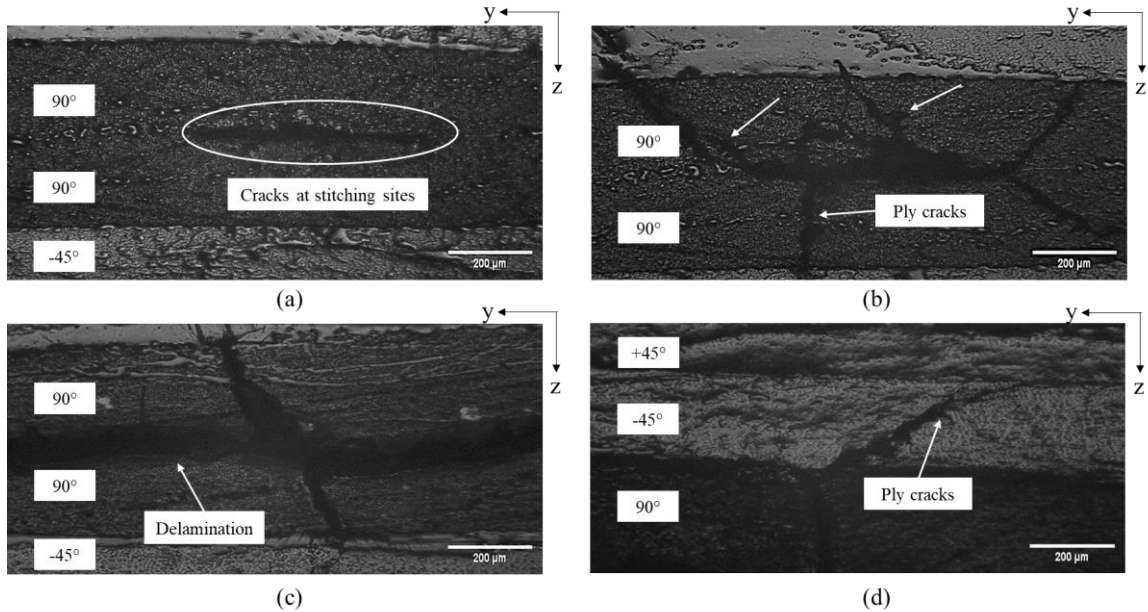
Figure 46: Damage features in the $[0/\pm 45/90]_s$ laminate under tension at (a) 0.29% strain (b) 0.61% strain (c) 0.86% strain (d) 1.29% strain

Damage was first observed as localized cracks at the stitching sites between the 90° plies after a strain of approximately 0.29% in the $[0/\pm 45/90]_s$ laminate (Figure 46). As the strain was increased to 0.61%, cracks were observed to extend through the thickness of the 90° plies, where the majority of these cracks originated from the damaged stitching sites. Some of the 90° ply cracks caused cracks to initiate in the adjacent -45° ply.

Ply cracks in the 90° and -45° plies continued to multiply with increasing strain and saturated once the applied strain exceeded 0.61% (Figure 46). Once the strain reached 0.86% (Figure 46), ply crack saturation is reached in 90° plies and the cracks initially observed at the stitching sites grew into delamination cracks at the interface between the 90° plies. These cracks will be referred to as 90/90 delamination cracks. Since the $+45^\circ$ and -45° plies were perpendicular, ply cracks in the -45° plies did not cause ply cracks to

initiate in the $+45^\circ$ plies. Instead, delamination cracks formed between the $+45^\circ$ and -45° plies, which will be referred to as $+45/-45$ delamination. Extension of the $90/90$ and $+45/-45$ delamination cracks were widespread after a strain of 1.29% (Figure 46), which was just before specimen failure.

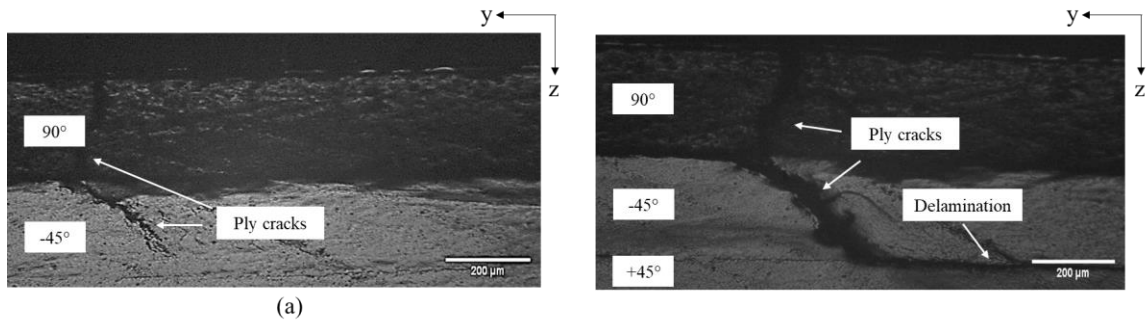
Figure 47: Damage features in the $[90/\pm 45/0]_s$ laminate under tension at (a) 0.70% strain (b) 1.10% strain

On the other hand, damage in the $[90/\pm 45/0]_s$ laminate along the x-direction (Figure 47) was observed to initiate after an applied strain of approximately 0.70%. The strain at onset of damage was likely higher for transverse loading since cracks did not initiate at the stitching sites. Uniformly spaced cracks were observed in the 0° plies, where some of these cracks initiated ply cracks in the adjacent $+45^\circ$ ply, as in the $[0/\pm 45/90]_s$ laminate. Cracks continued to multiply in 0° and $+45^\circ$ plies with increasing strain. The reduced spacing between the cracks lead to overlapping of the relaxed stress fields in the crack vicinities due to which the stresses in between two neighbouring cracks were not high enough for a new crack to form (i.e., crack shielding). Ply cracks seemed to saturate at this point, which was observed at approximately 1.10% strain. Thereafter, delamination crack started to grow at the ± 45 ply interface, which preceded specimen failure.

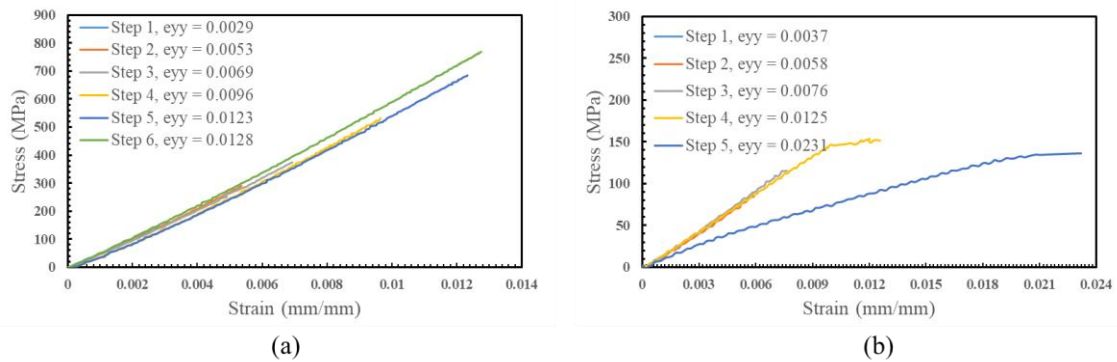
Figure 48: Stress-strain curves from interrupted tension tests for (a) $[\pm 45/0]_s$ laminate (b) $[\pm 45/90]_s$ laminate

The response of the $[\pm 45/0_2]_s$ laminate was dominated by the on-axis 0° plies, which resulted in a linear elastic stress-strain behaviour (Figure 48.a.). In contrast, the stress-strain response for the loaded $[\pm 45/90_2]_s$ laminate exhibited nonlinearity prior to reaching the peak strain (Figure 48.b.).

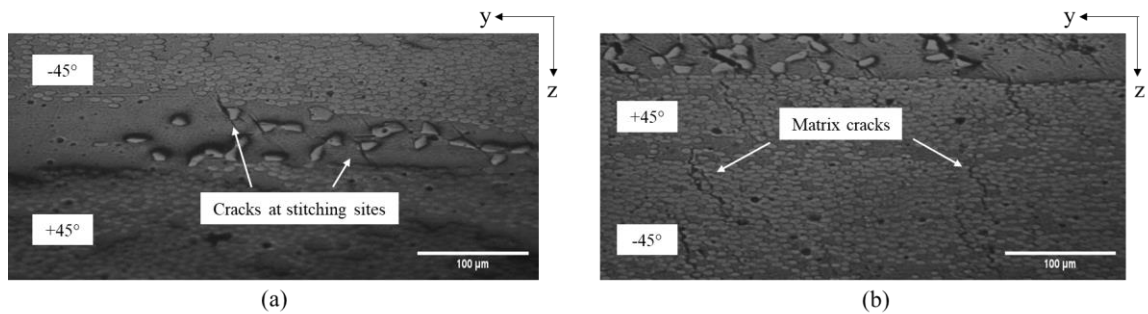
Figure 49: Damage features in the $[\pm 45/0_2]_s$ laminate under tension at (a) 0.69% strain (b) 1.23% strain

In the $[\pm 45/0_2]_s$ laminate, damage initiation was observed in the form of cracks at stitching sites at 0.69% (Figure 49.a.). Cracking in multiple stitching sites was observed as the strain was increased. Minor cracking was observed in -45° ply at 1.23% strain (Figure 49.b.), which was just before specimen failure. The minor cracks in the -45° ply are not counted as ply cracks since they do not span the entire ply thickness. The failure is expected to have occurred when multiple neighbouring fibers present in the same plane in the 0° plies fractured, rendering the specimen incapable of carrying further load.

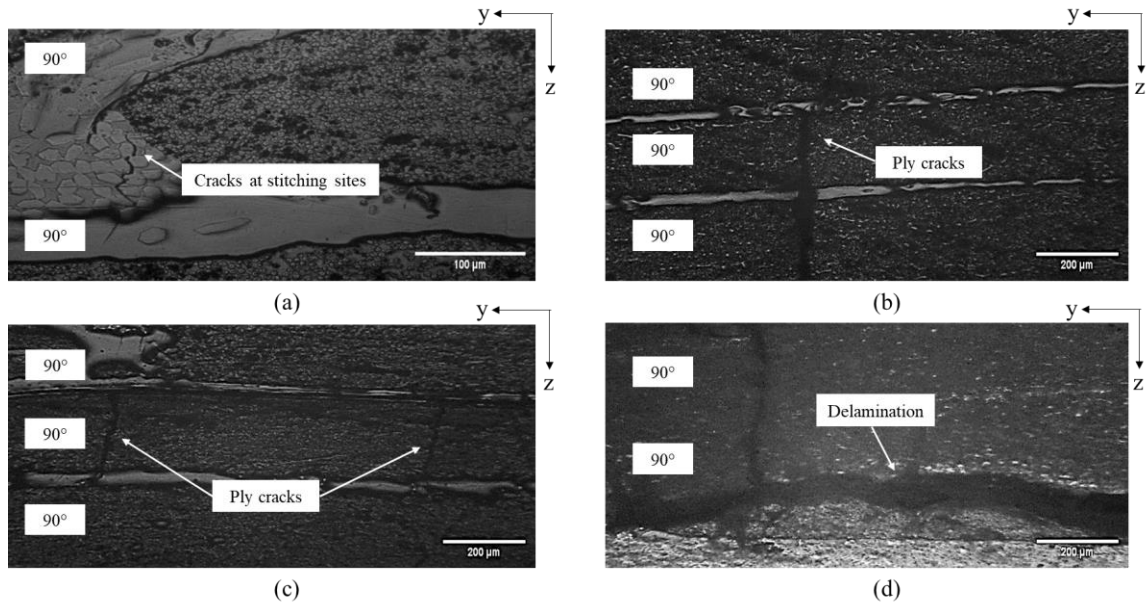
Figure 50: Damage features in the $[\pm 45/90]_s$ laminate under tension at (a) 0.37% strain (b) 0.58% strain (c) 0.76% strain (d) 1.25% strain

The damage evolution process in $[\pm 45/90_2]_s$ laminate was comparable to the damage progression in the $[0/\pm 45/90]_s$ laminate. Cracks were observed at the stitching sites between 90° plies at 0.37% strain, as can be seen in Figure 50.a. As the strain was increased to 0.58% (Figure 50.b.), the cracks in stitching sites were found to nucleate ply cracks in 90° plies. However, the 90° ply cracks instantly saturated and the damage progression was then primarily in the form of $90/90$ delamination cracks and ply cracks in $+45^\circ$ plies. Once these two damage modes stopped growing at 1.25% strain (Figure 50.d.), the primary damage growth was in the form of delamination crack along the $+45/-45$ ply interface up to a strain of 2.31%, after which the specimen failed.

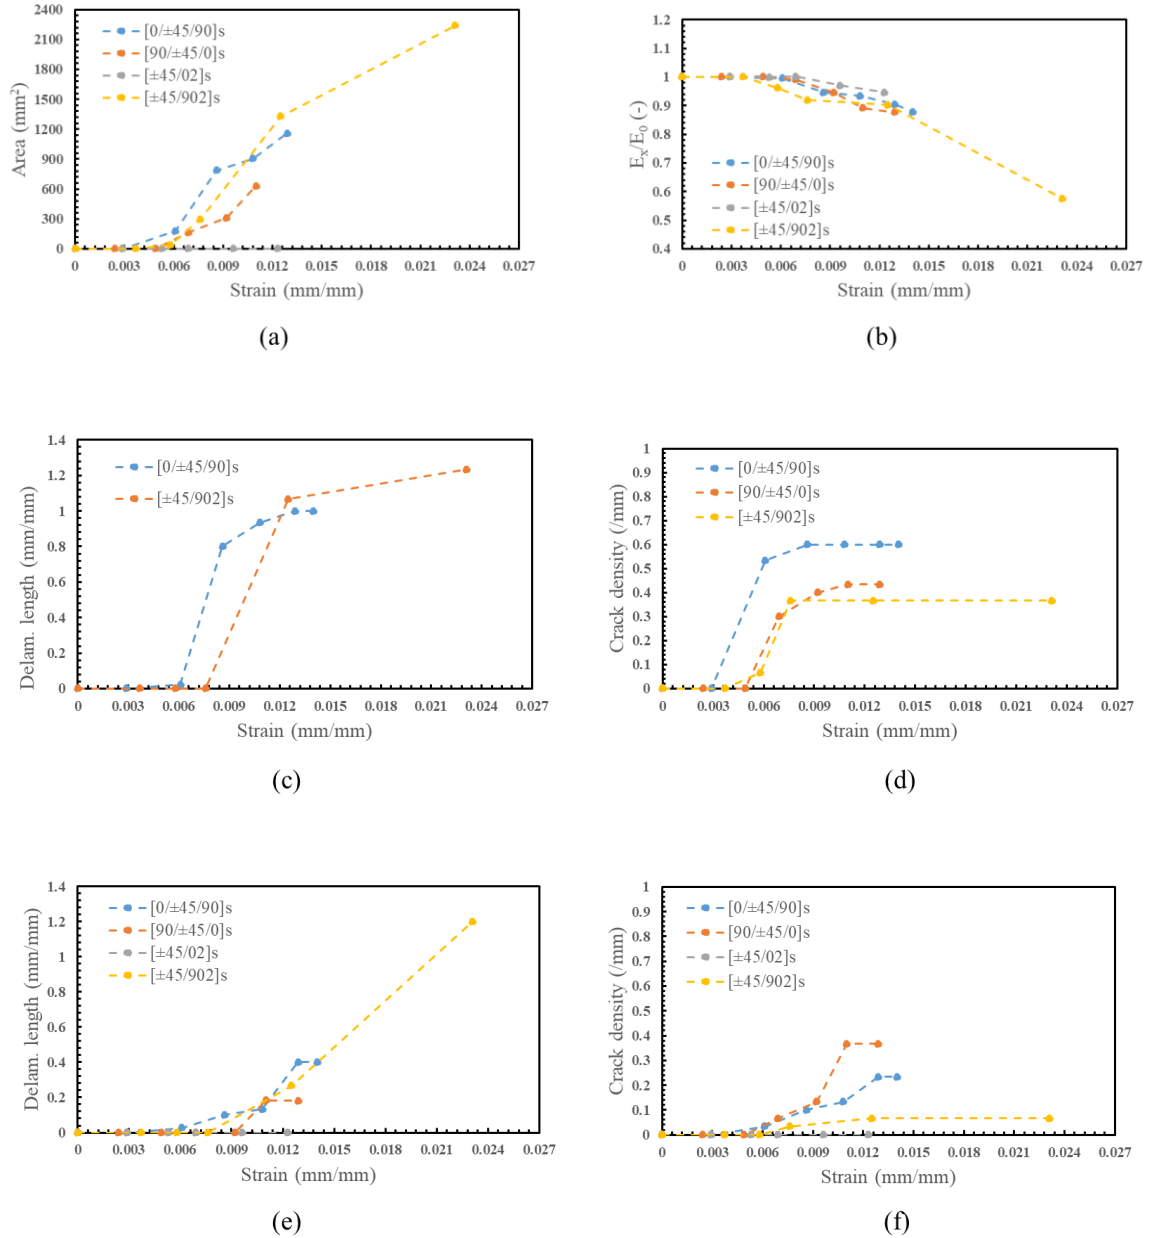
Figure 51: Influence of stacking sequence on (a) total damage area (b) laminate stiffness degradation (c) 90/90 delamination crack growth (d) ply crack multiplication in 90° plies (e) +45/-45 delamination growth (f) ply crack multiplication in 45° plies

The damage modes observed in the studied laminates under axial and transverse tensile loads were quantified and correlated with stiffness degradation (Figure 51). The total damage area is considered to be summation of ply crack and delamination crack surface areas. Ply cracks and delamination cracks were both assumed to span the entire width of the specimen. The number of ply cracks was multiplied by width and ply thickness to calculate area associated with ply cracking. The delamination area was determined by multiplying measured delamination lengths and specimen width. Clear drops in laminate stiffness can be seen corresponding to increase in damage areas (Figure 51). Laminate stiffness was calculated from the stress-strain curves of the interrupted tests (Figure 45 and Figure 50) within the strain range of 0.1%-0.2%. Although the stiffness of both, $[0/\pm 45/90]_s$ and $[90/\pm 45/0]_s$ laminates, drops to 87% of the initial stiffness (E_0) at the end of the test, the damage area is higher for the $[0/\pm 45/90]_s$ laminate. The most significant drop in laminate stiffness was observed in the case of $[\pm 45/90]_s$ laminate, which was about 57% of E_0 . The major contribution to stiffness drops in $[0/\pm 45/90]_s$ laminate and $[\pm 45/90]_s$ laminate came from 90/90 delamination crack (Figure 51).
