Damage in Non-Crimp Fabric carbon fiber reinforced epoxy composites under various mechanical loading conditions

A thesis submitted in partial fulfillment of the requirements for the Doctor of Philosophy degree in Mechanical and Materials Engineering

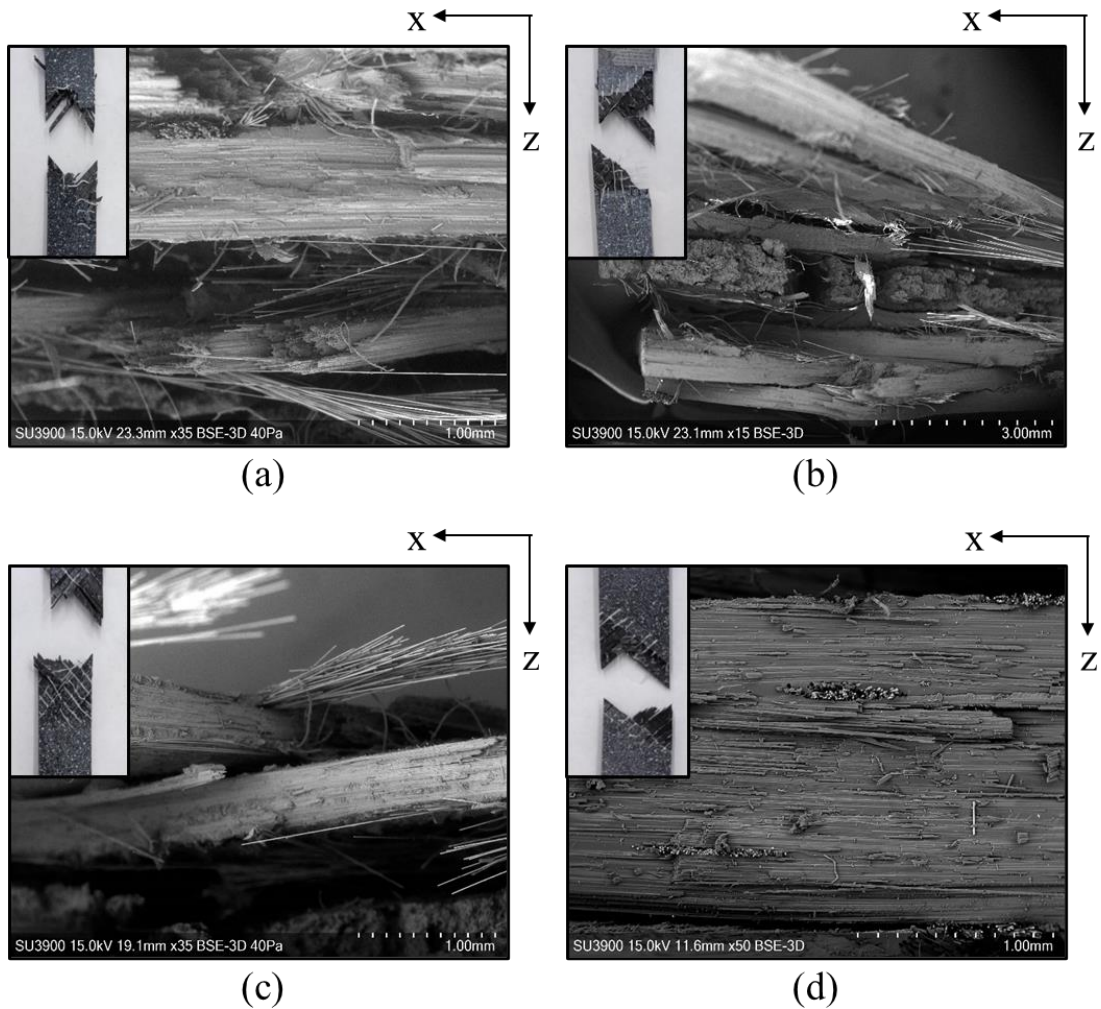
Figure 52: Post failure surfaces of (a) $[0/\pm 45/90]_s$ laminate (b) $[90/\pm 45/0]_s$ laminate (c) $[\pm 45/0]_2$ laminate (d) $[\pm 45/90]_2$ laminate

As was discussed in the previous sections (Section 6.2.2), although the actual process of damage growth is dependent on the stacking sequences and loading conditions, the catastrophic failure of the test coupons is dictated by the failure of 0° plies. Visual inspection of the failed coupons revealed that the different plies failed on different planes, confirming the occurrence of delamination and matrix cracks prior to the final failure of the specimen. The scanning electron microscopy images of the failed surfaces of the multidirectional laminates are shown in Figure 52. Similar features may be observed on the 0° , 45° and 90° plies, irrespective of the ply stacking sequence and loading condition. The different laminates will hence not be discussed separately in this section.

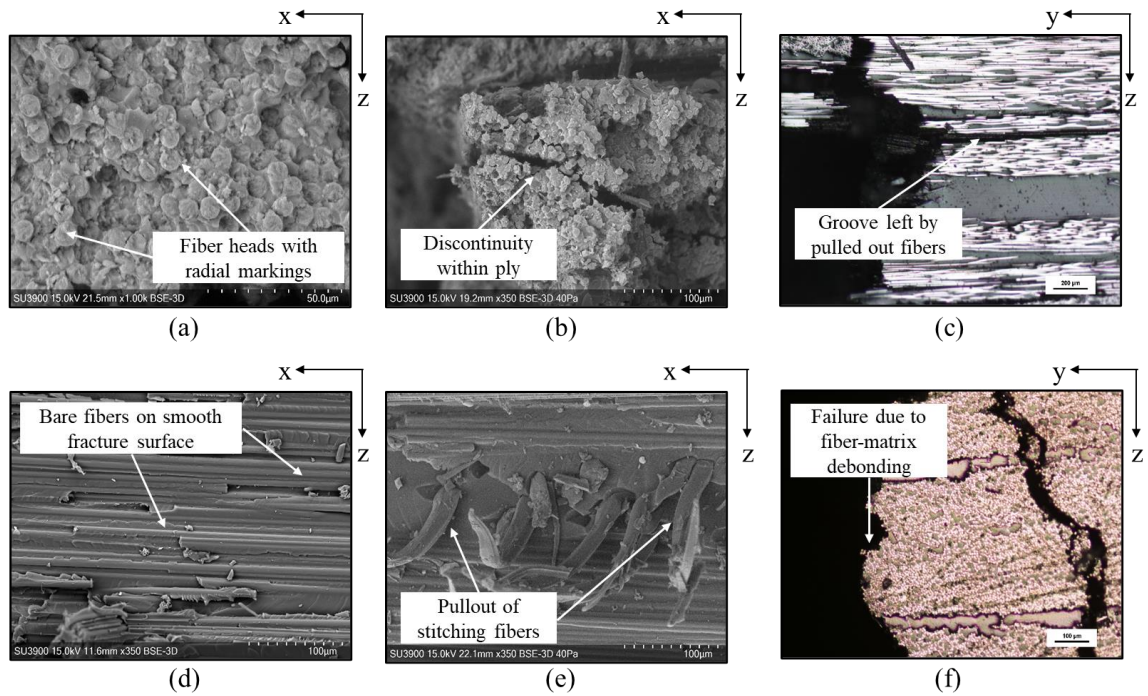
Figure 53: (a-b) Post failure surface of 0° plies (c) Edge image of failed 0° ply (d-e) Post failure surface of 90° plies (f) Edge image of failed 90° ply

Some of the general features observed on the surfaces of 0° and 90° plies in the laminates were similar to the distinguishing features observed on the surfaces of unidirectional composites (Section 6.1). The load bearing 0° plies were characterized by a rugged surface and radial markings extending from a local defect on broken fibers (Figure 53.a.). On the other hand, the surfaces of 90° plies were smooth with bare fibers and pockets of resin-rich areas, indicative of failure by fiber-matrix debonding. The edge images of the 90° plies revealed that the catastrophic crack passed through the tows and not along the tow boundary (Figure 53.d. and Figure 53.f.).

Other than the common general features observed on the surfaces of 0° plies, unlike in unidirectional composites, the failure was non-coplanar. The surface (Figure 53.b.) and edge images (Figure 53.c.) revealed the presence of grooves left behind by the pulled-out fibers. This indicates that fiber breaks occur at multiple points throughout the ply. The locations of these fiber breaks may correspond to breaks in the adjacent compliant plies. The single fiber breaks then cause failure of neighboring fibers, which then get pulled out as in clusters or as a bundle upon catastrophic failure, leaving behind the grooves. Similarly, in the 90° plies, in addition to the features observed in transversely loaded unidirectional composites, pull-out of stitching polyester fibers was observed on the surface. Localized plastic deformation was observed in the immediate vicinity of the pulled-out stitching fibers. This can be attributed to the continued stress transfer to the 90° plies through the adjacent stiffer plies.

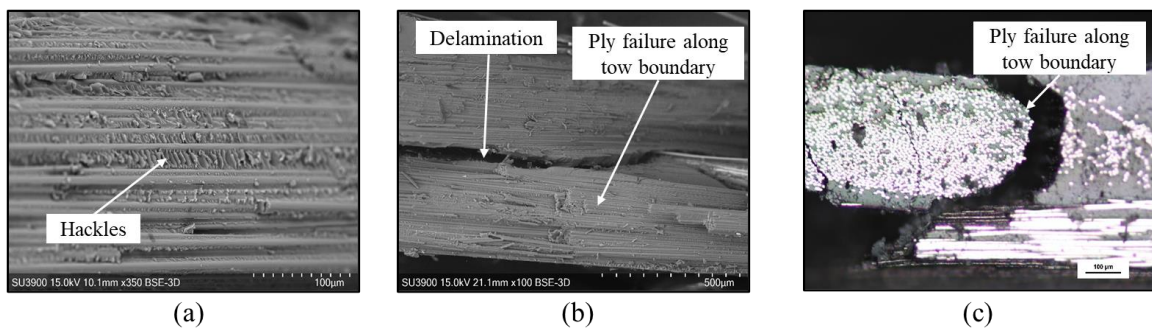
Figure 54: (a-b) Post failure surface of 45° plies (c) Edge image of failed 45° ply

A close inspection of failed 45° plies reveals the presence of hackles (Figure 54.a.), which are indicative of in-plane shear within the lamina. However, as was also observed in the damage evolution process (Section 6.2.2), the ± 45 interface is most prone to delamination owing to its orthogonality. The presence of delamination during the fracture process between $+45^\circ$ and -45° ply effectively degrades the level of constraint on the plies, allowing them to rotate in the direction of loading, which eventually leads to the tensile fracture of the 45° plies along the tow boundary (Figure 54.b. and Figure 54.c.). The features observed on the surfaces of 45° plies were consistent across the two tested laminates under the axial and transverse loading conditions.

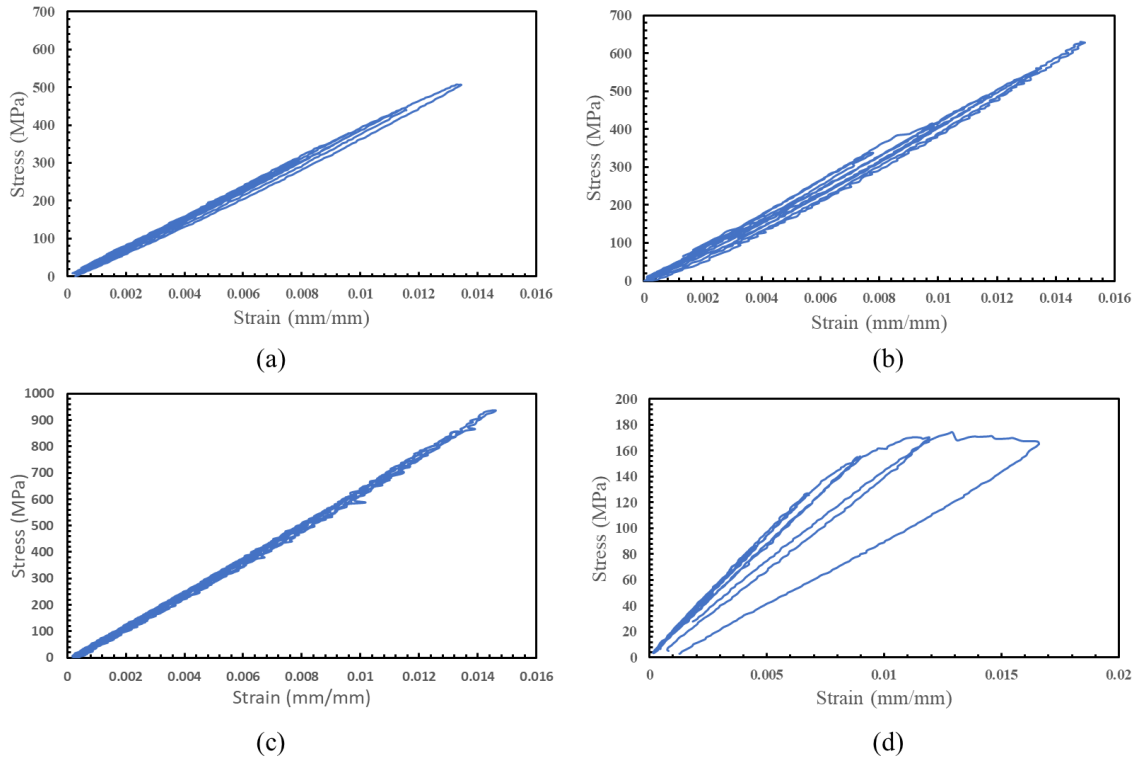
Figure 55: Stress-strain curves from loading-unloading test for (a) $[0/\pm 45/90]_s$ laminate (b) $[90/\pm 45/0]_s$ laminate (c) $[\pm 45/0/2]_s$ laminate (d) $[\pm 45/90/2]_s$ laminate

The second strategy for energy dissipation computation entailed performing loading-unloading tests. The test coupons with a similar geometry as used for the characterization and damage evolution tests were used for these displacement-controlled tests. The specimens were loaded in increments of 0.2 mm until failure at a cross head displacement rate of 2 mm/min. The cross head was brought back to a displacement value very close to 0 mm at the end of every loading cycle. The stress was calculated as a ratio of load readings from the load-cell and area and the strain in the tests was measured using DIC. The stress-strain curves for the tested laminates are shown in Figure 55. The energy dissipated in each step was calculated as a product of the area enclosed by the loop formed by the loading-unloading curves and the volume of the specimen used for strain measurement. The laminate stiffness was measured from the loading part of each step in the 0.1-0.2% strain range.

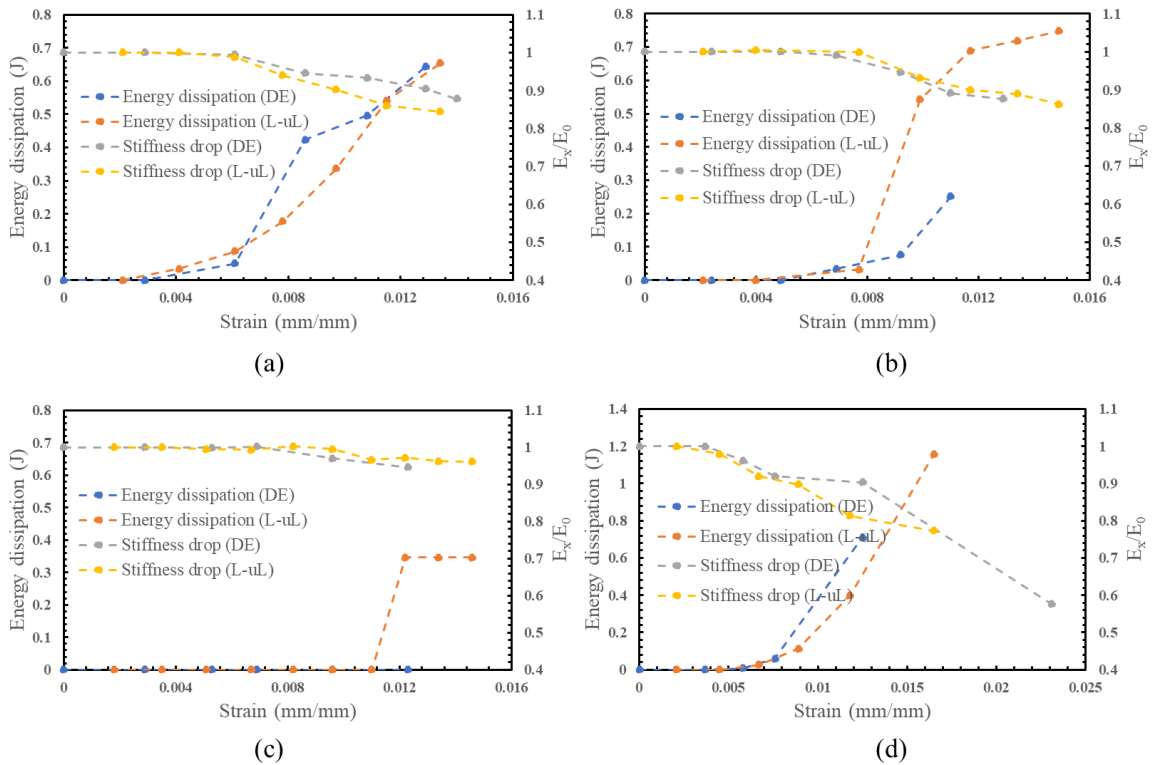
Figure 56: Energy dissipated in and stiffness drops in (a) $[0/\pm 45/90]_s$ laminate (b) $[90/\pm 45/0]_s$ laminate (c) $[\pm 45/0_2]_s$ laminate (d) $[\pm 45/90_2]_s$ laminate

The energy dissipation and stiffness drop from both the strategies are compared in Figure 56. ‘DE’ stands for ‘Damage Evolution’ and represents results from the first strategy (from the damage evolution tests). ‘L-uL’ stands for ‘Loading-unLoading’ and is representative of the results from the second strategy.

The energy dissipation and laminate stiffness trends are in general agreement for all the tested laminates. The energy dissipation value in damage evolution tests is higher than the loading-unloading tests at around 0.8% (Figure 56.a.) for $[0/\pm 45/90]_s$ laminate. A possible cause for the higher energy dissipation could be due to a higher delamination length in the damage evolution test specimen. As it was described in Section 6.2.2.1, the key damage mechanism was identified as 90/90 delamination. It was formed by joining of cracks in the transverse cracks, whose crack density is governed by the cracks in stitching sites. The occurrence of cracks in the weak stitching sites is stochastic. A higher number of cracks in stitching sites at lower strains may result in higher transverse crack

density and longer delamination lengths at higher strains, leading to higher energy dissipated. The DE specimen failed at a lower strain in the $[90/\pm 45/0]_s$ laminate (Figure 56.b.). The failure was governed by the failure of the load-bearing fibers, which is also a statistical phenomenon (as was described in Section 2.3.2.1, Section 6.1.1 and Section 6.2.3).

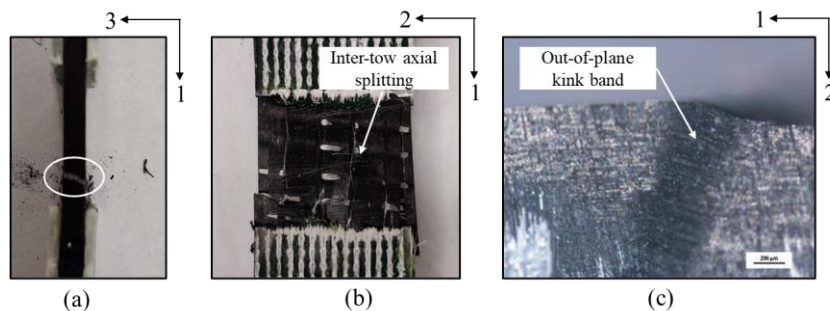
Figure 57: (a-c) Failure by out-of-plane kink band formation in unidirectional lamina under axial compression

The unidirectional lamina failed by fiber microbuckling under axial compression. An out-of-plane kink band may clearly be seen in Figure 57. No in-plane component was observed. Inter-tow axial splits were also observed in the failed specimens. However, it is inconclusive at this stage if the inter-tow splitting precedes or succeeds the kink band formation.

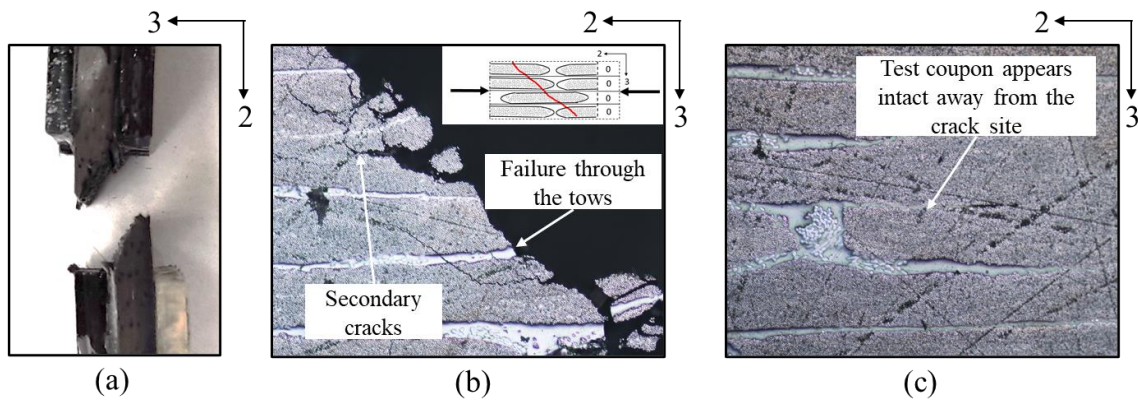
Figure 58: (a) Unidirectional lamina failed under transverse compression (b-c) Edge images of the test coupon failed under transverse compression

The failure of unidirectional test coupon under transverse compression is characterized by a single crack inclined to the loading direction (Figure 58.a.). The crack is a result of matrix yielding and fiber-matrix debonding. The average fracture angle was measured to be 53° . The crack propagated primarily through the tows (Figure 58.b.). Several secondary cracks branching out of the primary crack were also observed. The growth of the secondary cracks was also found to be primarily through the tows rather than along the tow boundaries. However, no damage was observed away from the immediate vicinity of the crack site (Figure 58.c.) in the test coupon.

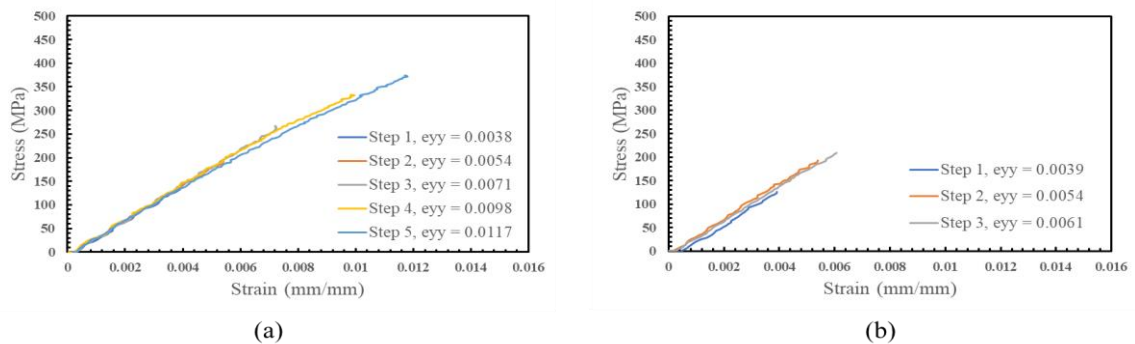
Figure 59: Stress-strain curves from interrupted compression tests for (a) $[0/\pm 45/90]_s$ laminate (b) $[90/\pm 45/0]_s$ laminate

The $[0/\pm 45/90]_s$ and $[90/\pm 45/0]_s$ laminates primarily exhibit linear elastic response (Figure 59) through majority of loading steps. First form of damage in $[0/\pm 45/90]_s$ laminate was observed at 0.71% strain as local cracks in the stitching sites (Figure 60.a.). As the coupon was further subjected to a greater load, cracks appeared in more stitching sites through the coupon, which corresponds to a change of slope in step 4 in Figure 59.a.. The load was sufficiently high at this point ($\epsilon_{yy} = 0.98\%$) for some of the cracks in the stitching sites to grow as delamination along the $0/+45$ and ± 45 interfaces (Figure 60.b.). The length of these cracks was in the order of tens of micrometers and hence could not be accurately quantified. The specimen suffered an instantaneous catastrophic failure in the next loading step at 1.17% strain.

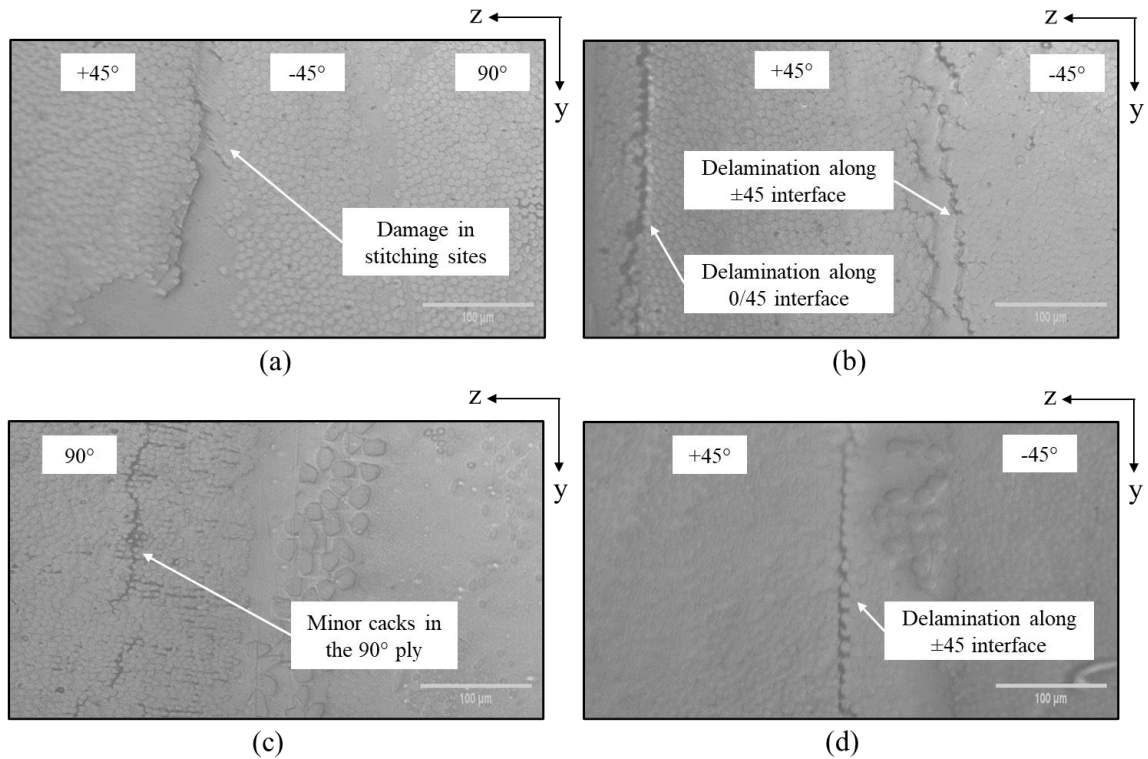
Figure 60: Damage in compression loaded (a) $[0/\pm 45/90]_s$ laminate at 0.71% strain (b) $[0/\pm 45/90]_s$ laminate at 0.98% strain (c) $[90/\pm 45/0]_s$ laminate at 0.39% strain (d) $[90/\pm 45/0]_s$ laminate at 0.54% strain

However, the damage initiation was observed at a lower strain in the $[90/\pm 45/0]_s$ laminate. Minor fiber-matrix debonding cracks were observed in the 90° plies (Figure 60.c.) at 0.39% strain. Majority of the cracks were confined to a single tow each in both the 90° plies. These cracks however caused no appreciable reduction in stiffness, as can be deduced from the linear-elastic stress-strain curves (steps 1 and 2 in Figure 59.b.). As the specimen was further strained to 0.54% strain, a single delamination crack, tens of micrometers long, was observed along the ± 45 interface (Figure 60.d.). This crack, however, does not seem to have grown from a cracked stitching site. The laminate failed in the next loading step (step 3 in Figure 59.b.).

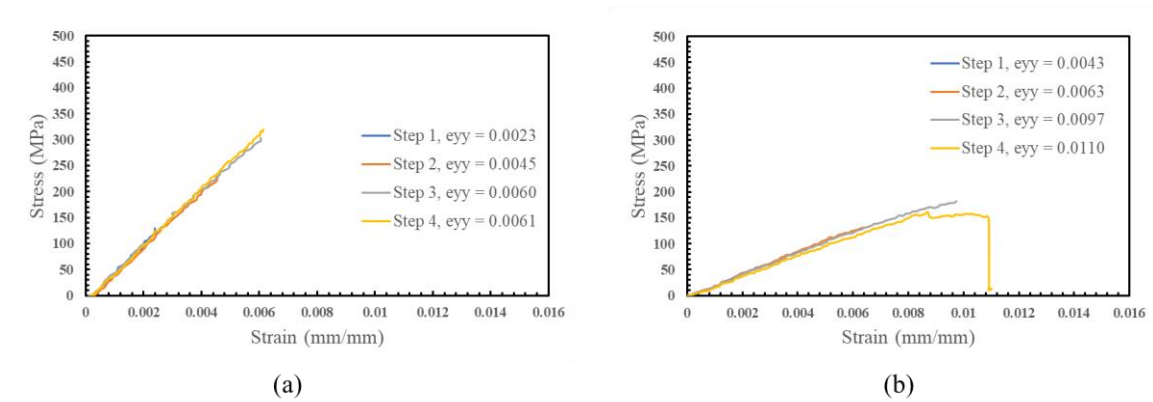
Figure 61: Stress-strain curves from interrupted compression tests for (a) $[\pm 45/0_2]_s$ laminate (b) $[\pm 45/90_2]_s$ laminate

The stress-strain response of the $[\pm 45/0_2]_s$ laminate under compression is primarily governed by the stiffer 0° plies (Figure 61.a.). The stress-strain response of this laminate under axial compression is linear-elastic through all loading steps. The damage initiates at the interface between glass yarns and matrix at 0.23% (Figure 62.a.) in this case. At higher loads, cracks were observed in multiple such glass yarn and stitching sites (Figure 62.b.). The laminate ultimately failed catastrophically when the load bearing 0° plies failed. On the other hand, in the $[\pm 45/90_2]_s$ laminate, the damage initiated in the stitching sites on ± 45 interface at 0.63% strain (Figure 62.c.), followed by delamination along ± 45 interface at 0.97% strain (Figure 62.d.) and eventual failure.

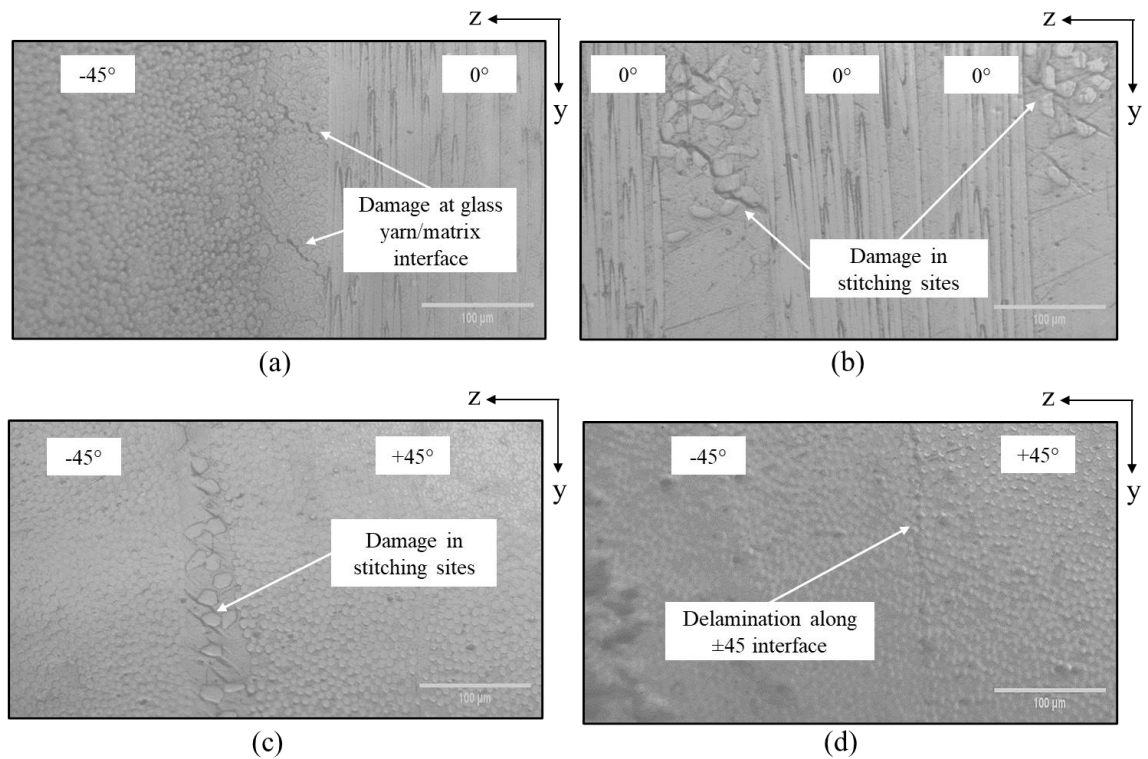
Figure 62: Damage in compression loaded (a) $[\pm 45/0_2]_s$ laminate at 0.23% strain (b) $[\pm 45/0_2]_s$ laminate at 0.60% strain (c) $[\pm 45/90_2]_s$ laminate at 0.63% strain (d) $[\pm 45/90_2]_s$ laminate at 0.97% strain

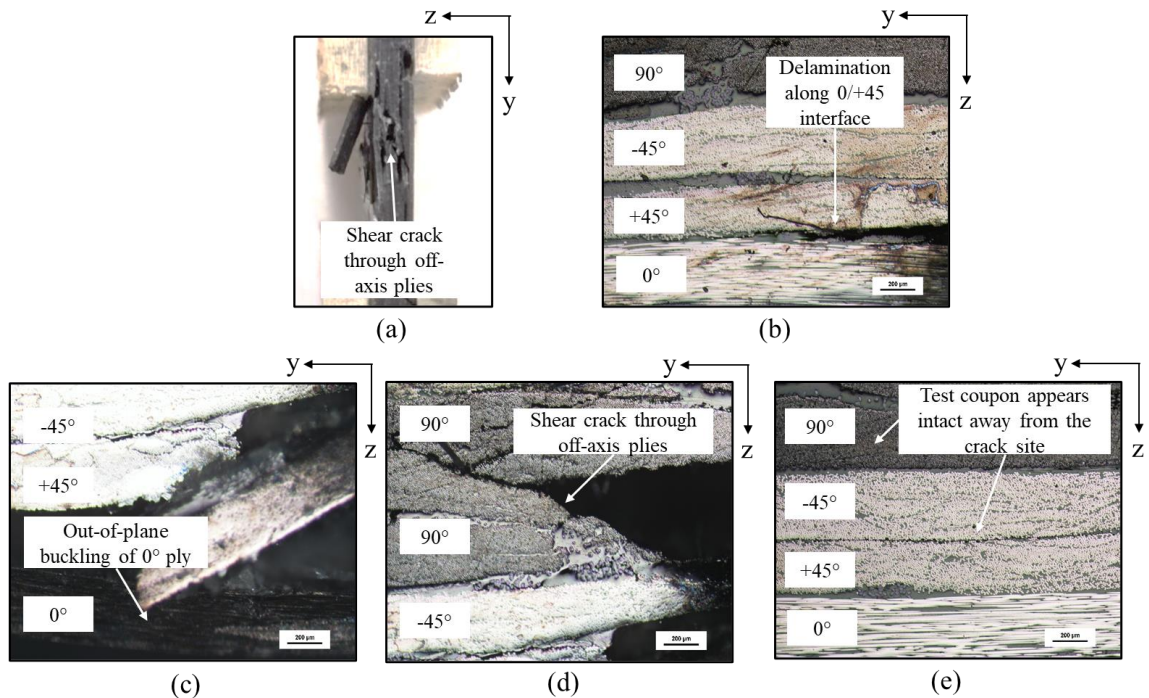
Figure 63: (a) [0/±45/90]_s laminate failed under compression (b-e) Edge images of failed [0/±45/90]_s laminate under compression

The failure of a $[0/\pm 45/90]_s$ laminate under axial compression is primarily characterized by out-of-plane buckling of 0° plies (aligned along y-direction) and the presence of a single angled crack through the off-axis 45° and 90° plies (Figure 63.a.) oriented at 51° to the loading direction. Similar to the transverse compressive failure in unidirectional composites, the angled crack through the off-axis plies is a combination of failure of the matrix by in-plane shear and fiber-matrix debonding. The key characteristic of the axial compressive failure in this laminate is, however, presence of delamination along $0/+45$ interface (Figure 63.b.). At a sufficiently high load, the local cracks in the stitching sites grow as delamination, which causes the 0° plies to buckle out-of-plane. The loss of the load-bearing 0° plies causes failure of off-axis plies by transverse compression failure mode through the tows (Figure 63.d.) and hence, catastrophic failure of the test coupon. The areas of the test coupon away from the failure site appear intact (Figure 63.e.).

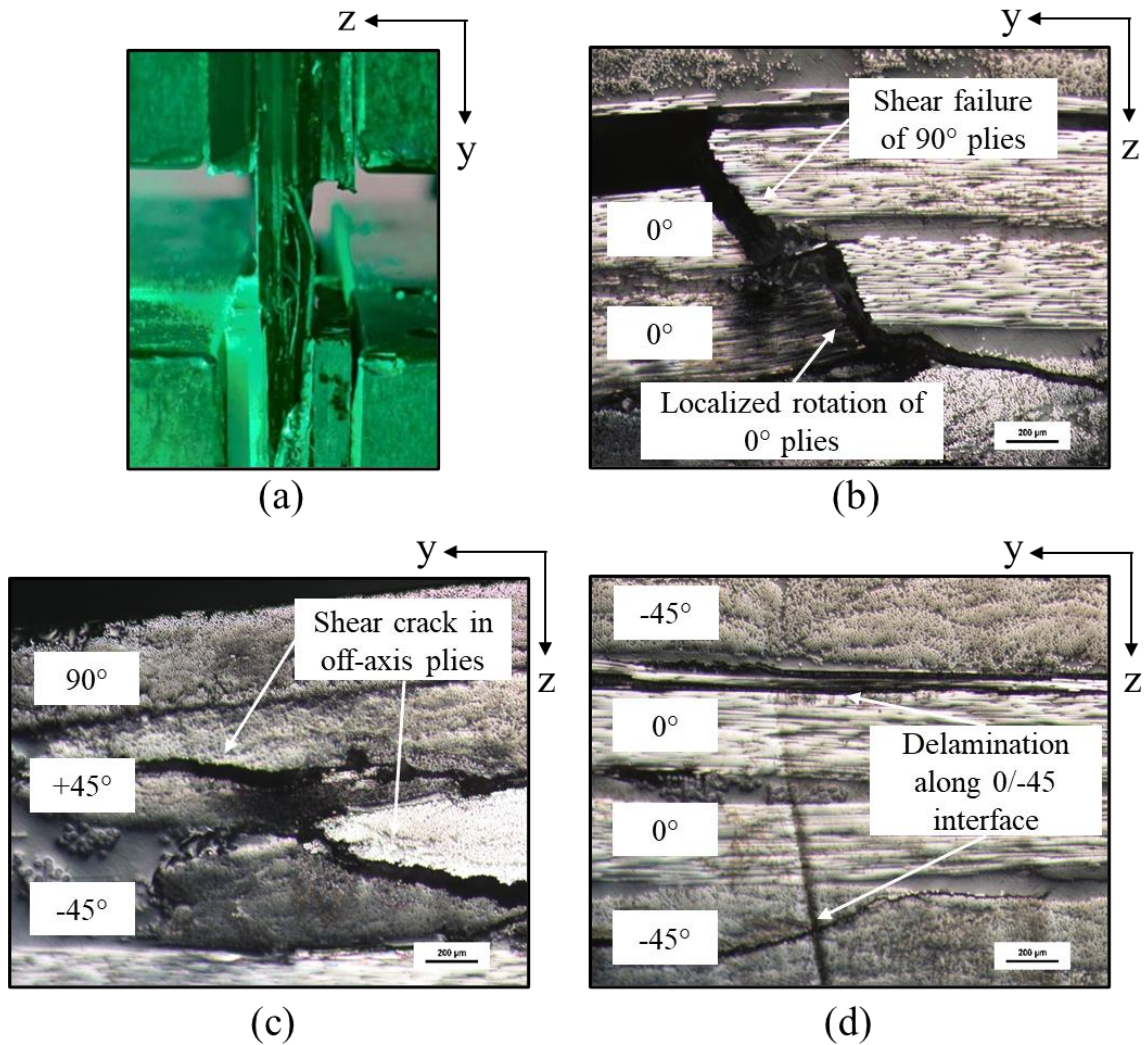
Figure 64: (a) $[90/\pm 45/0]_s$ laminate failed under compression (b-d) Edge images of failed $[90/\pm 45/0]_s$ laminate under compression

A different set of failure modes was observed in the [90/±45/0]_s laminate (Figure 63.a. and Figure 64.a.). Unlike in the [0/±45/90]_s laminate, the delamination seems to have a relatively lesser influence on the failure process. The load bearing plies are centrally located in this loading case. The failure of the laminate is hence driven primarily by the compressive failure of the centrally located 0° plies.

Figure 64.b. and Figure 64.c. reveal a failure of the load bearing plies by shear mode. This failure mode reportedly occurs in composites with very low fiber misalignment at practical volume fractions, when the fibers are closely packed and their relative deformations are in-phase (Agarwal, Broutman, & Chandrashekhara, 2015). This mode is characterized by failure of the plies inclined at approximately 45° to the loading direction (y-direction in Figure 64) and a localized rotation of the fibers (Figure 64.c.). Based on the results from damage evolution tests (Section 7.2.1), it may be said that the rotation of fibers must have occurred at the instant of failure, as no evidence of rotation was found before the failure. The failure of the 0° plies causes the laminate to collapse by buckling,

characterized by a single obliquely oriented shear crack through the off-axis plies, oriented at about 49° to the loading axis, on either side of the central load-bearing plies. A closer inspection also reveals the presence of delamination along 0° / -45° interface extending along y -direction (Figure 64.d.), but is unlikely to have played a major role in the catastrophic failure of the laminate.

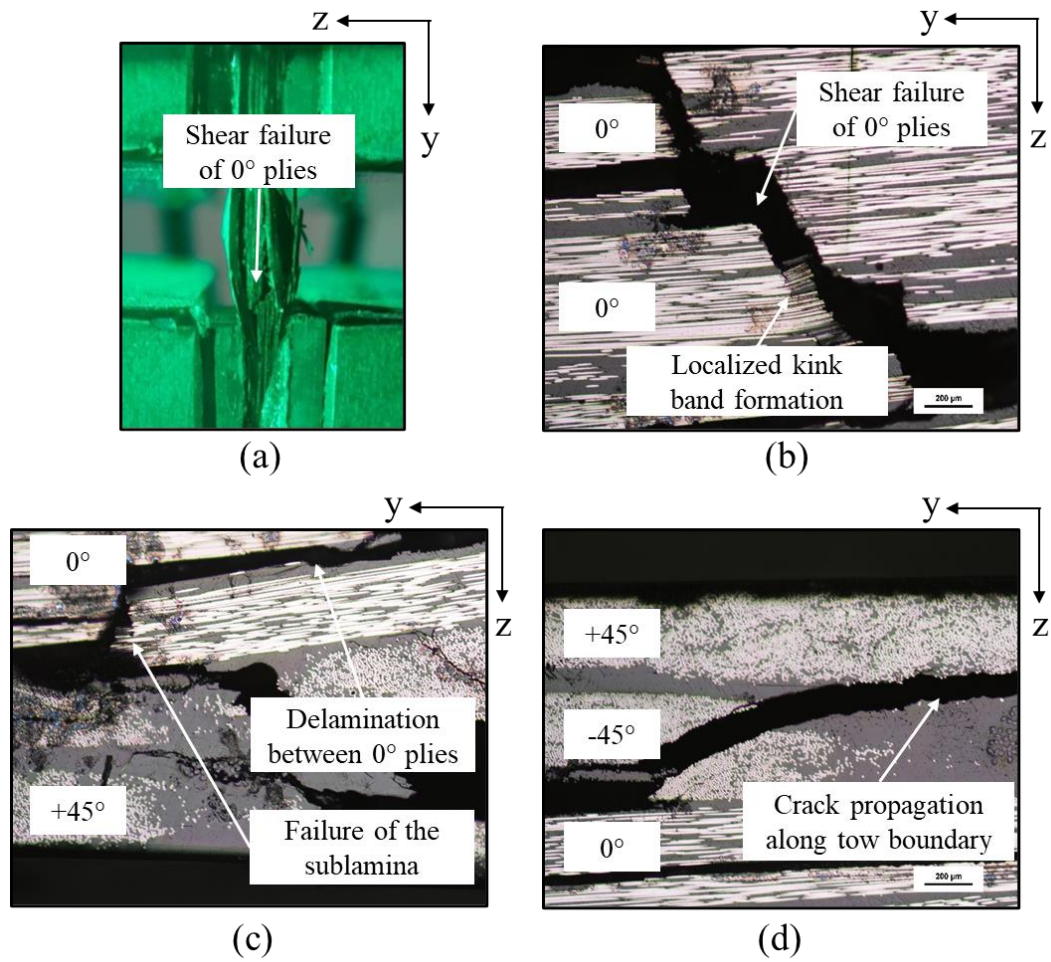
Figure 65: (a) $[\pm 45/0_2]_s$ laminate failed under compression (b-d) Edge images of failed $[\pm 45/0_2]_s$ laminate under compression

Similar to the failure in $[90/\pm 45/0]_s$ laminate (Section 7.2.2.1), the failure of $[\pm 45/0_2]_s$ laminate under compressive loading is governed by the failure of central load-bearing 0° plies (Figure 65.a.). The failure of the 0° plies in this case is, however, an amalgamation of different failure modes (Figure 65.b.-c.). Formation of localized kink band is observed, which is likely a result of local crimp in the fibers, along with the shear failure of the 0° plies, with the failure plane oriented at 33° to the loading axis. Further, localized delaminations were observed between the 0° plies. The delaminations effectively divided the stack of 0° plies into multiple sublamina, which then failed independently by localized rotations and shear. Since no onset of delamination was observed through the damage evolution process (Section 7.2.1), it is not possible to concretely conclude from the available data if the delaminations started to propagate prior to or during fiber failure. Once the 0° plies fail, the outer 45° plies fail at a site in the vicinity of failure site in 0° plies. While the crack may either propagate through the tows or along the boundary of the inner -45° ply, a definite tendency for the crack to propagate along the boundary of outer $+45^\circ$ ply at the ± 45 interface may be observed (Figure 65.d.). This may be attributed to the orthogonality of the ± 45 interface.

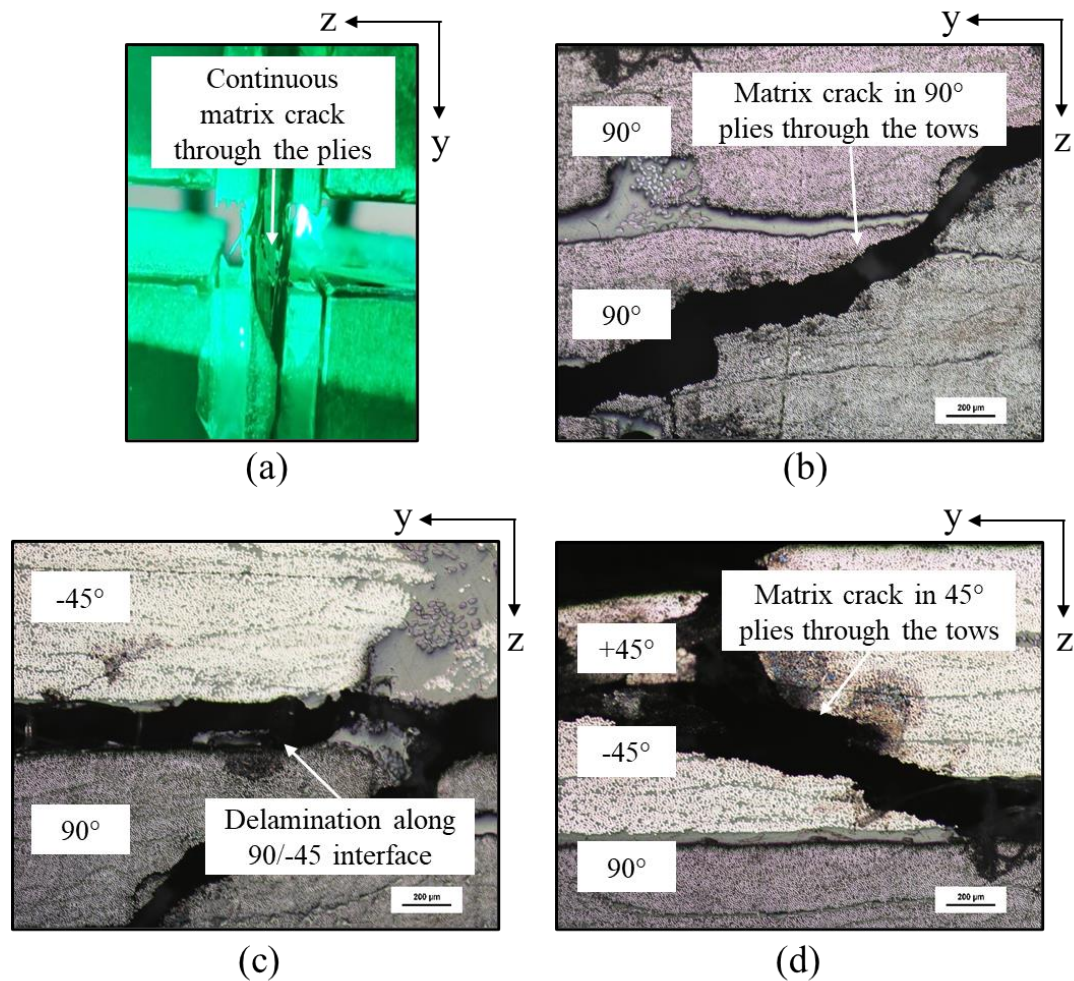
Figure 66: (a) $[\pm 45/90_2]_s$ laminate failed under compression (b-d) Edge images of failed $[\pm 45/90_2]_s$ laminate under compression

On the other hand, all the plies in the $[\pm 45/90_2]_s$ laminate are effectively off-axis plies. The failure hence occurs by the transverse compression mode, i.e., by yielding of the matrix due to in-plane shear and fiber-matrix debonding, as is characterized by the presence of an oblique crack inclined at 58° and parallel to the fibers (Figure 66.a.). The crack passes through the tows in 90° plies (Figure 66.b.). Further, delaminations are observed along the $90/-45$ interface (Figure 66.c.), but no such interply crack was observed along the ± 45 interface, as was generally the case under other loading conditions. The crack through 90° plies, together with the delamination along $0/+45$ interface and the crack passing through the tows in the outer 45° plies (Figure 66.d.) forms one continuous crack in the $[\pm 45/90_2]_s$ laminate under compressive loading.

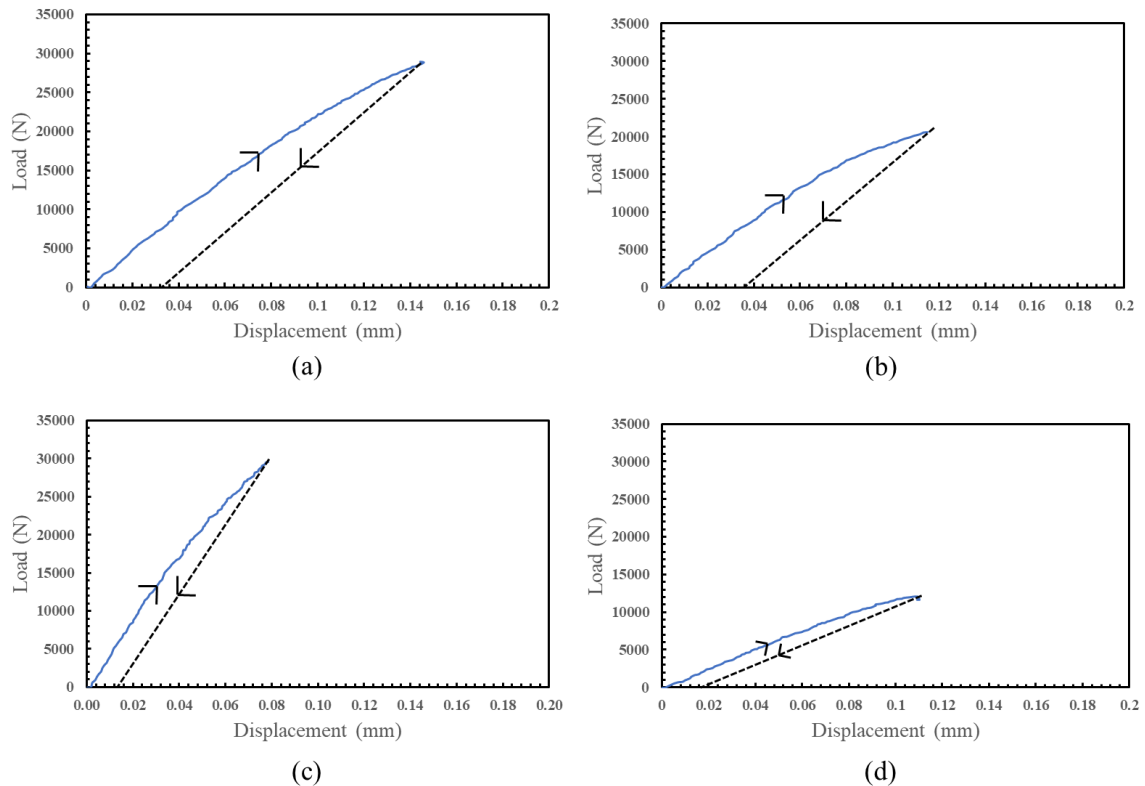
Figure 67: Representative load-displacement curves for (a) $[0/\pm 45/90]_s$ laminate (b) $[90/\pm 45/0]_s$ laminate (c) $[\pm 45/0]_2$ laminate (d) $[\pm 45/90]_2$ laminate

The energy dissipated in the laminate may be calculated using the load-displacement curves (Representative curves shown in Figure 67). The blue part of the curves is the loading part of the curve, as recorded during uninterrupted tests. The black dashed line is the unloading curve, which is assumed to trace back along a path parallel to the initial elastic region of the loading curve. This assumption implies that all the energy dissipated in the damage, responsible for the change of slope of the loading curve after elastic regime, is non-recoverable and that the damage is permanent. The total energy dissipated in damage (Table 4) is the area enclosed by the loading-unloading loop. The calculated energies are listed in Appendix 15.

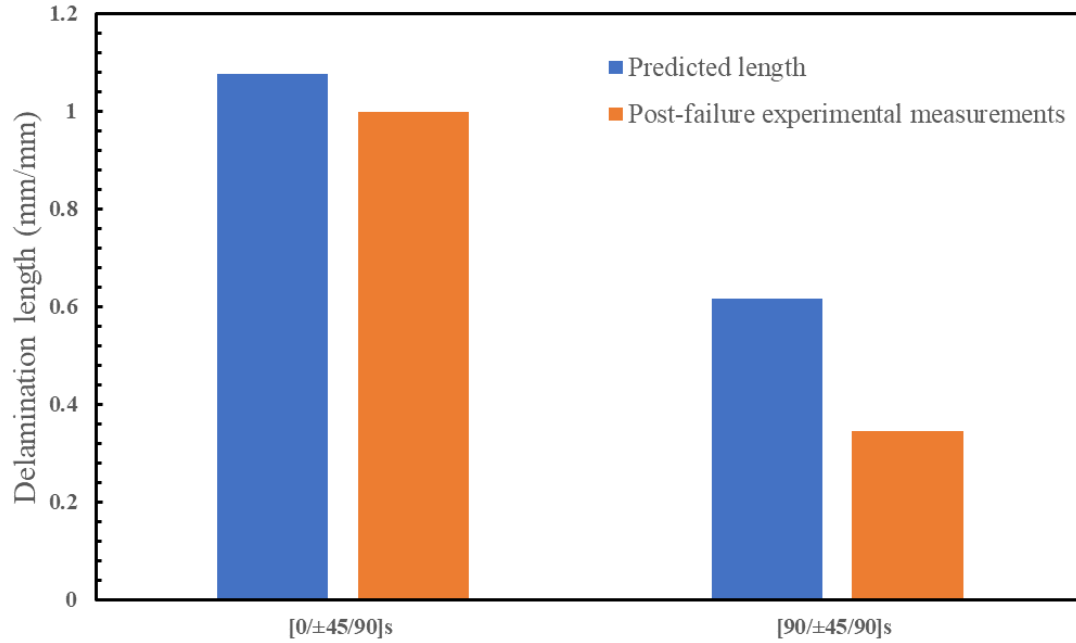
Figure 68: Comparison of predicted delamination lengths and post-failure measurements in $[0/\pm 45/90]_s$ and $[90/\pm 45/90]_s$ laminates under compression

Similarly, the energy is dissipated in two matrix shear cracks, one fiber shear crack and delamination along 90/-45 interface in the $[90/\pm 45/0]_s$ laminate. Therefore, applying the same treatment as before, the energies dissipated in the matrix and fiber shear cracks were first determined. The energies were subtracted from the total dissipated energy, and the remaining energy was used to predict the length of delamination, which was approximately 16 mm in this case.

The predicted lengths are total delamination lengths in the specimen, i.e., a summation of delamination along both the 0/+45 or 90/-45 interfaces. The normalized predicted length is very close to the experimentally measured and normalized post-failure delamination length in the $[0/\pm 45/90]_s$ laminate, but appears to be overpredicted in the $[90/\pm 45/0]_s$ laminate (Figure 68). The overprediction in $[90/\pm 45/0]_s$ laminate is expected to be a reflection of an unaccounted population of secondary fiber/matrix debonds that were observed in damage evolution process (Section 7.2.1.1).

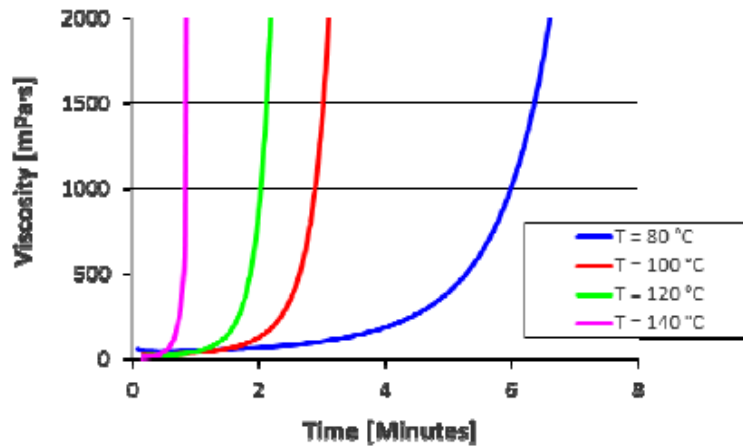
Viscosity profiles data of formulation at different temperatures

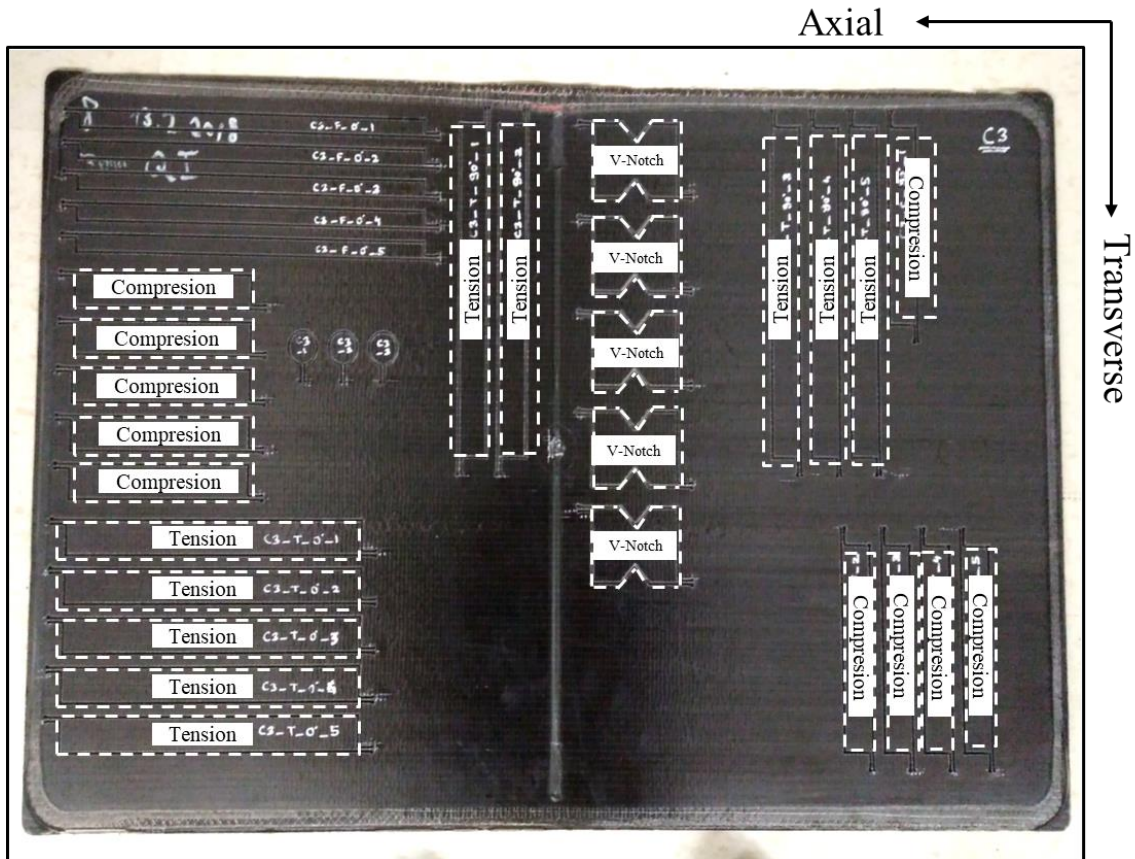
Appendix 4: Plaque of NCF composites manufactured using HP-RTM process with specimen cutting position

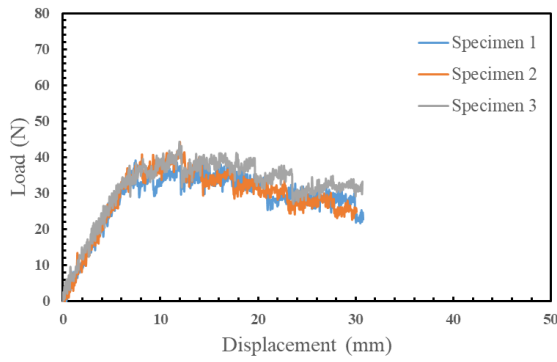
Appendix 7: Unfiltered load-displacement curves under Mode-I loads

Unidirectional lamina

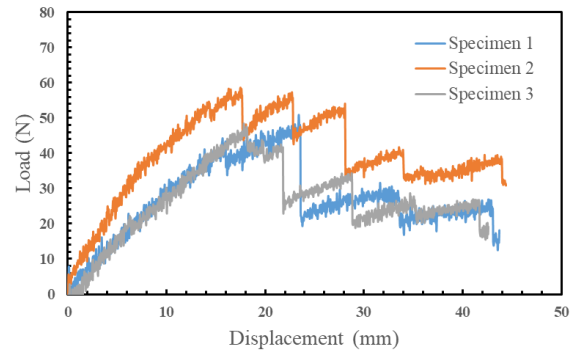
Cross-ply laminate

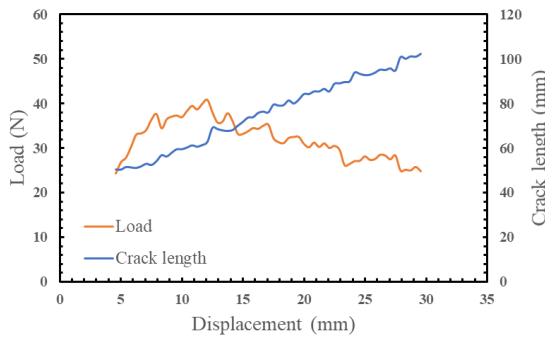
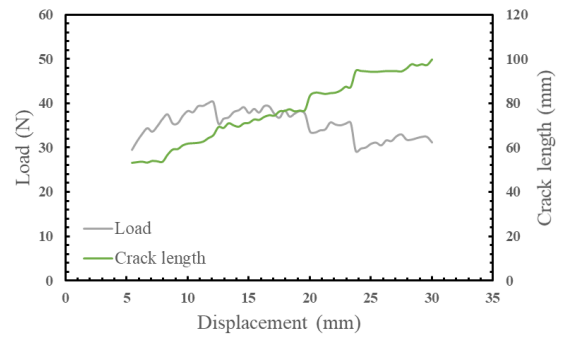
Appendix 8: Mode-I crack growth characteristics in unidirectional lamina

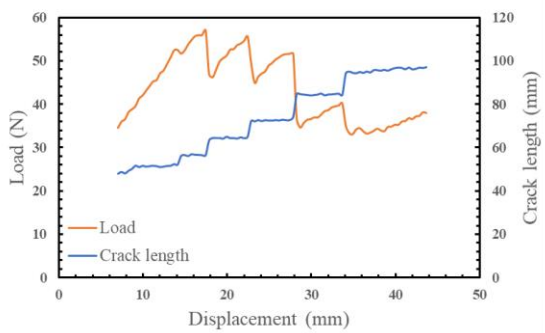
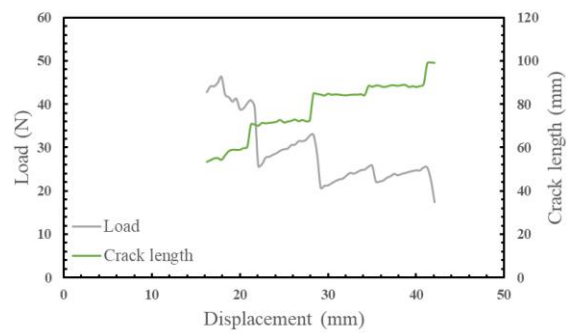
Appendix 9: Mode-I crack growth characteristics in cross-ply laminates

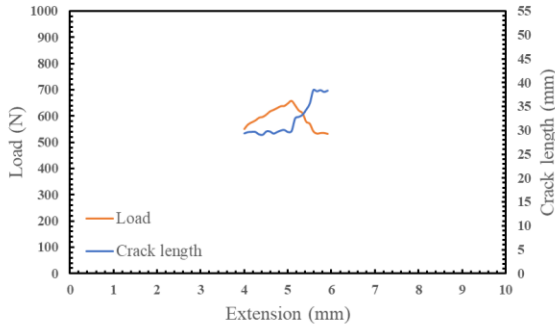
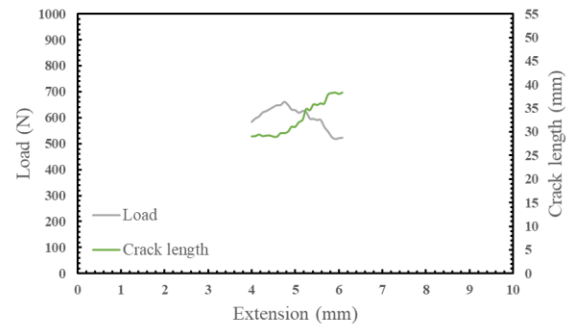
Appendix 10: Mode-II crack growth characteristics in unidirectional lamina

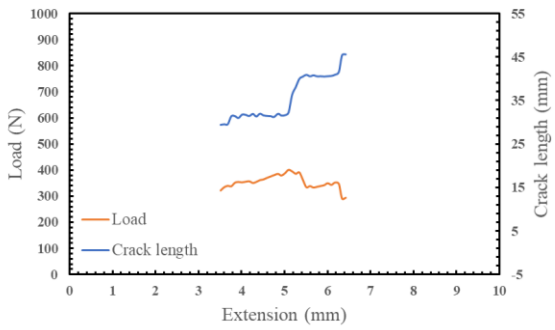
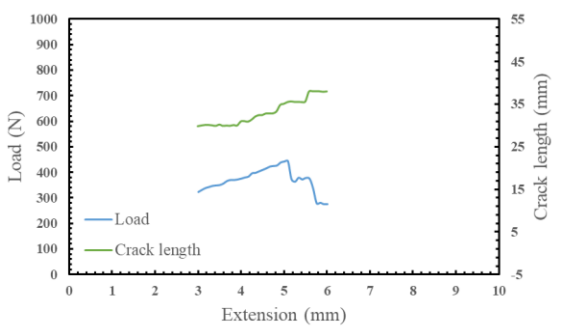
Appendix 11: Mode-II crack growth characteristics in cross-ply laminates

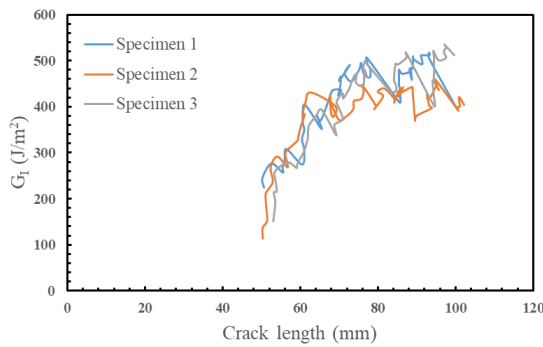
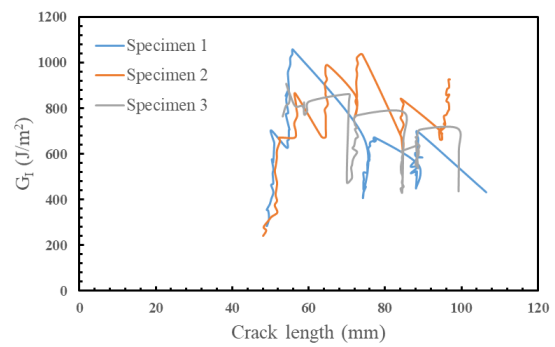
Appendix 12: R-curves under Mode-I opening loads

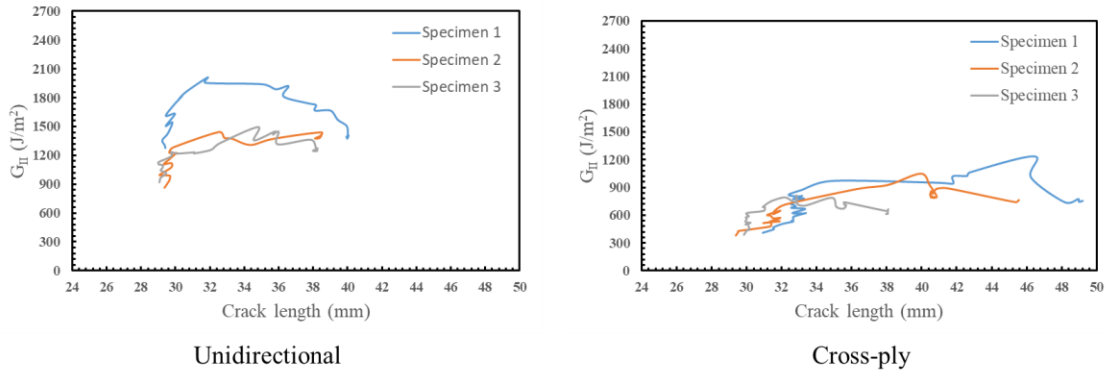
Appendix 13: R-curves under Mode-II shearing loads
