Damage in Non-Crimp Fabric carbon fiber reinforced epoxy composites under various mechanical loading conditions

A thesis submitted in partial fulfillment of the requirements for the Doctor of Philosophy degree in Mechanical and Materials Engineering

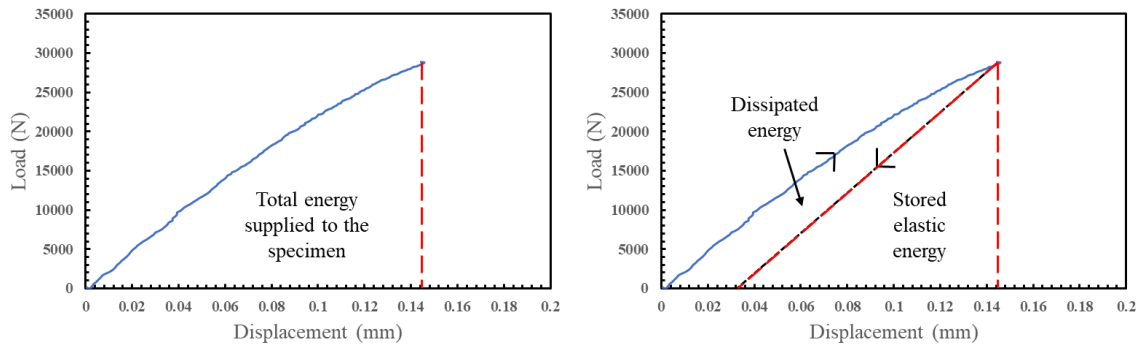
The energies stored and dissipated in the composites upon application of mechanical loads can be determined from the load-displacement curves. Let us consider the mechanical response of and the associated energy balance in $[0/\pm 45/90]_s$ laminate under an axial compressive load as an example.

Energy balance in $[0/\pm 45/90]_s$ laminate under axial compression

The total energy supplied to a specimen is determined by calculating the area under the load-displacement curve. The total energy can be resolved into two components: 1. The energy permanently dissipated and lost 2. The recoverable energy stored elastically in the material. The total energy is mathematically expressed as a summation of the two aforementioned energies.
