**Confirmed Tornado
Newmarket, Ontario
July 17, 2006**

Tornado F-Scale Assessment

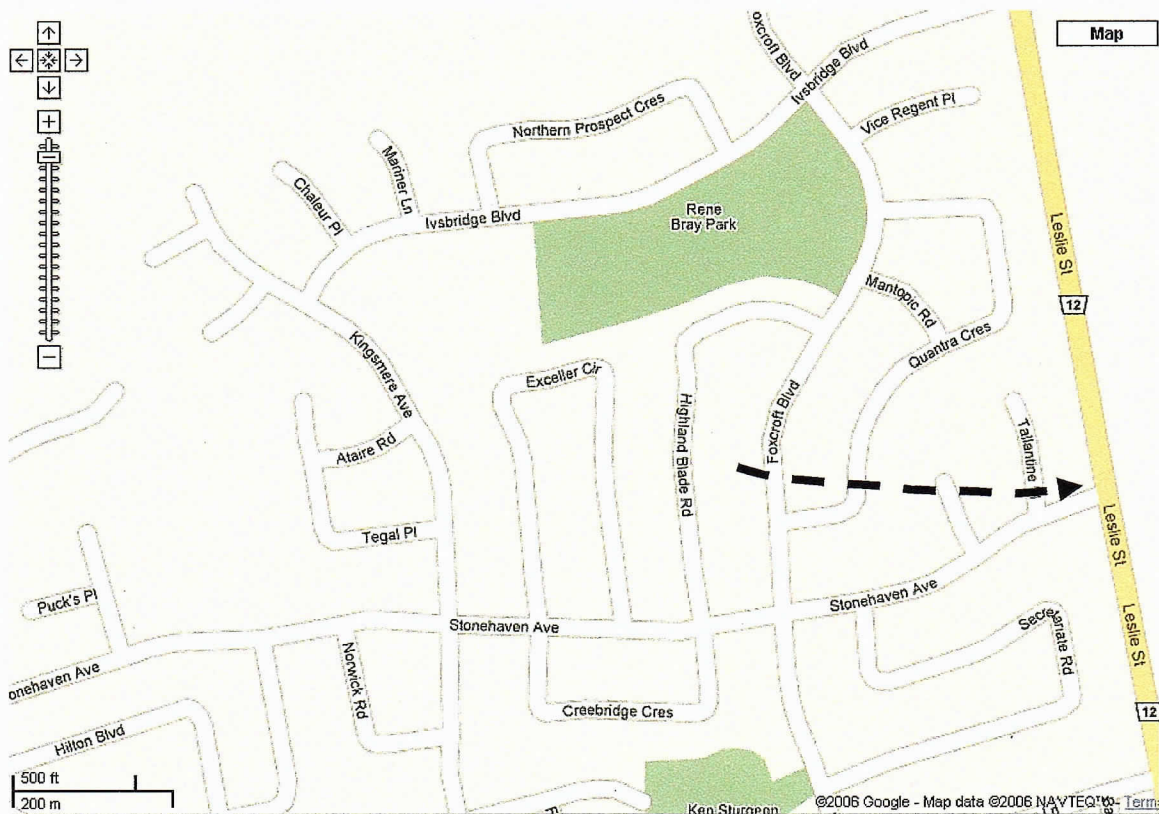
3. Newmarket, Stonehaven Subdivision

At this location there was a narrow track of damage (perhaps 20-30 m wide) extending for about 500 m, beginning on Foxcroft Boulevard and ending at Leslie Street. The land east of Leslie St is being developed as a new subdivision has been stripped bare.

Most of the debris was carried in a northeasterly direction, although one house suffered damage on its north side. In two cases backyard “jungle gyms” were destroyed and knocked down neighboring fences, both moving toward the north. Slats from a wooden fence appear to have been carried eastward about 200 m from Quantra Cres to Landresse Court. We found two instances where aluminum soffits were pulled downward from garage or verandah overhangs. At 798 Landresse Court an asphalt shingle was impaled in a wooden door.
