Confirmed Tornado Rice Lake, Ontario August 20, 2009

Tornado F-Scale Assessment

OSPC Storm Damage Survey Report

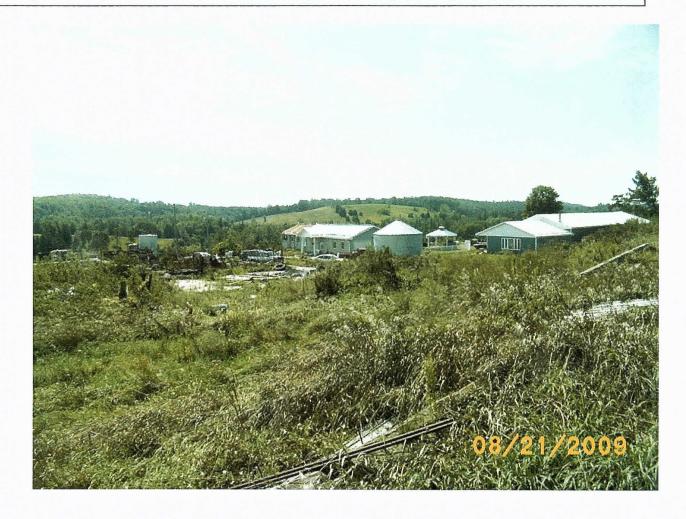
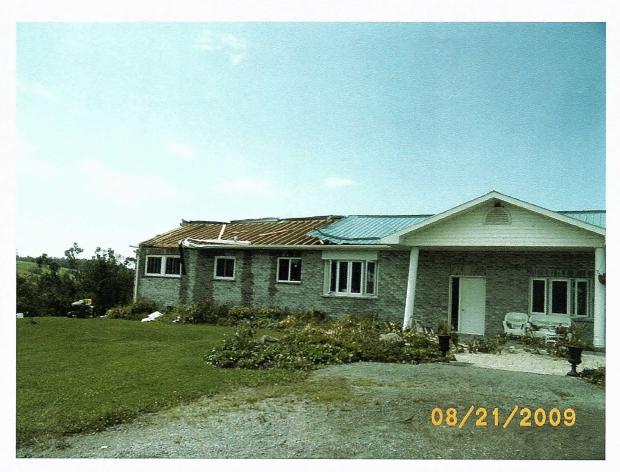
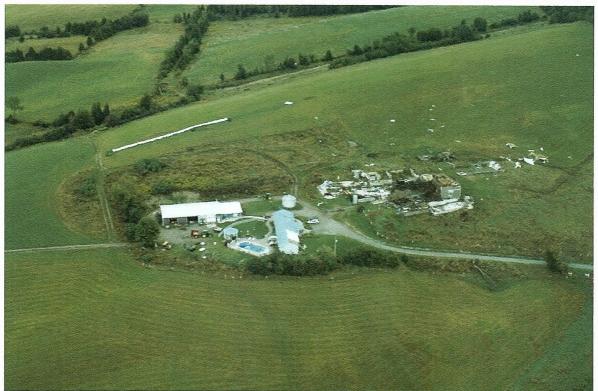
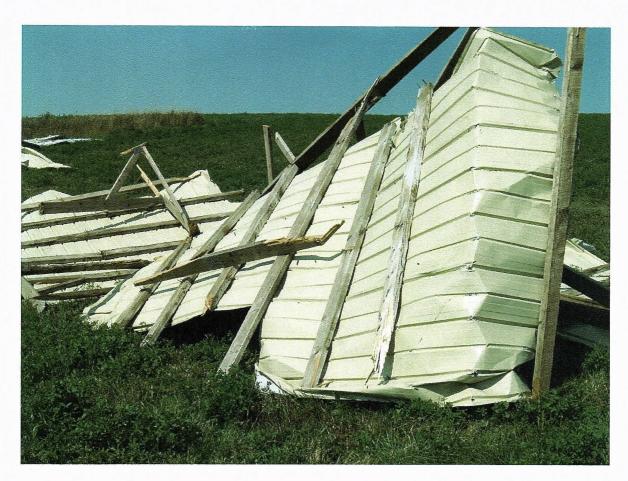
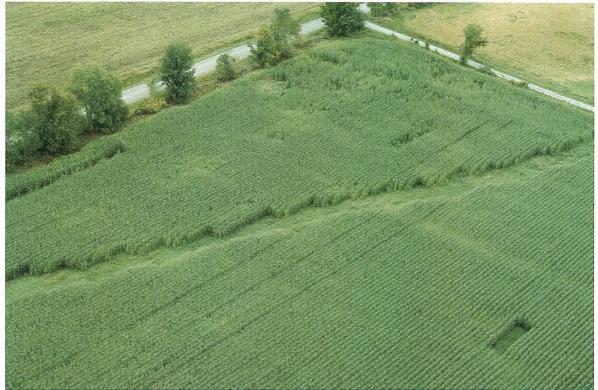
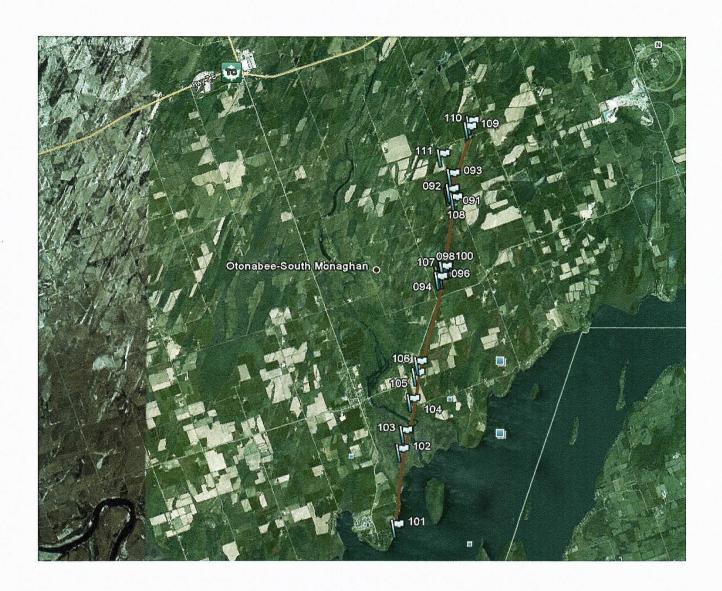
Other Notes There is a very distinct path cut in a corn field, with damage very

localized. Neighbours had no damage

#32 – Facing West. Extensive roof damage (half peeled off and blown away) on house.

- #46 Looking SE. Tree damage along driveway.
- #47 Looking SE. Tree damage along other side of driveway, indicator of path width.
- #48 Photo of barn with 2/3 of the roof lifted off (repairs were being made) and blown 300 m north east.
- #49 Looking NE. Base of large pine tree that was snapped about half way up, trunk diameter = 2-3 ft.
- #50 Looking NE. Wider view of pine tree damage with top of tree snapped off.
- #51 & 52 Facing North. Trees further along the damage path, with their tops snapped off.
- #53 Photo of Arn standing beside our sea plane! ◎

#57-71 – Shots taken of the damages caused by the tornado as seen from the plane. Roughly correspond to the waypoints, although there were more photographs taken than waypoints plotted.
