EXPERIMENTAL INVESTIGATION OF TWO-WAY CONCRETE PANELS EXPOSED TO IMPACT LOAD

Heba G.S. Bayoumy
The American University in Cairo, Egypt

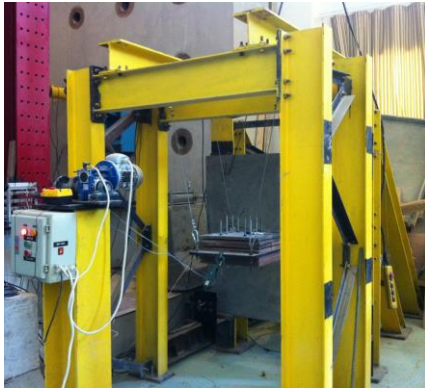
Figure 1: Impact apparatus (Bayoumy 2014)

The test apparatus is a pendulum type impact loading one, designed to hold specimens of different structural elements. This apparatus was designed for a previous research (Cherif, 2009). A winch is used to raise the pendulum mass to the desired height and then release it to hit the specimen. A load cell is attached to the mass striking the reinforced concrete slab to measure the impact force. Different load cells can be placed on the frame supporting the specimen to measure the reaction forces. Figure 1 shows a picture of the impact apparatus.

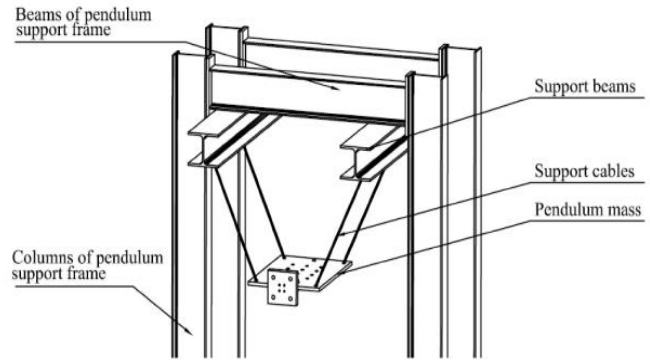
Figure 2: Pendulum mass (Cherif 2009)

The apparatus is designed to support pendulum mass between 80 and 500 kg (Cherif 2009). The impact mass, shown in Figure 2, is constant throughout the test and is equal to 357 kg, as well as the drop height of the mass that is equal to 150 mm, measured from a constant datum. All the details about the experimental testing program is elaborated more in Bayoumy (2014). The impact force caused by the applied impact weight is recorded by the action load cell placed at the center of the face of the impactor. Four load cells, placed approximately at the corners of the panels, with equal distance in between, were used to measure the reaction forces transmitted to the supports. For the surface

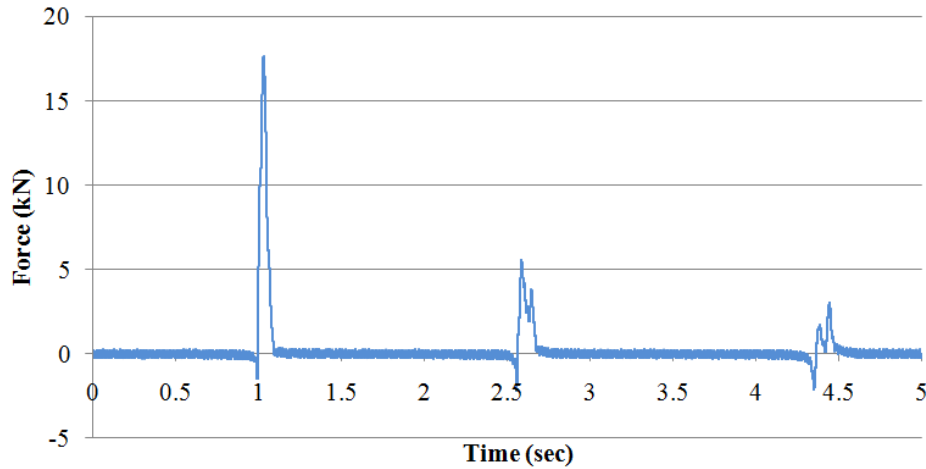
Figure 3: Load - time history (S# 2-1st hit)

The load-time history for the control specimen S# 2 is illustrated in Figure 3. It presents a typical load-time history and a good representative for other R/C specimens under impact load. Ferrocement panels did not sustain more than one hit and they failed, so the load cell recorded one peak force only at the time of the impact. S# 2 recorded a maximum action load of magnitude 17.63 kN at time 1.02 sec. A typical shape for the first wave of the impact load for S#2 is shown in Figure 4, where it also shows a clear illustration of the period load t_d (97 ms).

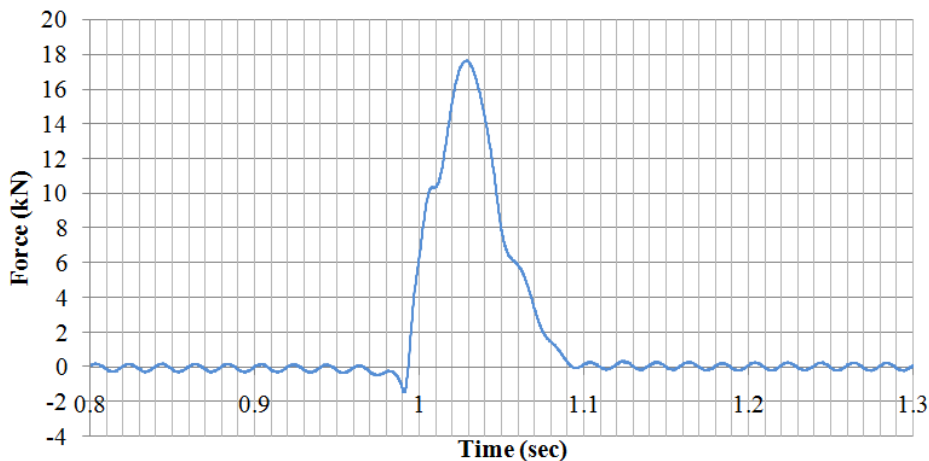
Figure 4: Period of load- t_d (S# 2-1st hit)

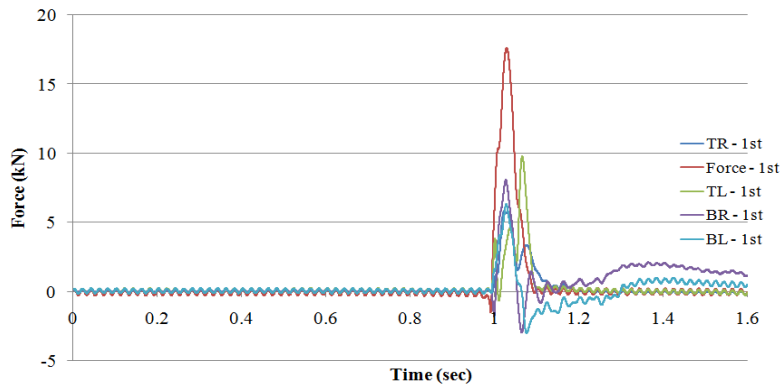
Figure 5: Action - reactions (S# 2 - 1st hit)

The relationship between the maximum action force and all the maximum values of reaction forces recorded for each support for the control specimen S# 2 is shown in Figure 5. The illustration is presenting the values at the first hit, where the load cell recorded the highest load values. By analyzing the results of this specimen, it was noted that at the first hit, there was much difference between the action force and each reaction force, but then, this difference started to decrease at later hits. At the first hit, the specimen shows large action force; much larger than the reactions. The action force in all hits is always higher than each support reaction force and the values of support reactions usually are close to each other except for two load cells at the first hit.

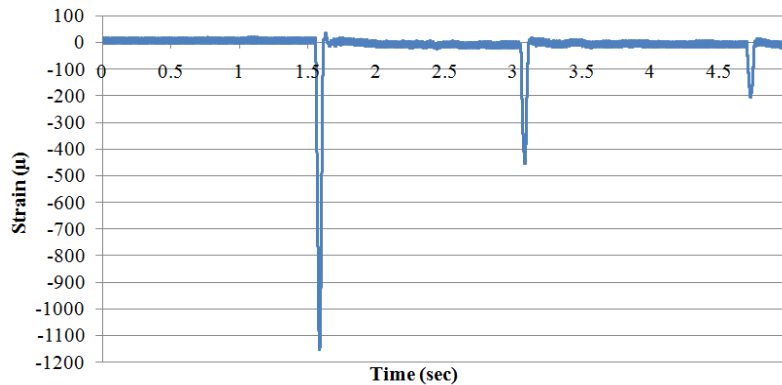
Figure 6: Strain - time St.1 (S# 3 - 1st hit)

Negative strains are induced at the front side of the panel facing the impact as the force is of a compressive type. The values of the strains for St.1 for all R/C specimens were all negative and ranged from 714.16 to 1625.7 μ . As the panel is exposed to more impact strikes, the measurements of the strains induced is expected to increase throughout the test. Specimen #1 was an exception, as the strain readings were decreasing with the hits. Also, for S# 2, the strain slightly decreased between the intermediate and the final strike, however, the difference in both specimens was not high. Other than that, strain recorded for all the panels was increasing with the hits. A good illustration for the change of strain with time is presented in Figure 6, where it presents the values of St.1 for S# 3 at the first hit. The maximum value measured by the strain gauge happened to be at exact the same time of the impact load with a zero time delay. The load cell rebounded twice for S# 3, so this was shown in the corresponding peak values measured by the strain gauge in the figure below. The values of the negative strains at the front side of both ferrocement panels were within the same range of that of the reinforced concrete ones. When comparing between both F.C panels, it is was found that more strain was induced at the specimen with the double mesh reinforcement

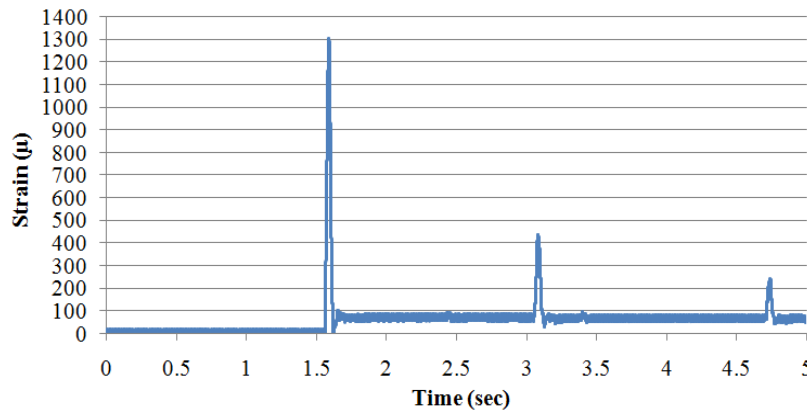
Figure 7: Strain - time St.2 (S# 3 - 1st hit)

The difference between the values of the strains at the compression and the tension sides is not significant. Some of the back strain gauges were damaged during the test due to a disruption in the internal sensor caused by the impact shock or possible manufacture faults. The readings for back-side strain gauges recorded positive strain as they are under a tensile force. Values recorded for S# 1 were significantly low compared to other readings, which indicates an instrumental error while testing. The strain gauges of S# 2 and S# 4 were damaged after the first strike, reading both a constant reading of 5186.3 μ . These results for both specimens were discarded. Figure 7 shows the strain of St.2 for S# 3 at the first hit, where it best represents strain at the back side as strain is increasing with the hits. Both strain gauges for the ferrocement panels failed after reaching the limit of the gauge, but the gauge placed for S# 6 recorded much less value than that of S# 5.

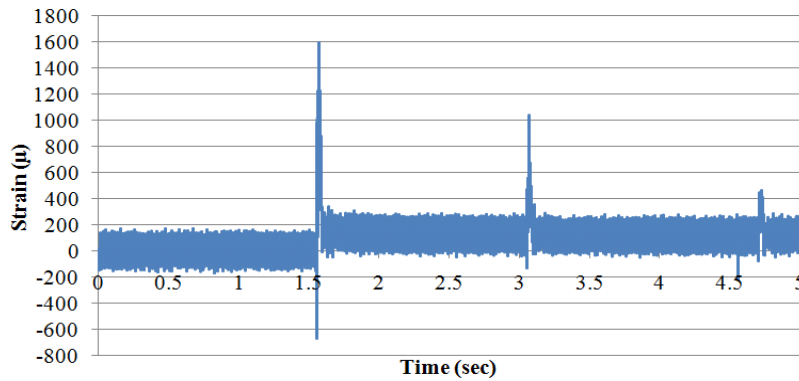
Figure 8: Strain - time St.3 (S# 3 - 1st hit)

Values recorded for St.3 were as anticipated, except for S# 2 and S# 4 as they failed by reaching the limit of the gauge after the third hit. S# 4 recorded the lowest value at the first hits compared to other R/C specimens, but it then recorded an inconvenient high negative value, which can be due to sensor malfunctioning or poor gluing of the gauge. Figure 8 shows the strain values of St.3 for S# 3 after the initial hit. By comparing the readings of strain gauges at the two different locations along the panel; middle and quarter, it was noted that the values were within the same range for all specimens, except S# 1, where the readings at the middle were much lower than that at the back. In general, it is expected that the values of strain at the middle of the span to be more than that at the quarter. For the ferrocement panels, St.3 recorded the highest noise vibrations of all specimens. The gauges recorded maximum value of 553.2 and 947.8 μ for the double mesh and single mesh slabs (S# 5 and S# 6), respectively. Unlike St. 2, St. 3 recorded less value at double mesh specimen than that at the single mesh panel.

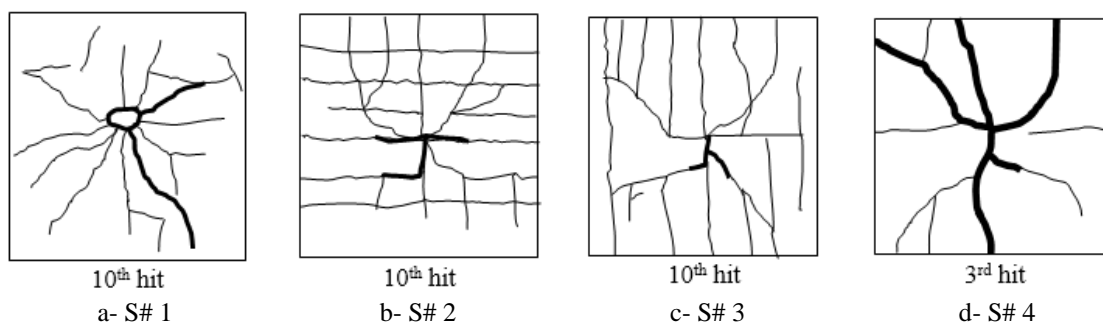
Figure 9: Cracks sketch- back side of R/C specimens

The observations of the failure mode and the cracking that happened at each specimen type is presented in this section. Figures 9a-c shows a sketch of the final cracking pattern for each of the four reinforced concrete specimens. For S # 1, the cracks on the back surface showed a fanned pattern coming out of the centre of the impact point and propagating. At first it started as minimal hair cracks and then these hair cracks were developed and got wider around the center of the impact region by the end of the test. This specimen was stiff enough to sustain the load and it did not fail after impacting ten hits. The cracking pattern of S# 2 is of a different type. At first, horizontal (transverse) cracks started to appear and by the fifth hit, few longitudinal cracks started from the center of the impact region and propagated along the longitudinal direction of the slab. By the end of the test, cracks at the center became wider and deeper and slab deflection remarkably increased.

For S# 3, long and wide cracks appeared right after the first hit. Along the test, few more cracks were developed and there was an increase in the crack width of cracks at the middle of the slab. Cracking increased rapidly during the last five hits. As shown in Figure 9-c, a rigid region appears near the middle and the left side of the back surface. Cracks were developed above and below this area. This may be explained as during casting, the reinforcement at this specific region was shifted more towards the back of the slab thus, increasing the effective depth and the tensile reinforcement at this area. Slab damage observation of S# 4 is very distinctive from all other R/C specimens. This specimen is a weak one as concluded from studying the reaction forces. It completely failed after the first three hits only and then the test was terminated. Starting from the first hit, the slab experienced cracks of very high thicknesses and depths. The overall number of cracks is minimal, but most of the cracks were wide and deep. The widest crack was found to be near the center, indicating that this is the slab's weakest point.
