A restorative approach for class II resin composite restorations: A two-year follow-up

A Restorative Approach for Class II Resin Composite Restorations: A Two-Year Follow-up

SUMMARY

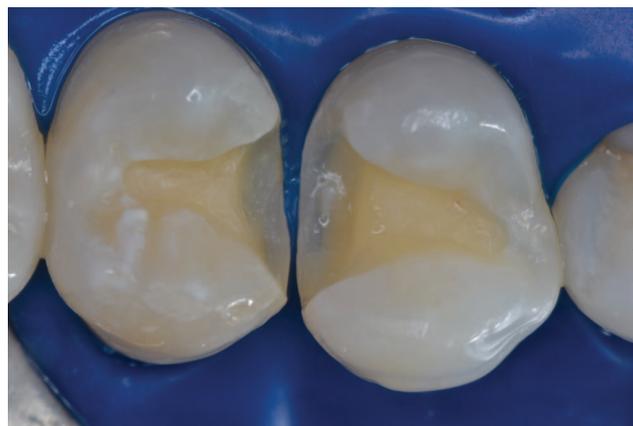
Figure 2. Restorations were removed and the preparations were refined with a No. 245 carbide bur. Note the presence of enamel around all margins of the cavity preparation. Obtuse angles were developed at the proximal margins to increase the number of enamel rods exposed for the acid conditioning.

Isolation was performed using a rubber dam. The old composite restorations were removed, and the preparations were refined with a No. 245 carbide bur. Bevels were placed at the facial and lingual walls of the proximal box using a diamond needle bur (DET-CEF, Brasseler, Quebec, Canada). Unsupported enamel at the gingival margins was finished with gingival margin trimmers (Hu-Friedy Mfg Co, Chicago, IL, USA) (Figure 2).

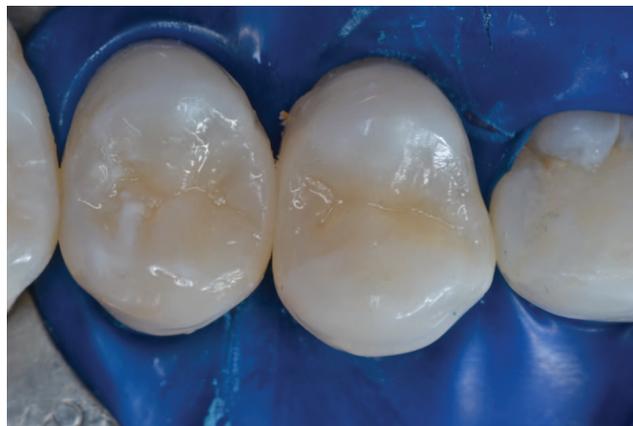
Figure 4. Final aspect of the Class II restorations after application of the surface sealer.

Finishing and polishing procedures were accomplished with the use of a diamond bur (DET-CEF, Brasseler) followed by rubber points (Pogo Points, Dentsply Caulk, Milford, DE, USA). Proximal and occlusal embrasures were refined with fine disks (Sof-lex Finishing/Polishing Kit, 3M/ESPE). After polishing, a surface-penetrating sealant was applied to each restored tooth (Perma Seal, Ultradent, South Jordan, UT, USA). The resin composite surfaces, including the margins, were etched with 35% phosphoric acid for 5 seconds, rinsed and dried. A thin layer of a surface sealer was then rubbed into the surfaces, gently air thinned, and light-cured for 20 seconds (Figure 4).
