**Confirmed Tornado  
Beachburg, Ontario  
June 22, 2004**

## **Tornado F-Scale Assessment**

**Explanation of Assessment:** From a couple of newspaper articles: photos of 1 or 2 old barns that were either demolished or carried away. Also a picture of a mobile home that was moved ~35feet with no dragging marks on the ground. There is also a statement in the article about the neighbour claiming he saw the tornado.

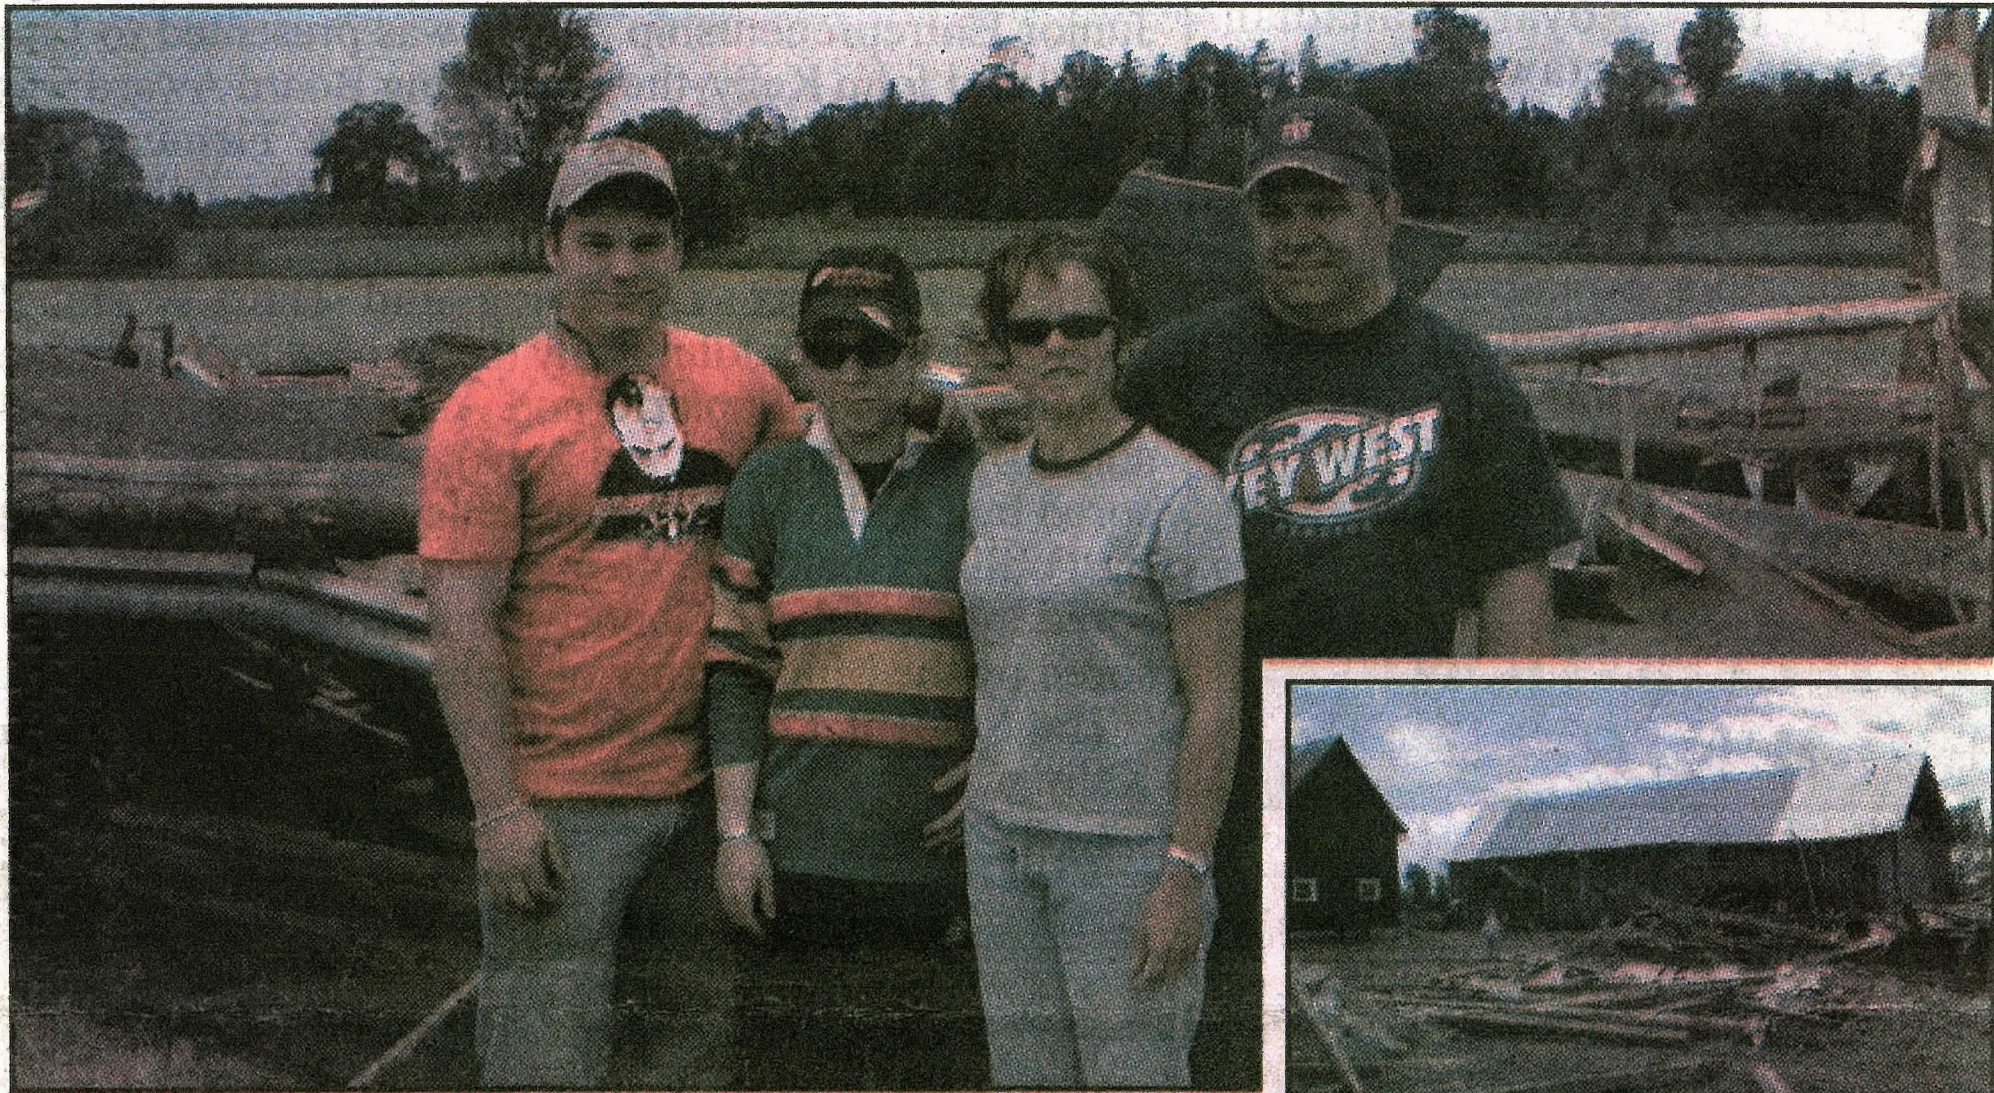
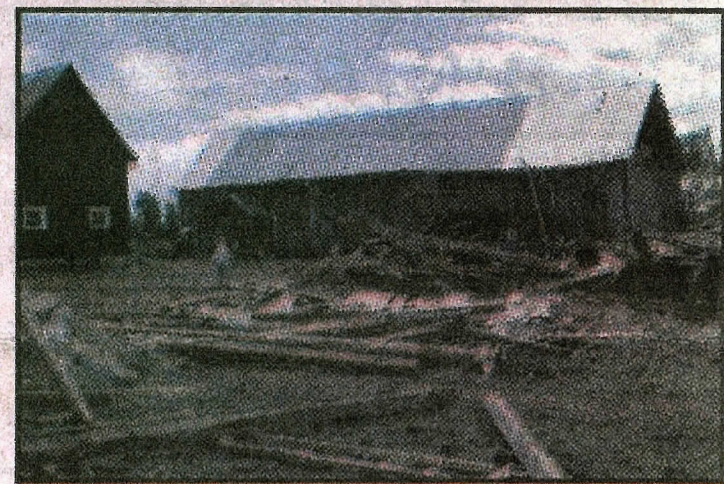
**ALL OK** – The Summers family are counting themselves lucky after an apparent tornado touched down on their property last week and only destroyed a 100-year-old barn. From the left are Brian, Alicia, Cathy and Tim. Inset at the right is what remains of the barn. (Observer photo by Dave Noppe)

The biggest casualty was a more than 100-year-old barn that is now nothing more than a twisted pile of broken lumber.

The roof of the barn was torn off and thrown into a nearby field.
