**Confirmed Tornado  
Avon, Ontario  
June 25, 2009**

## **Tornado F-Scale Assessment**

# OSPC Storm Damage Survey Report

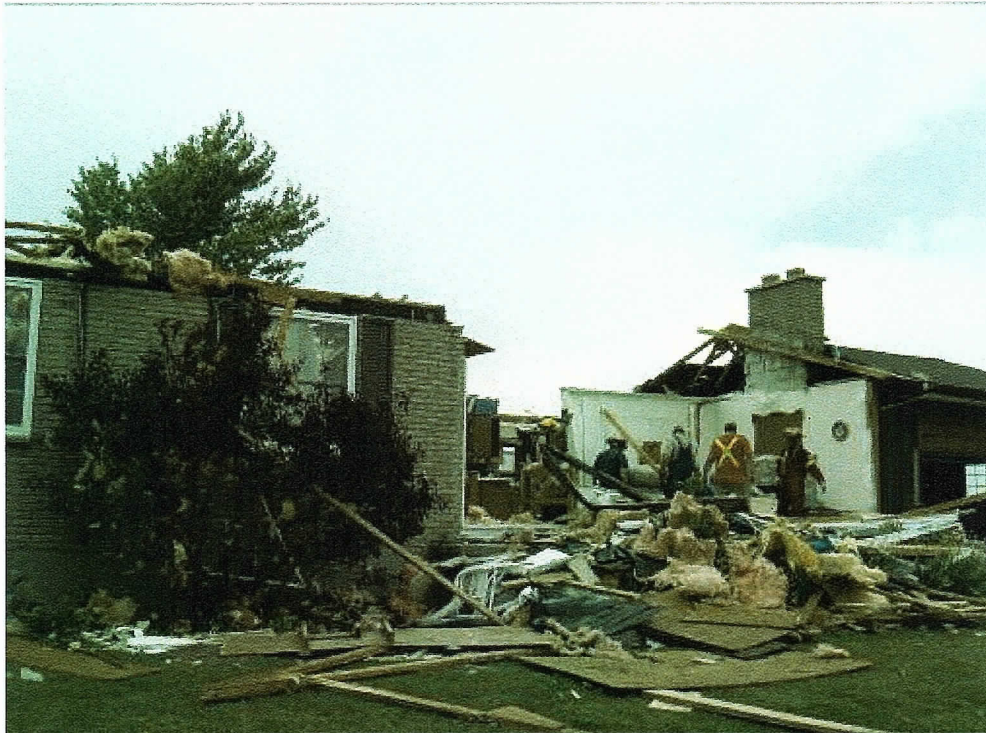
Bungalow at 51342 Wilson Line

| Damage Description | 51342 Wilson Line bungalow seriously damaged with roof removed and front wall knocked over. Tree immediately north of home had only two or three branches broken. Barn roof damage at 3279 Avon Dr and more significant barn damage at 2669 Gladestone Dr. | |
