**Confirmed Tornado
Clandeboye, Ontario
June 8, 2008**

Tornado F-Scale Assessment

Assessment: F1

Explanation of Assessment: A small shed was completely destroyed, and witnesses saw a trailer being flipped over.

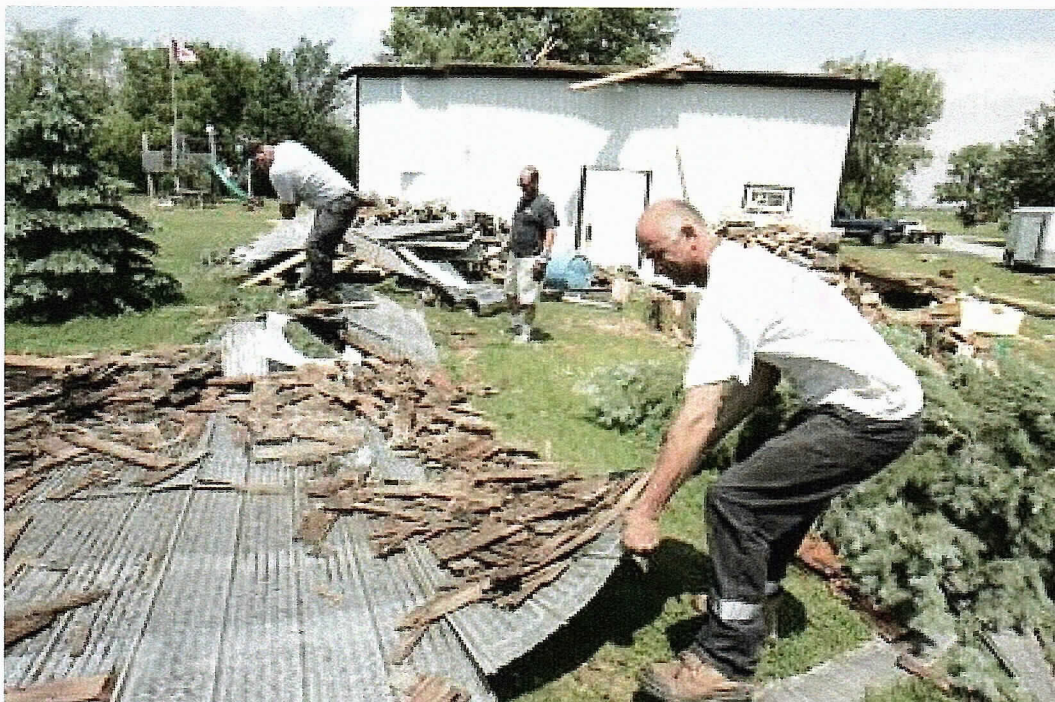
Shed that was destroyed
