Confirmed Tornado Redstone Lake, Ontario August 20, 2009

Brad L. Rousseau Tornado Data Production Assistant, Environment Canada February 26th, 2010

OSPC Storm Damage Survey Report

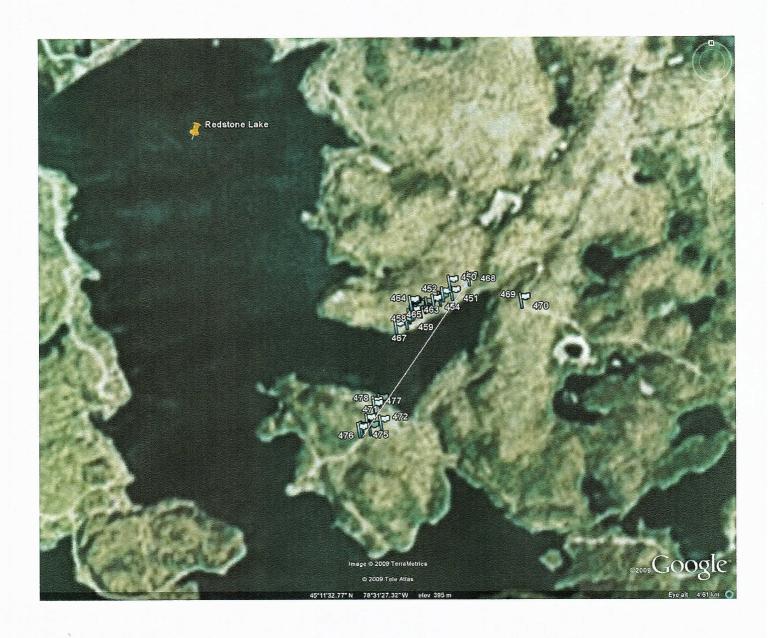
Storm damage survey Map detailing damage area

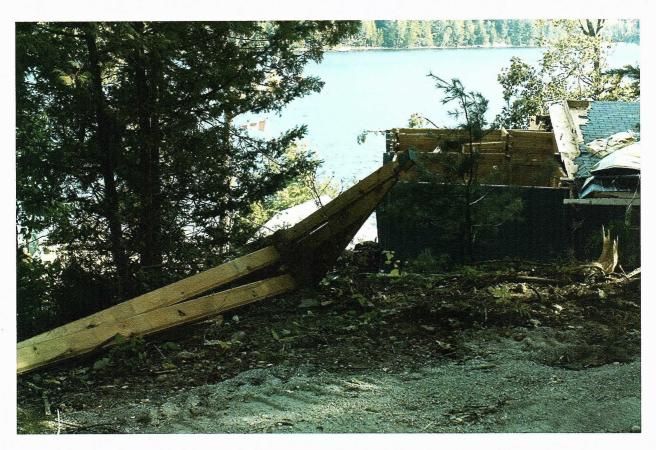
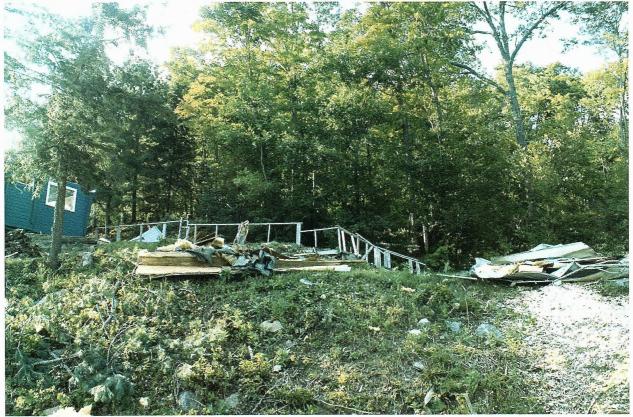
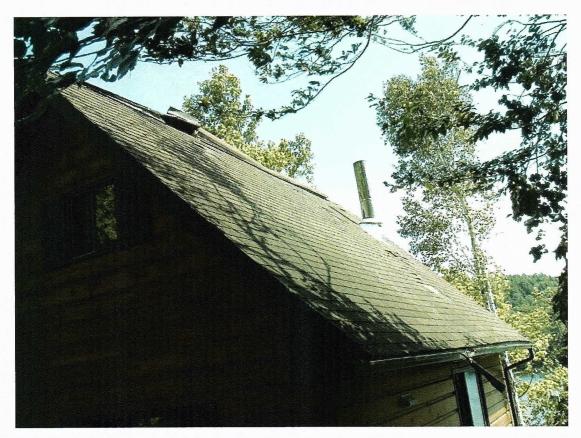
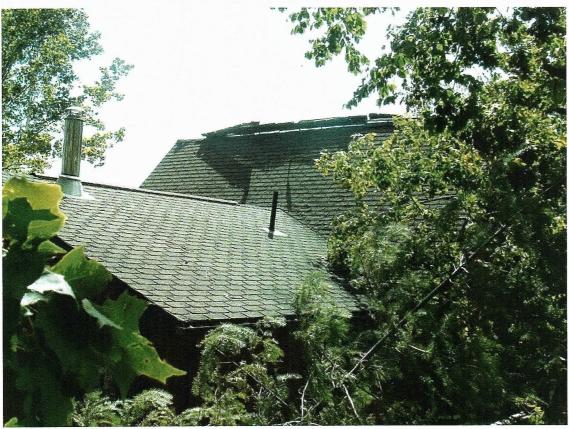
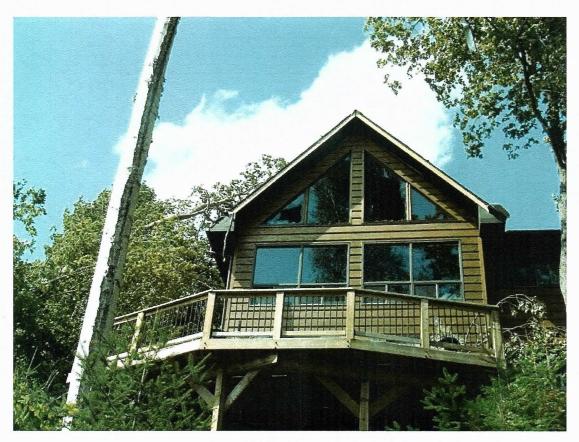
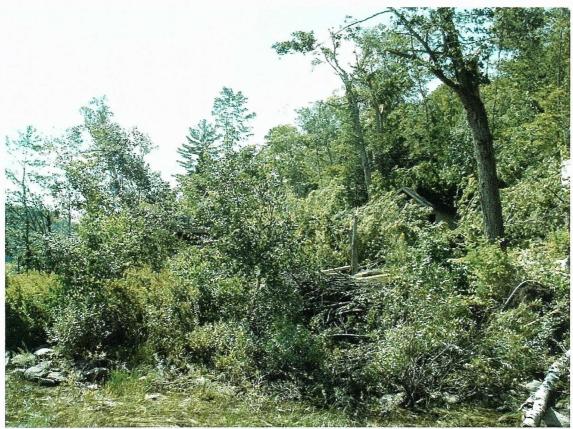
Photos of tree damage, and damage to cottages both structural and cosmetic

Explanation of Assessment: Intermittent trees snapped and uprooted, with some evidence of convergent damage. Some shingles and fascia removed from roof. One cottage had part of roof removed.
